PROJECT ASSESSMENT

“Shot-crete Job Gone Wrong”

CITY OF GRANT CITY
GRANT CITY, MISSOURI

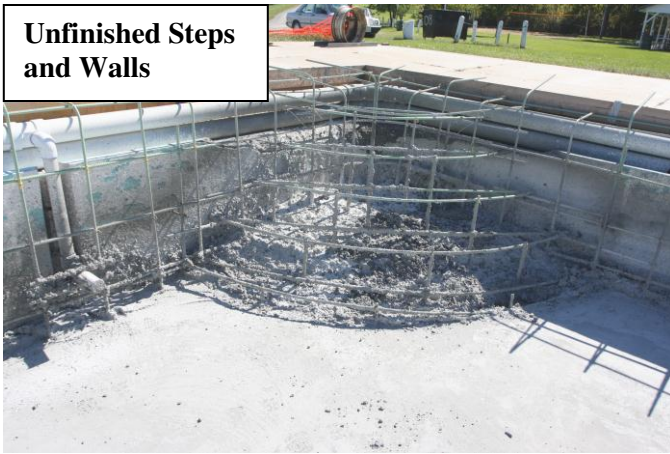
Unfinished Steps and Walls

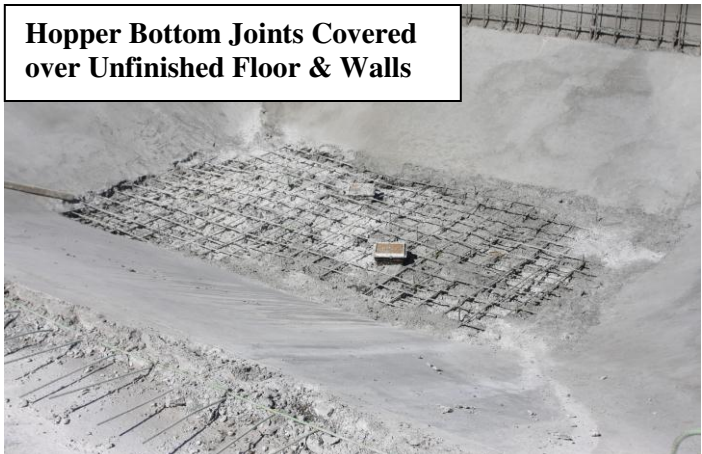
Hopper Bottom Joints Covered over Unfinished Floor & Walls

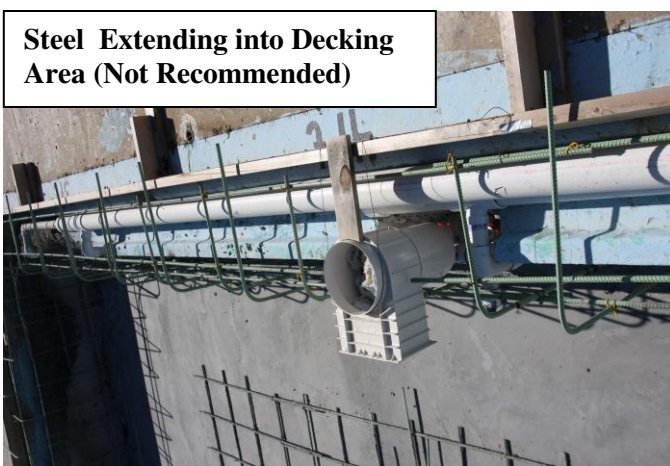
Steel Extending into Decking Area (Not Recommended)
