PROJECT ASSESSMENT

“Shot-crete Job Gone Wrong”

RENOVATION PLAN

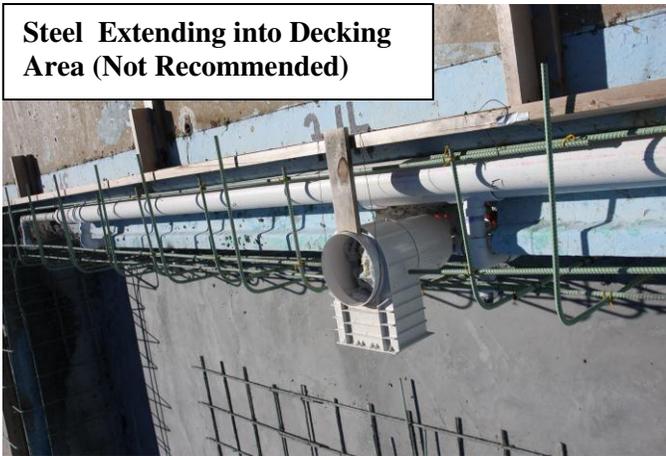
Steel Extending into Decking Area (Not Recommended)
