### **PROJECT HISTORY**

### METROPOLITAN CONDOMINIUMS

KANSAS CITY, MISSOURI

# **PROJECT ASSESSMENT**"What needed to be done"

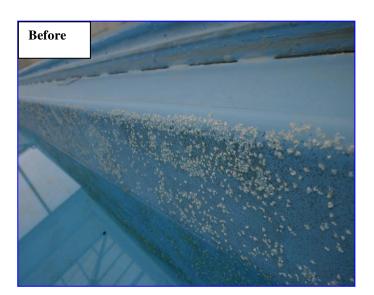
An indoor, sectionally fabricated aluminum pool that was plagued by unsightly deposits and surface discoloration throughout the pool surface. A byproduct of aluminum corrosion, these white, crystalline, barnacle-type deposits was possibly an aluminum bromide chemical compound. Also evident on the surface was a large volume of 'black pinholes' that routinely appear when thick, high solids coatings are applied. With windows completely exposing the pool to UV rays from the sun, degradation and chalking of the existing pool coating left a film of residue rubbing off of the pool surface. No provisions were in place to protect dissimilar metals (S/S, aluminum, & galvanized steel) coming into contact with each other in this very active, electronic environment. Surface and fixture corrosion was extensive.

Being an indoor pool on the 14th floor made abrasive blasting somewhat impractical. Eventually, mechanical grinding was chosen to remove all the deposits and degraded coating from the pool surface and gutter channels. In an effort to rid the contact of dissimilar metals touching each other, corroded stainless steel

ladders were replaced by non-conductive, reinforced vinyl ladders, the existing metal lights were replaced by low voltage, plastic bodied lights, and the entire pool surface was sealed with the non-conducting INTER-GLASS® Reinforced Composite System.
