PROJECT HISTORY
ANNE ARUNDEL COMMUNITY COLLEGE
ARNOLD, MARYLAND

COMPLETION: 2009

PROJECT ASSESSMENT

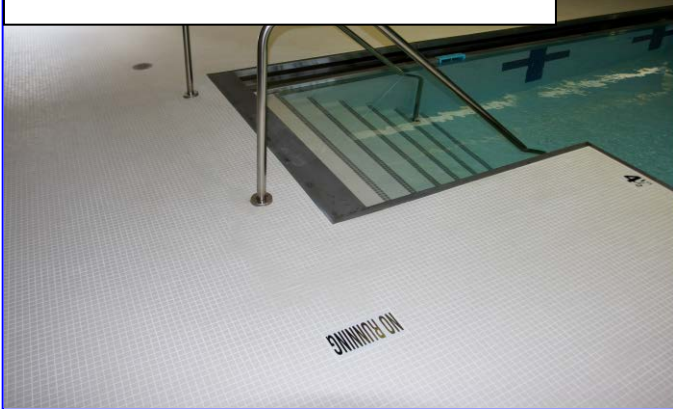
New Concrete Steps & Gutter Additions

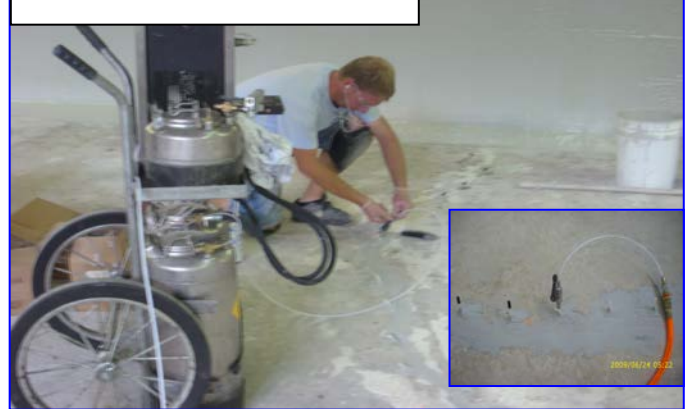
Epoxy Injection in Progress

High-pressure epoxy injection was used to repair the structural cracks, new rebar was installed, primed with a zinc-based coating to inhibit rust, and encased in epoxy mortar. To fully seal the pool structure, a **Hydro Ester Protection System** was installed over the entire surface. 1”x1” tile was then applied to the entire pool surface. A medium pressure UV filter system was installed to work in concert with the existing filtration system. Deck tile was installed using standard cement-based materials. The pool was filled and started, and is currently leak free and operating beautifully.

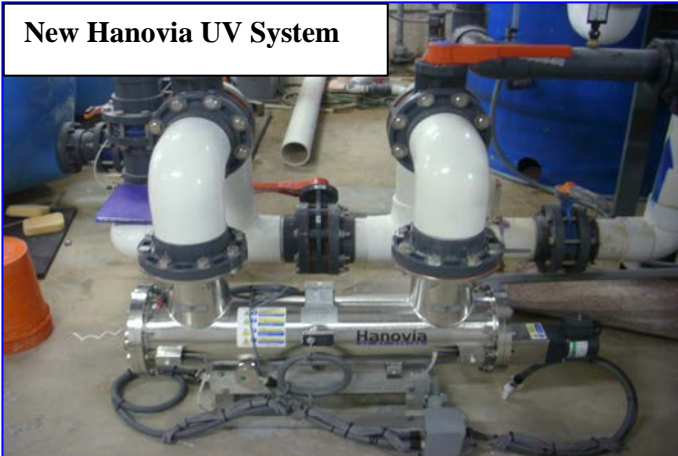
New Hanovia UV System

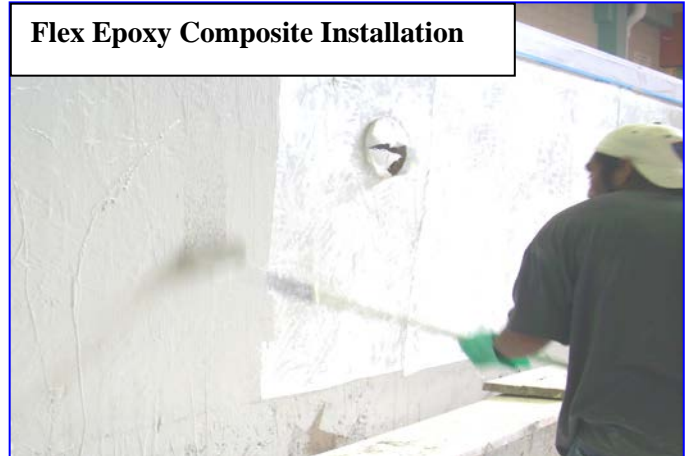
Flex Epoxy Composite Installation

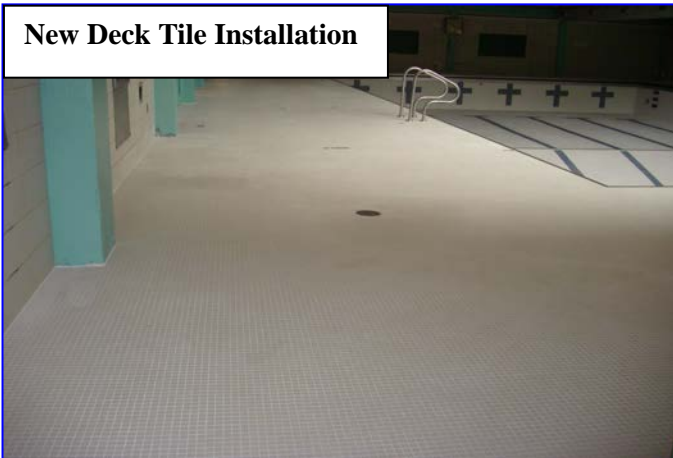
New Deck Tile Installation

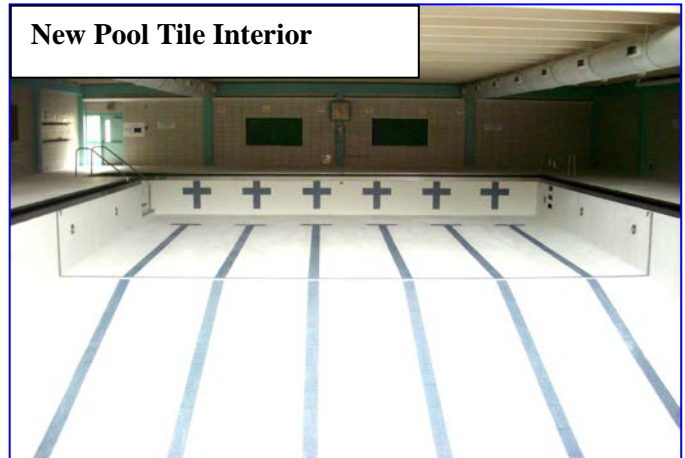
New Pool Tile Interior
