**PROJECT ASSESSMENT**  
*“What needed to be done”*

# CITY OF BURLINGAME, KANSAS

## BURLINGAME, KANSAS

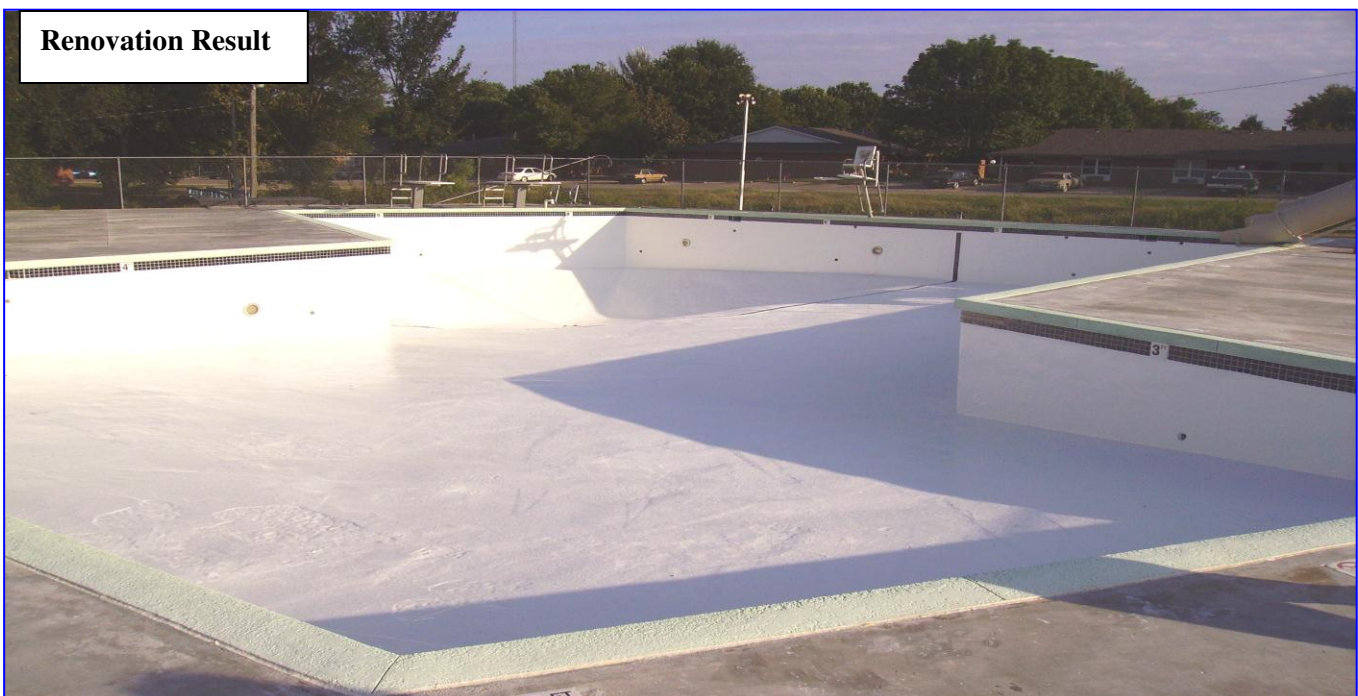
This large, formed and poured commercial pool was in need of complete re-construction. The entire pool interior including the expansion joints and waterline tiling was covered with a spray applied fiberglass liner only a couple of seasons before our work began. With no room for expansion or contraction, and a poorly prepared substrate, the liner began to release pulling off chunks of freeze damaged sub-surface concrete along with it. The pool coping was badly deteriorated and releasing from the bond beam at numerous locations around the perimeter of the pool.

Following removal of the liner, waterline tiling and all loose and deteriorated concrete, the surface received high-pressure abrasive water blasting. High-grade epoxy sealants filled structure cracks in the pool shell. The complete existing concrete surface including the tile bed area was reinforced with a pneumatically applied, course, quartz aggregate cementitious render coat utilizing fibers, bonding and water reducing agents

in the mix. New frost-proof waterline tiling was installed. Particular care was taken to cut and rebuild a previously filled expansion joint between the existing pool shell and pool decking before forming and pouring an *in situ* cantilever coping, topped with colored kool-deck. The INTER-GLASS® Reinforced Composite System was installed over the entire remaining pool interior surface.
