## PROJECT ASSESSMENT

"PVC Problems."

## **RENOVATION PLAN**

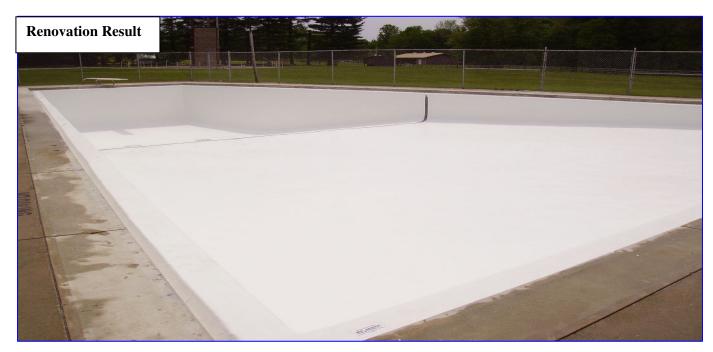
Several years ago, the camp owners of this large outdoor, shot-creted and plastered pool opted to install a PVC Liner. After some years of use, the liner began exhibiting unappealing traits such as folds, discoloration, and pinholes resulting in tears and water loss. Moisture and condensation that transport through the liner and seep up through the pool shell by hydro static pressure became trapped. Yearly cycles of trapped freeze / thawed water damaged the plaster and concrete surface under the liner, resulting in tearing apart layers of the subsurface and demonstrating how damage and corrosion beneath an unbonded sheet lining can proceed unnoticed for several years. Structure cracks also affected the pool shell.

The deteriorated liner and disintegrating, contaminated felt material under the liner were cut apart and removed. Chunks of plaster and concrete damaged by being trapped under the liner through several years of freeze/thaw cycling were removed. Following high water pressure blasting (>5000 psi), and setting up

hydrostatic water pressure relief by diaphragm pumping, all the structure cracks were permanently sealed with a high-grade epoxy sealant and InterSteel. Finally, the entire pool received the INTER-GLASS® Reinforced Composite System that included a frost-proof tiled depth transition line.
