PROJECT ASSESSMENT

RENOVATION PLAN

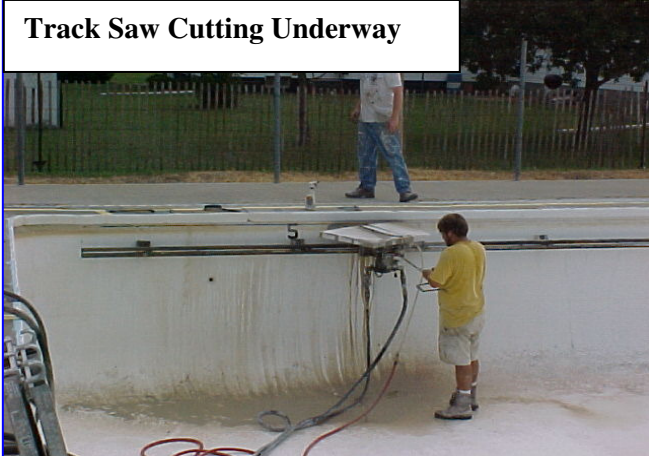
Track Saw Cutting Underway

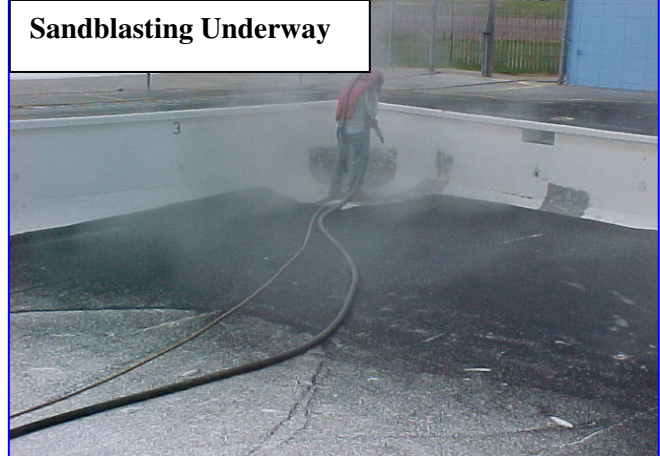
Sandblasting Underway

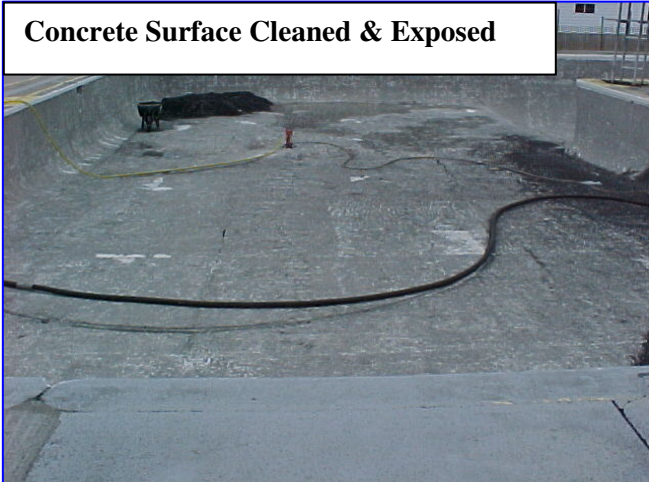
Concrete Surface Cleaned & Exposed

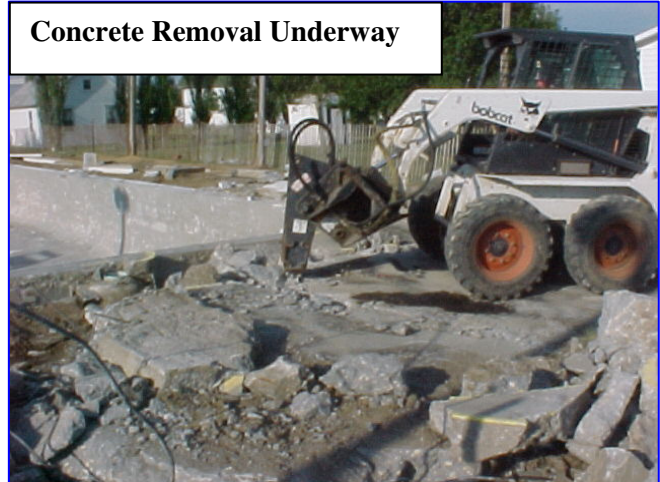
Concrete Removal Underway

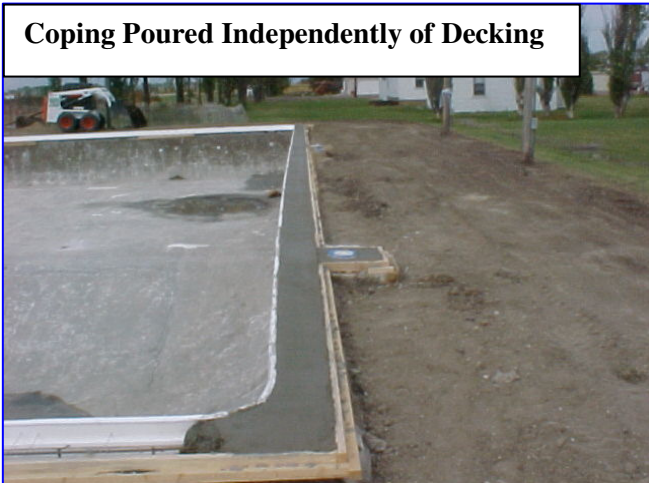
Coping Poured Independently of Decking

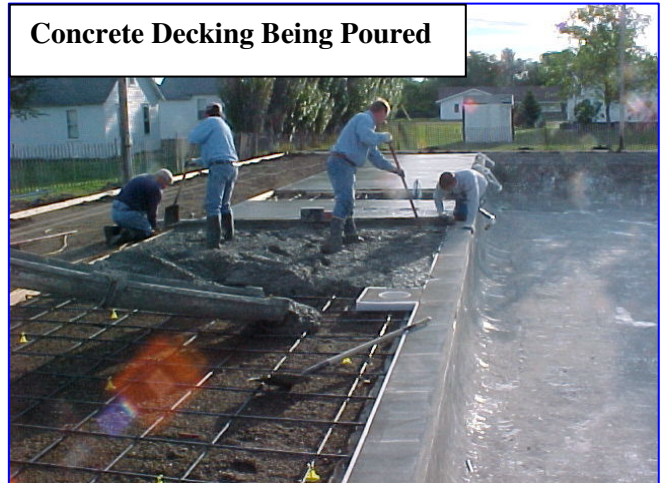
Concrete Decking Being Poured
