PROJECT ASSESSMENT

FOREST LAKE HOMEOWNERS ASSOCIATION

LINCOLN, NEBRASKA

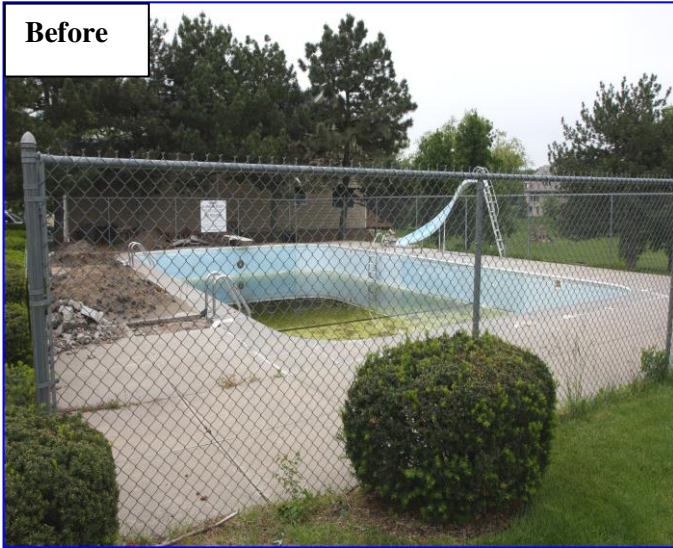
Before

This medium sized, commercial acrylic-vinyl panel wall/poured concrete bottom pool was suffering from leaking and outdated, black flexible krylon piping held together with hose clamps. One wall panel was so structurally damaged that it needed replacement. Cracked and deteriorated pool coping was pulling away from the pool decking, and a blistered and failing spray applied PVC vinyl membrane was applied on the pool floor. Structural cracks radiating up through the sprayed applied vinyl membrane allowed chemically treated pool water to come into contact with the reinforcement steel.

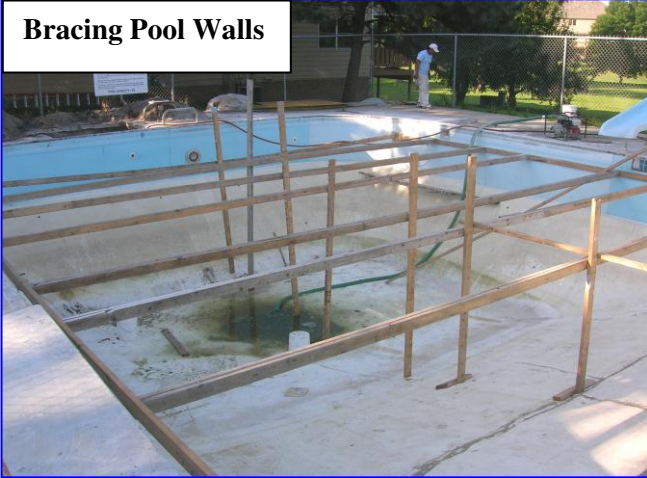
Bracing Pool Walls

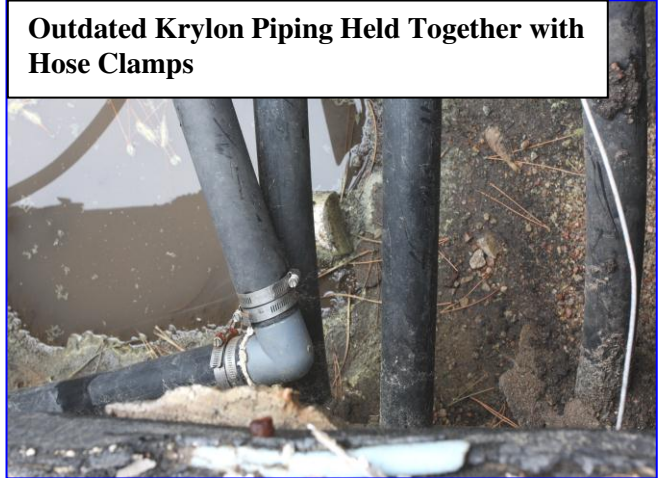
Outdated Krylon Piping Held Together with Hose Clamps

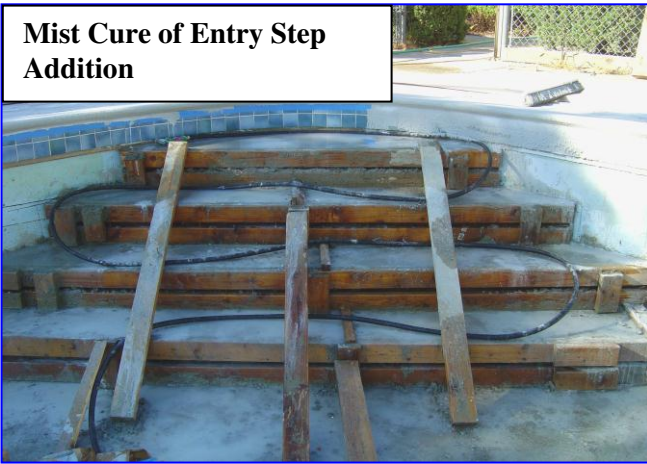
Mist Cure of Entry Step Addition

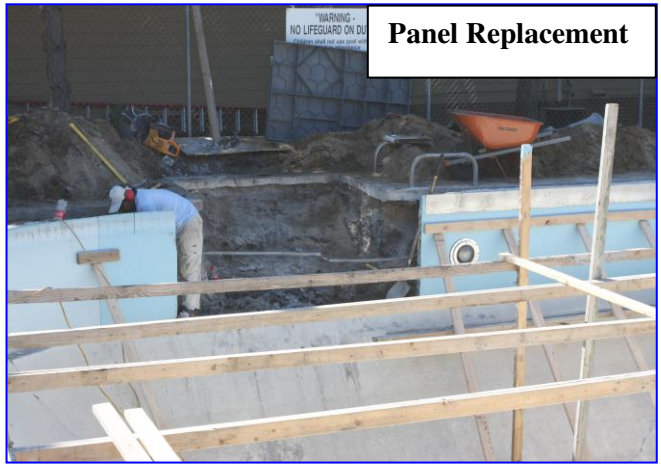
Panel Replacement

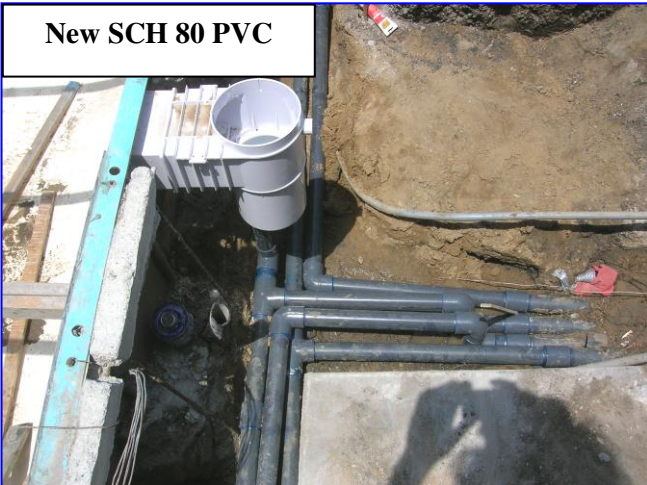
New SCH 80 PVC

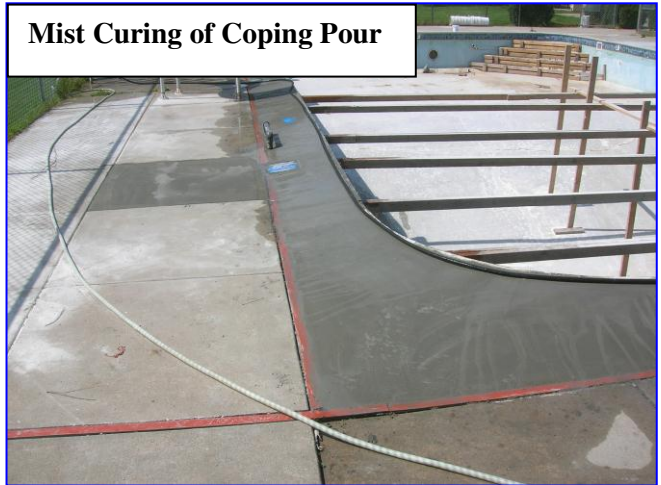
Mist Curing of Coping Pour
