### PROJECT ASSESSMENT

### RENOVATION PLAN

# LAKE PARK PLAZA CONDOMINIUMS

## CHICAGO, ILLINOIS

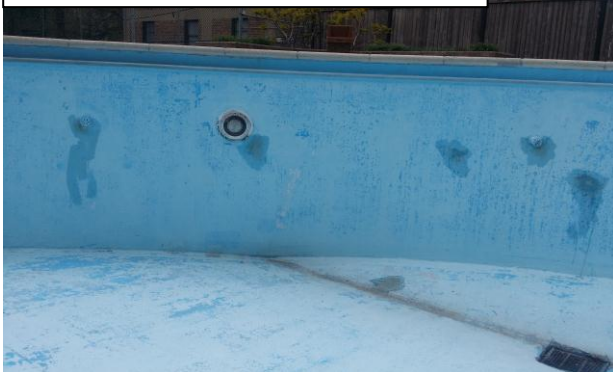
Surface Before Removal Begins

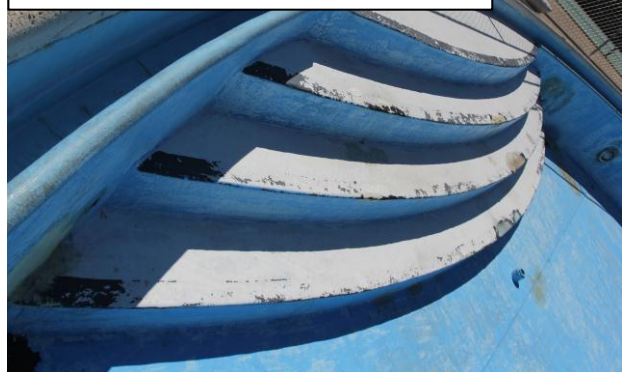
Entry Steps at Start of Project

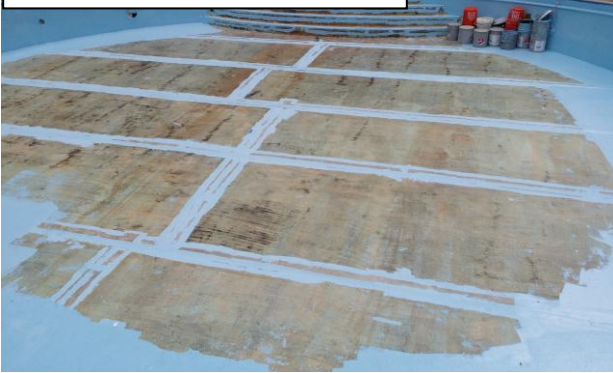
Paint Removal Underway

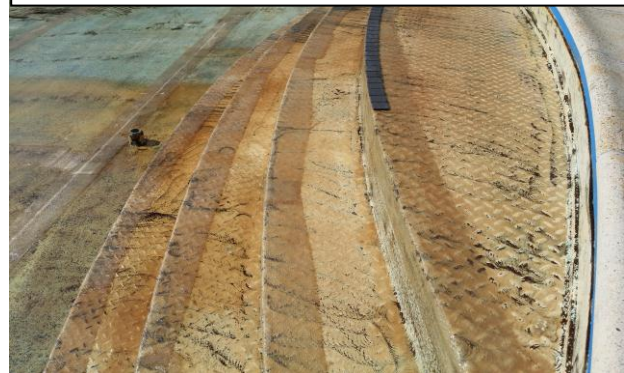
Zinc Coating, Multiaxial Fabrics, & Tile Install

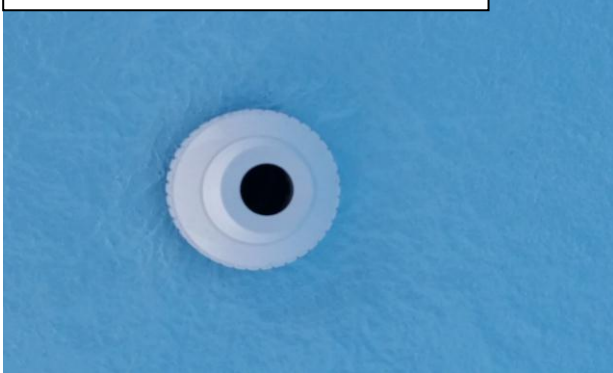
Updated Return Line Inlet

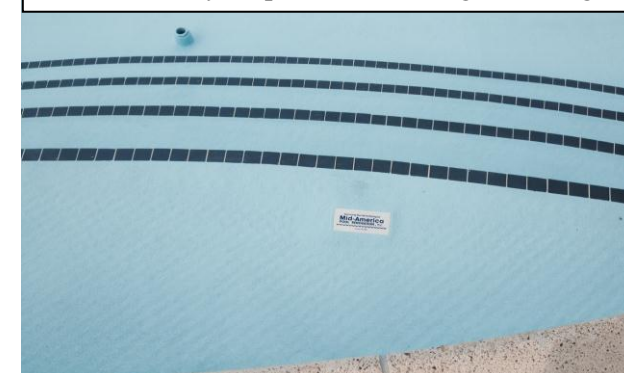
Restored Entry Steps with Tiled Edge Marking
