PROJECT HISTORY—SITE PRESERVATION

LINCOLN PARK ZOO – KOVLER SEA LION POOL

CHICAGO, ILLINOIS

2016

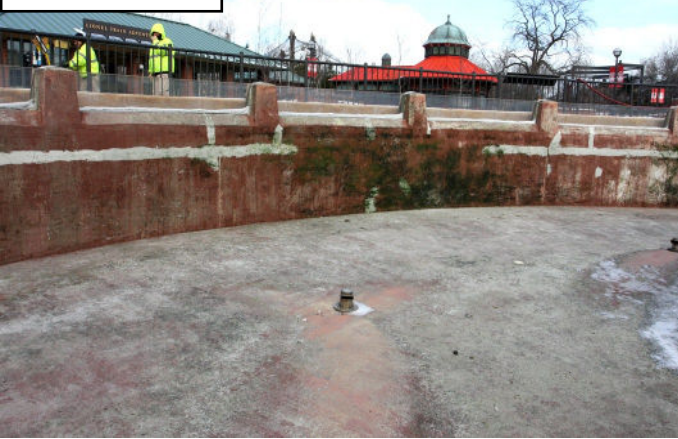
Before Renovation

Originally built in 1879, and partially refurbished in 1969, the aging 130 year old Kovler Sea Lion Pool was suffering from extensive water loss (in excess of 20,000 gallons a day), numerous structure cracks, deterioration of its existing coatings and sealants, and many unsightly short term surface patches and repairs. Unsealed concrete, cracks in the faux rocks, and expansion and construction joints with missing sealant were all viable channels for water loss. The 4-FT high overflow ‘tunnel’ with remaining embedded shards from the deteriorating original iron construction forms presented the most challenging efforts for rehabilitation work.

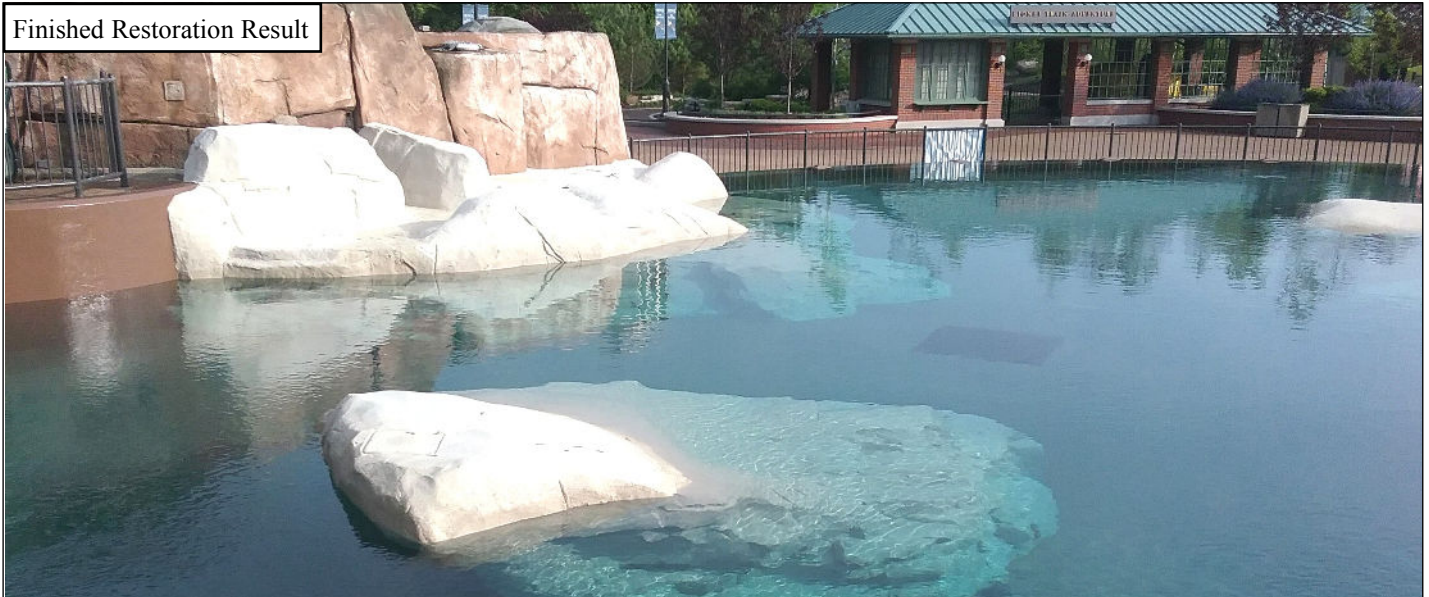
Finished Restoration Result

Trapped water in the rock features was drained out, cracks were filled, and given a colored Cementitious Waterproofing Protective Coating. Structure cracks in the pool shell were cleaned, epoxy injected and permanently sealed with a proprietary I/G crack sealing system. Holes in the concrete structure were filled and primed with an Epoxy Amine. Remaining embedded iron construction forms were covered with Armatec® EpoCem® coating material. An epoxy elastomeric penetrating resin was installed over the entire surface, followed by two layers of integrally colored INTER-GLASS® and a final coating of fluoro-polymer.

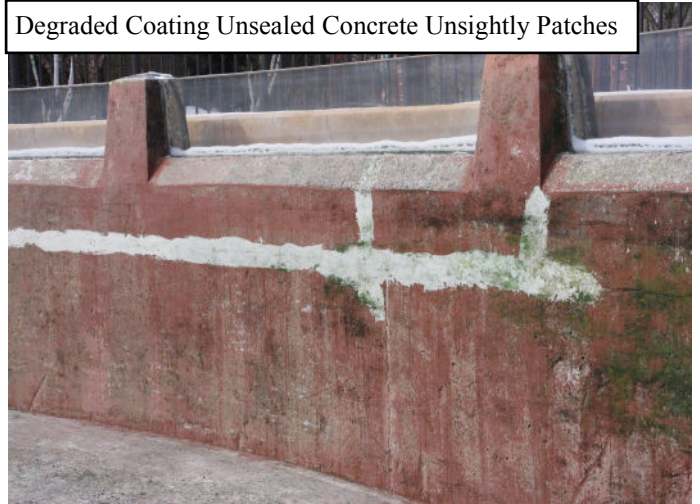
Degraded Coating Unsealed Concrete Unsightly Patches

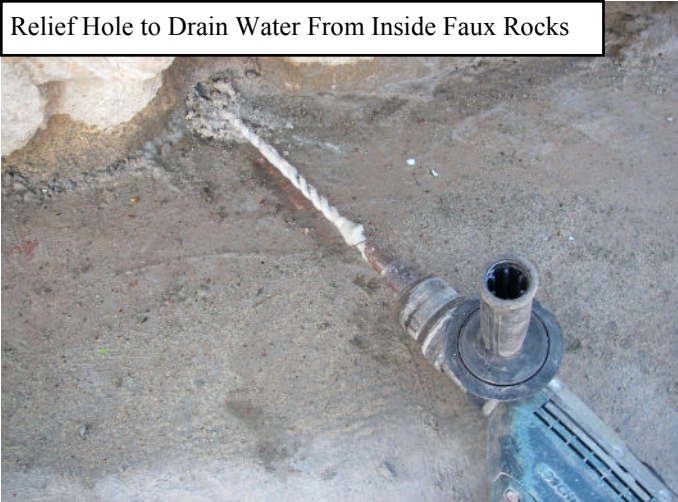
Relief Hole to Drain Water From Inside Faux Rocks

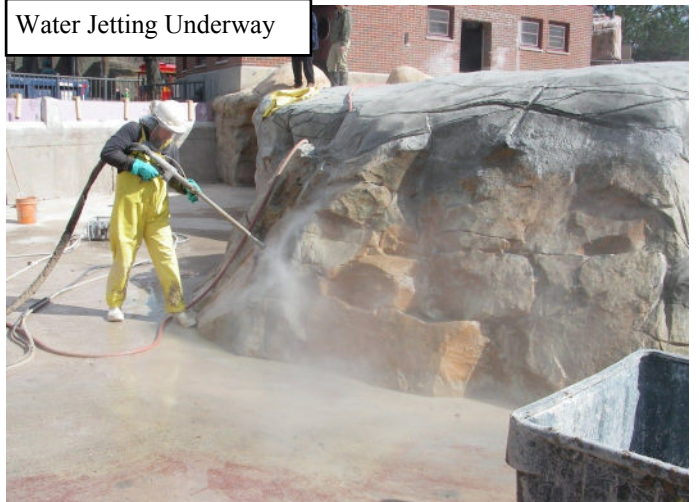
Water Jetting Underway

To insure the plumbing system was not contributing to water loss, before work began, the entire recirculation system was pressure tested. Having no leaks or compromises found, plans proceeded for a long-term successful rehabilitation. Existing coatings, contaminants and deteriorated sealants by 40,000 psi Water Jetting. Eight large viewing panels were removed to protect the viewing area during twork, 3/4” plywood being secured in their place. Auto-roller carts were used to carry workers and materials in the difficult access 4FT high overflow tunnel. Following water jetting, the pool was water blasted, cleaned and allowed to dry.

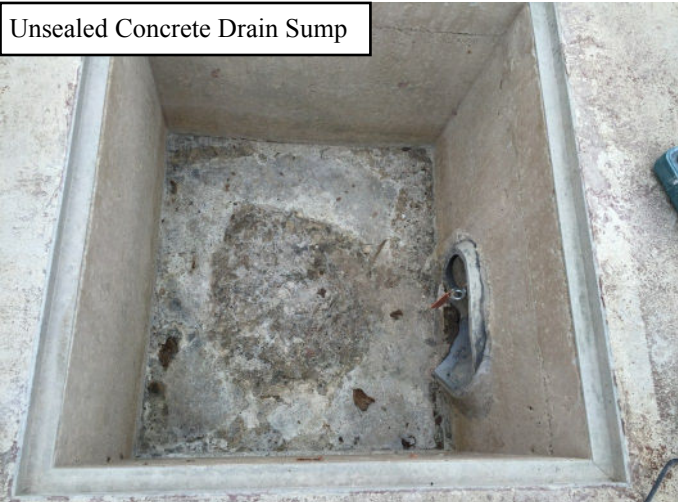
Unsealed Concrete Drain Sump

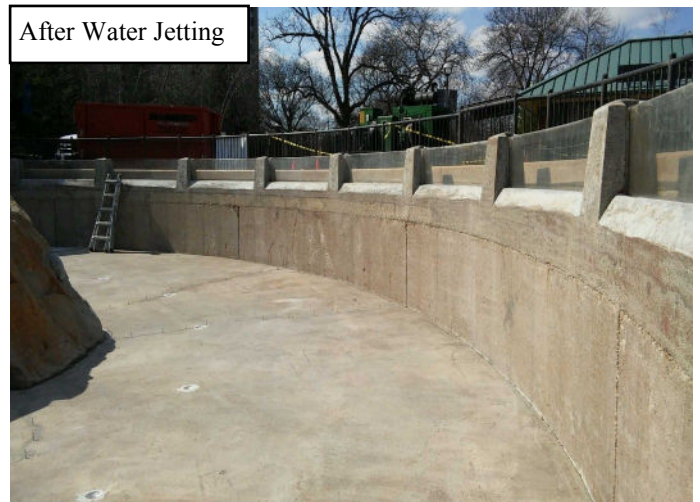
After Water Jetting

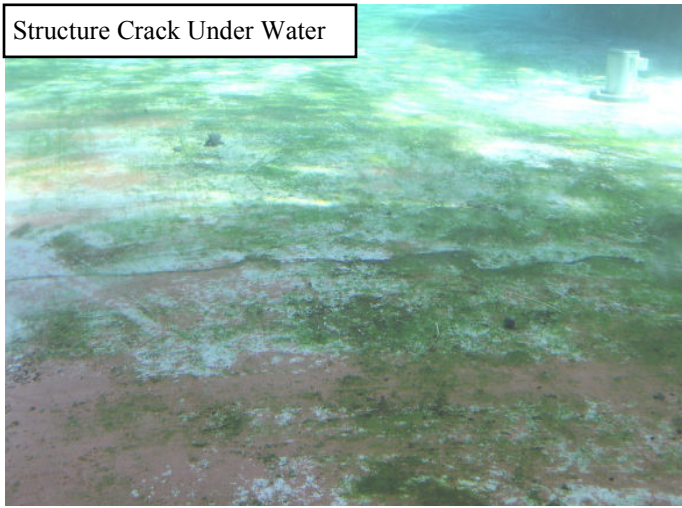
Structure Crack Under Water

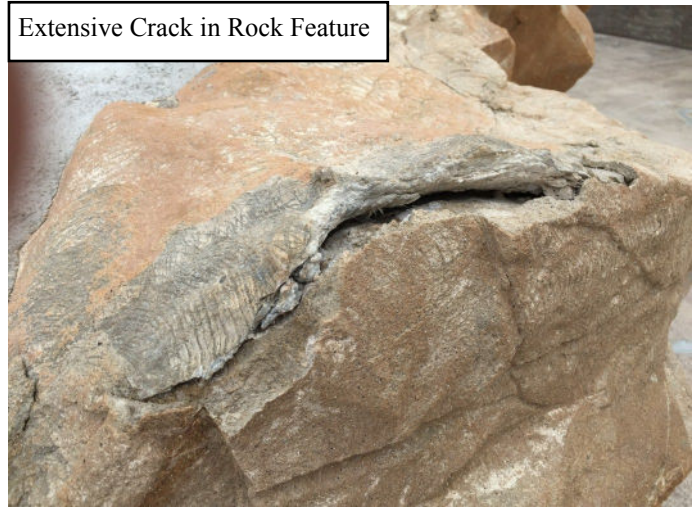
Extensive Crack in Rock Feature

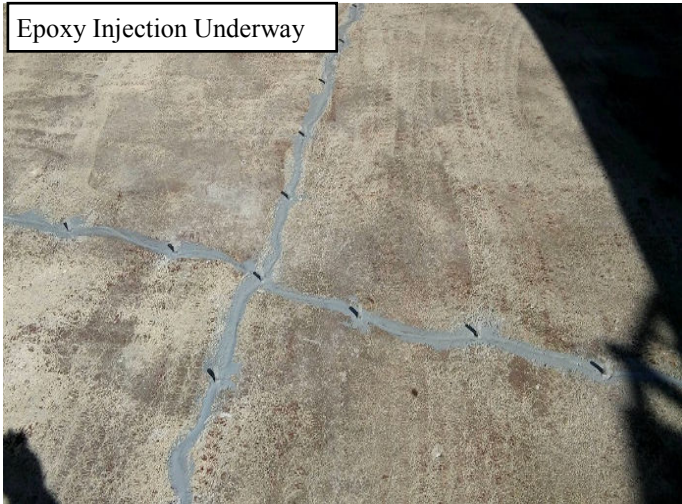
Epoxy Injection Underway

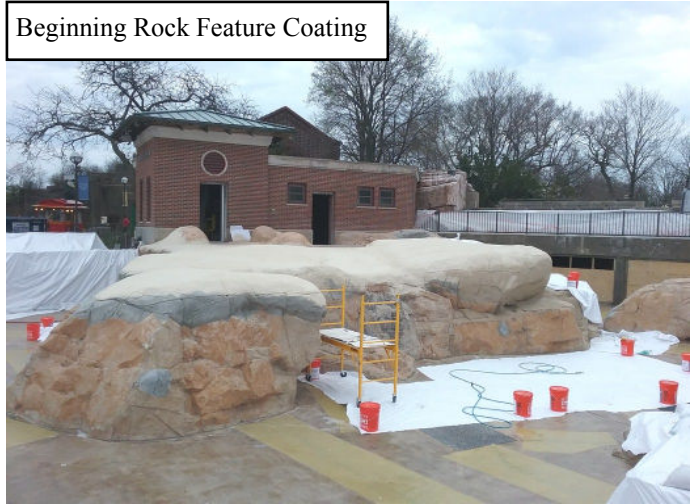
Beginning Rock Feature Coating

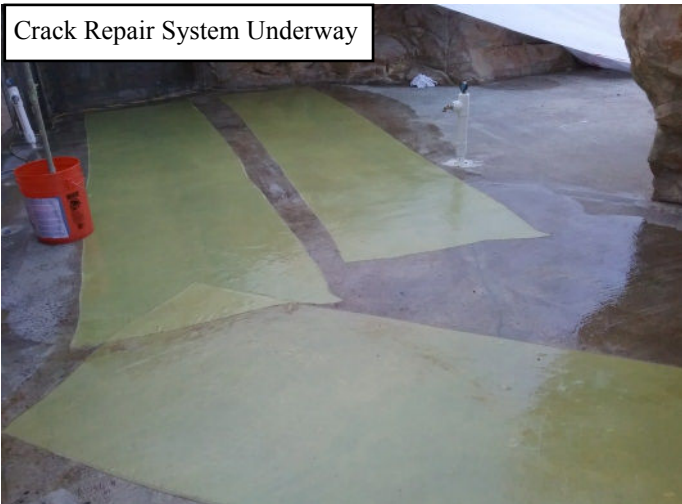
Crack Repair System Underway

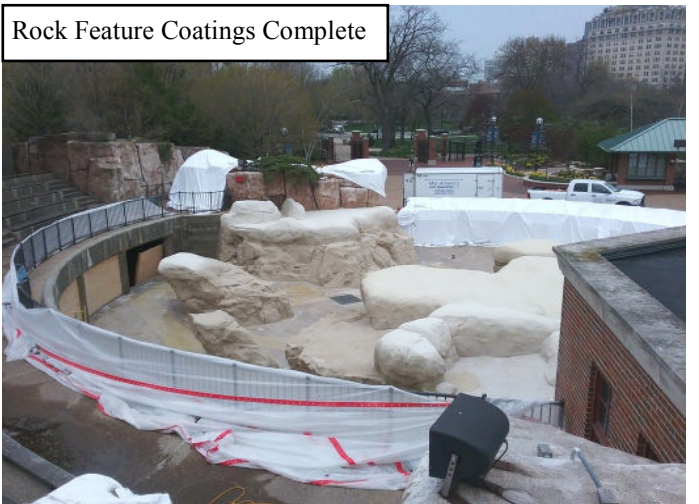
Rock Feature Coatings Complete

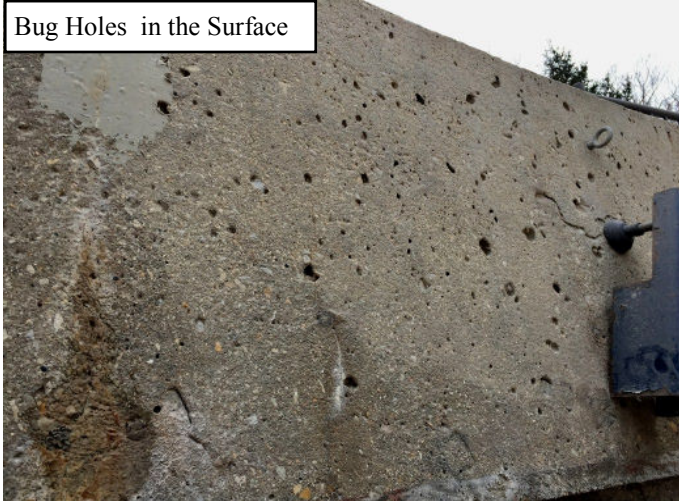
Bug Holes in the Surface

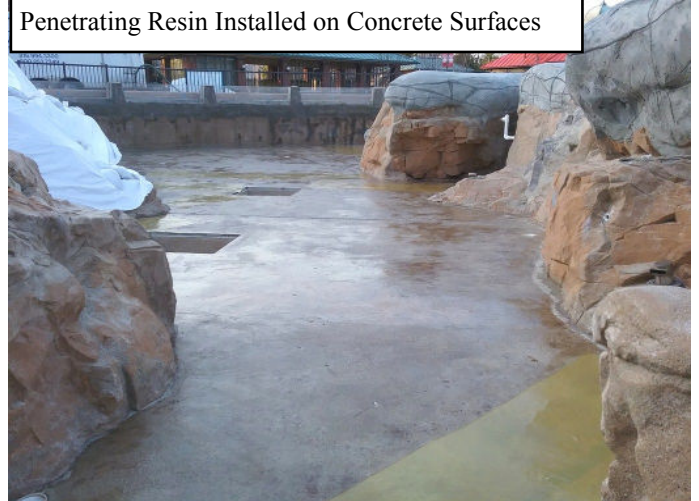
Penetrating Resin Installed on Concrete Surfaces

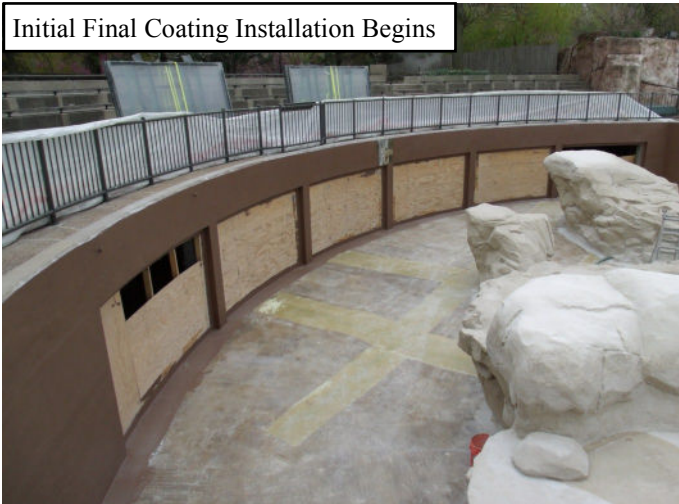
Initial Final Coating Installation Begins

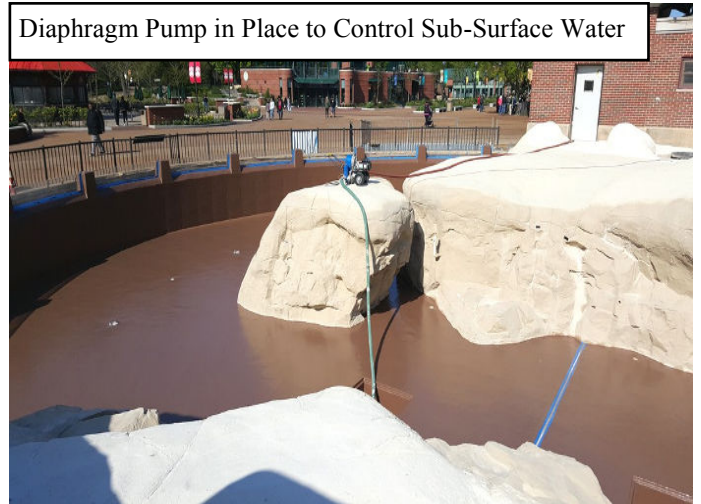
Diaphragm Pump in Place to Control Sub-Surface Water
