PROJECT HISTORY

LONGVIEW COMMUNITY COLLEGE

LEE'S SUMMIT, MISSOURI

Completion : 2012

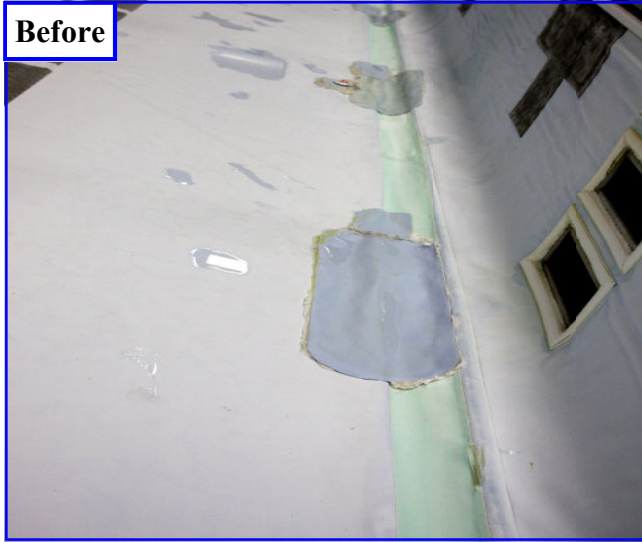
Before

In 2006, because of a difference of \$1,018 in Bids, Longview Community College installed a cover-up PVC Membrane instead of a fully-bonded re-surfacing system on their competition swimming pool. Within 4-months of installation the Membrane lifted in the 13FT depth area requiring closure of the pool, total draining and repair. Since this 2006 installation, numerous repairs and patches have been done on the Membrane to the point that the pool interior began to look hideous. Patches and repairs were only one part of the problem. A pump was required to remove water accumulating under the Membrane along with a 'trip-hazard' hose running across the deck to move this water out to a drain, many wrinkles, torn and dismantled weld seams and stains that gave the pool an unsightly appearance.

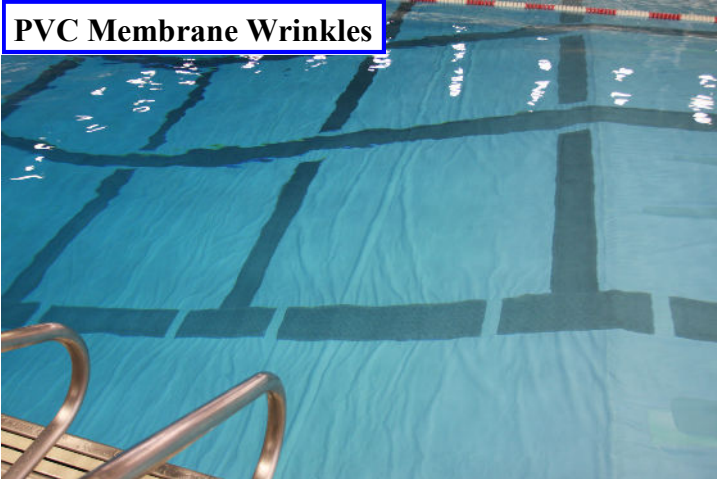
PVC Membrane Wrinkles

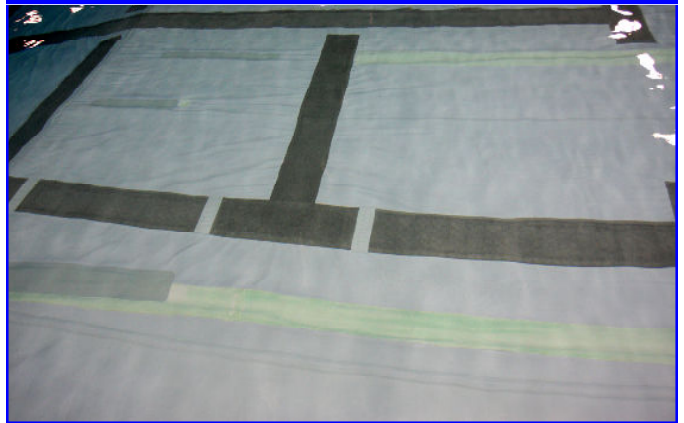
Outline of Hose Used to Remove Water under PVC

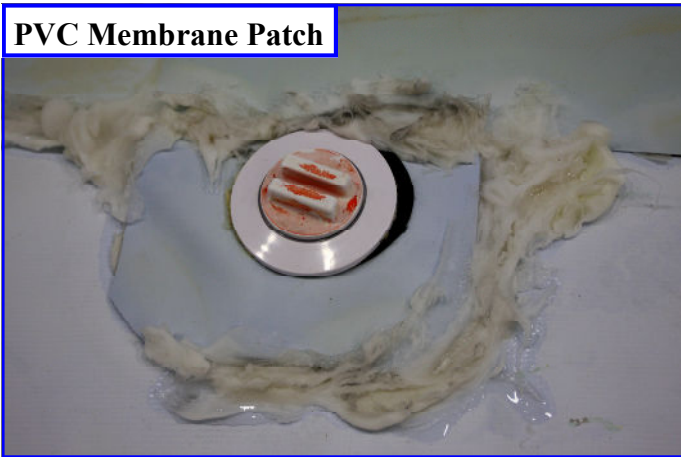
PVC Membrane Patch

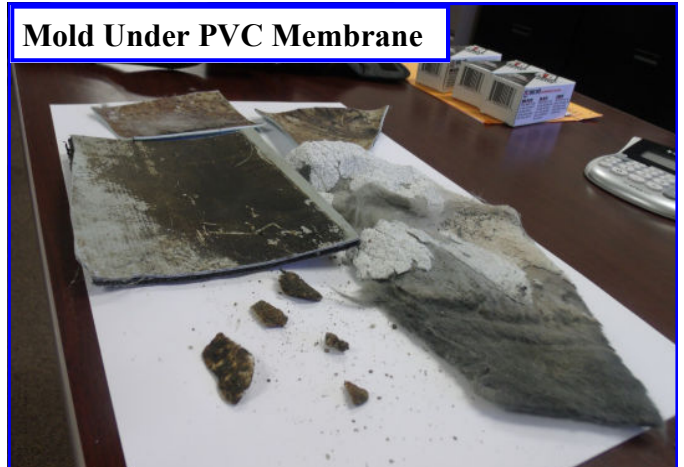
Mold Under PVC Membrane

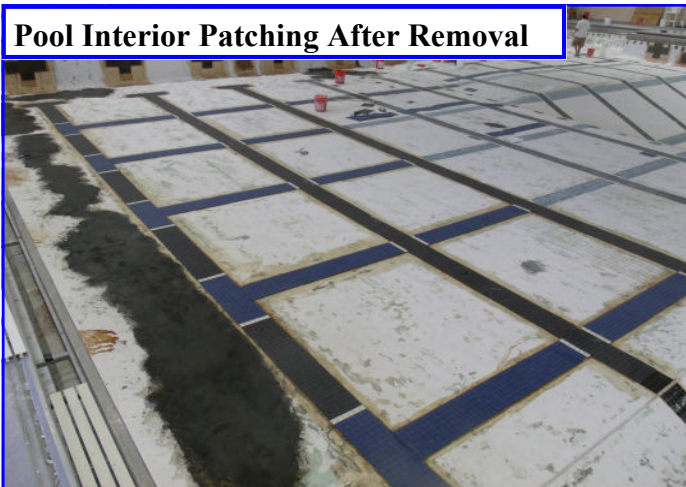
Pool Interior Patching After Removal

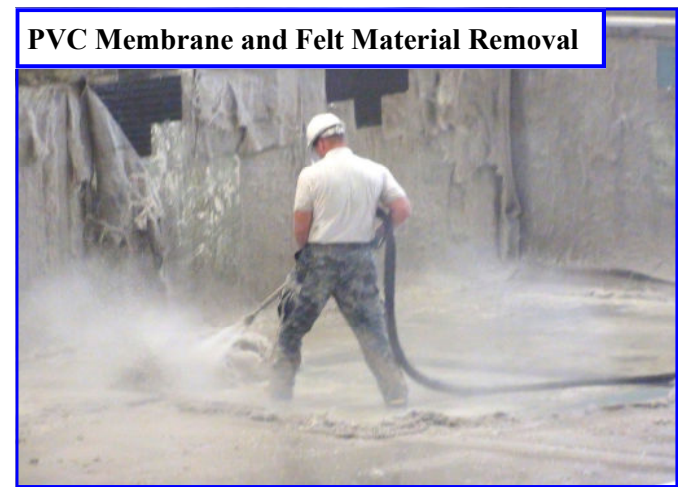
PVC Membrane and Felt Material Removal
