**PROJECT HISTORY**  
**REGATTA CONDOMINIUMS**  
**CHICAGO, ILLINOIS**

**COMPLETION: 2016**

**PROJECT ASSESSMENT**

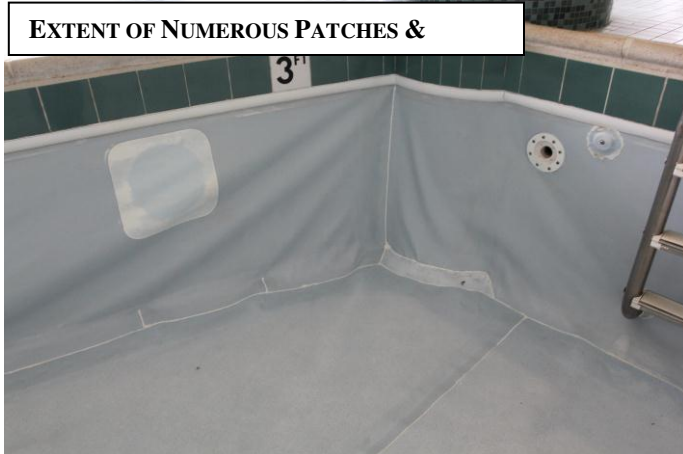
EXTENT OF NUMEROUS PATCHES &

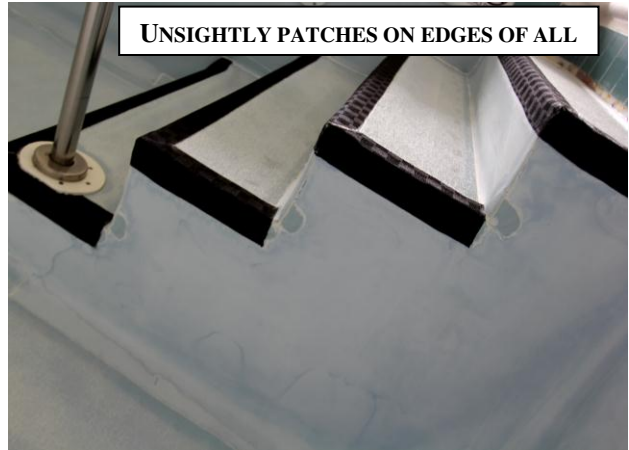
UNSIGHTLY PATCHES ON EDGES OF ALL

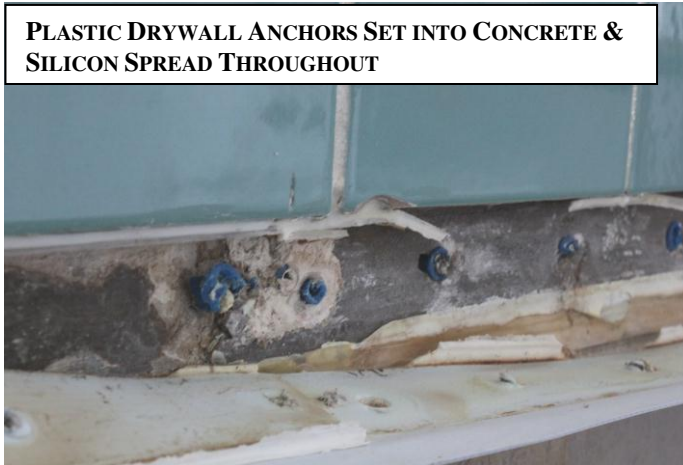
A plastic ‘ending point’ to the liner was added directly under water line tiling. This holding track was held in place by plastic drywall anchors drilled into the concrete and Tap-con® screws on approximately 3” centers. Each screw was then covered with ‘globbs’ of silicon.

PLASTIC DRYWALL ANCHORS SET INTO CONCRETE & SILICON SPREAD THROUGHOUT

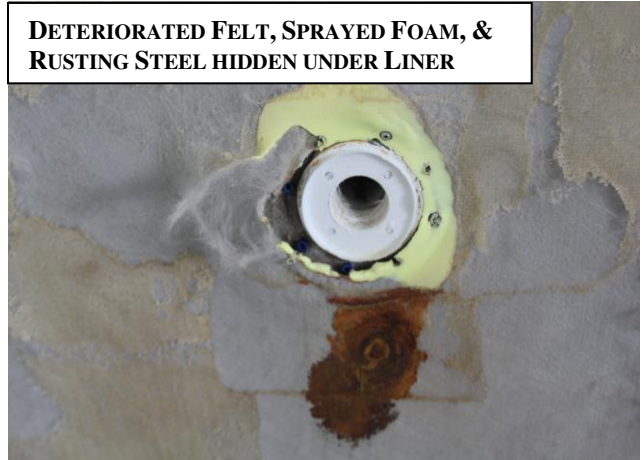
Generally, removal of the actual PVC liner is fairly easy. Once it is cut into sections, it can be pulled away, rolled up and discarded. The difficulty in the removal process comes in removing the glued, degraded felt backer material placed onto the concrete under the vinyl.

DETERIORATED FELT, SPRAYED FOAM, & RUSTING STEEL HIDDEN UNDER LINER

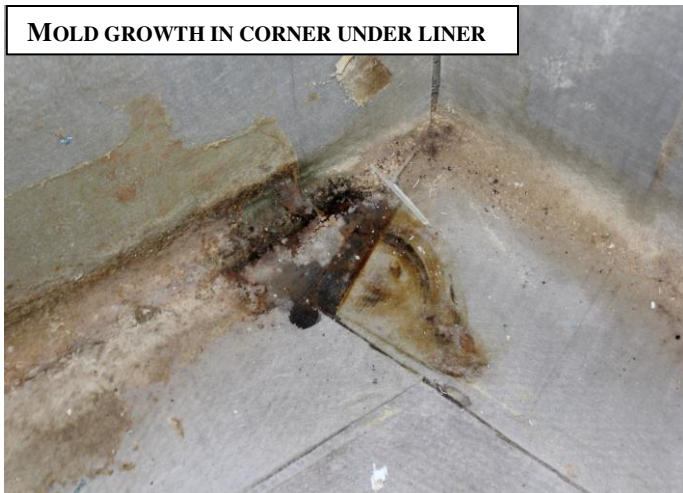
MOLD GROWTH IN CORNER UNDER LINER
