PROJECT HISTORY
REGATTA CONDOMINIUMS
CHICAGO, ILLINOIS

COMPLETION: 2016

PROJECT ASSESSMENT

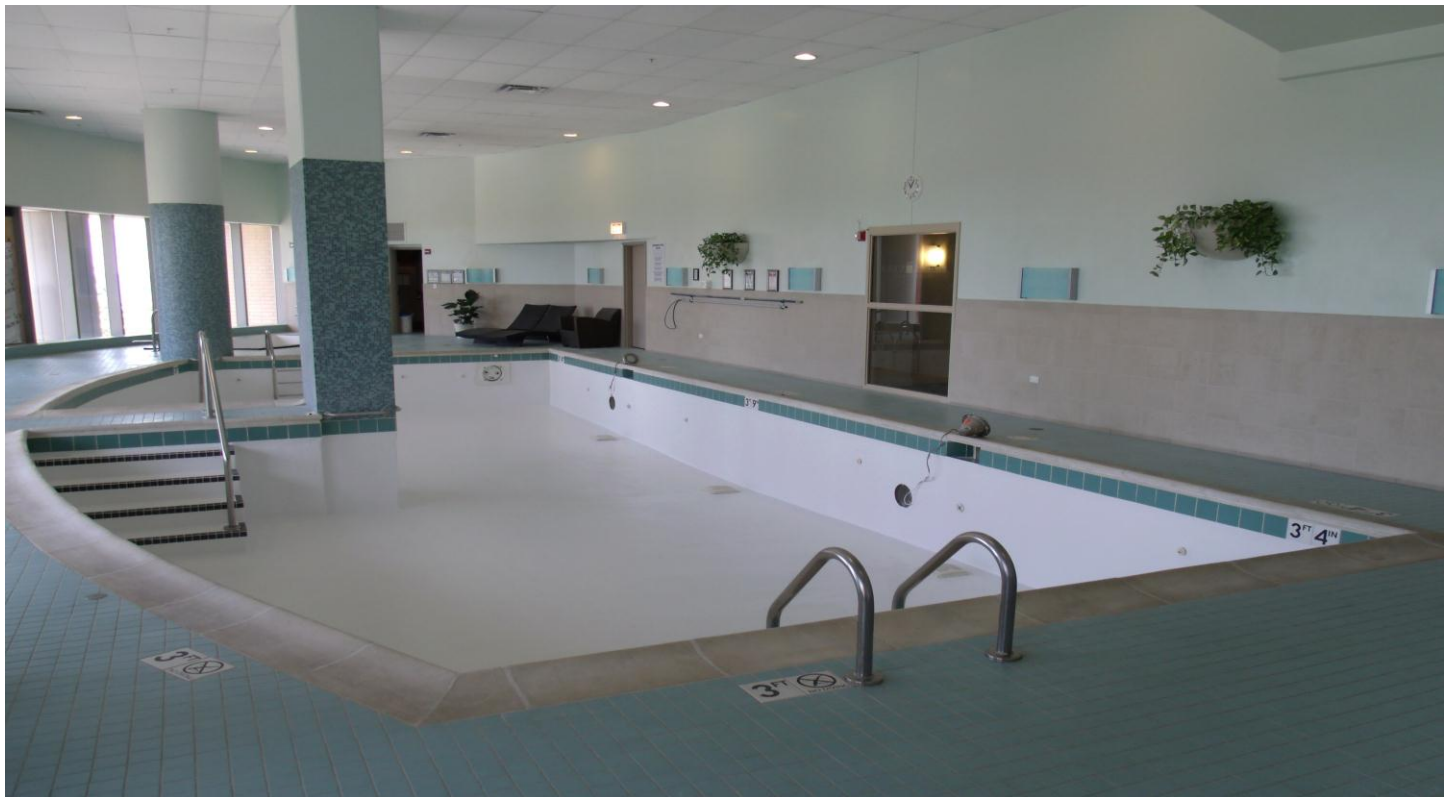
A wrinkled, discolored and patched PVC liner is not very appealing to look at, especially at a prestigious condominium association overlooking Lake Michigan. However, there was another problem that overshadowed the liner’s appearance, and that was water leakage through the liner to the condominium unit directly below the pool. Notwithstanding numerous patches in the liner, water continued leaking to the floor below resulting in the pool being closed for several years. It was time for a re-surfacing change.

Generally, removal of the actual PVC liner is fairly easy. Once it is cut into sections, it can be pulled away, rolled up and discarded. The difficulty in the removal process comes in removing the glued, degraded felt backer material placed onto the concrete under the vinyl.

A plastic ‘ending point’ to the liner was added directly under water line tiling. This holding track was held in place by plastic drywall anchors drilled into the concrete and Tap-con® screws on approximately 3” centers. Each screw was then covered with ‘globbs’ of silicon.
