# ROCK SPRINGS 4-H CAMP – HISTORIC RESTORATION PROJECT

JUNCTION CITY, KANSAS

COMPLETION: 2013

## PROJECT ASSESSMENT

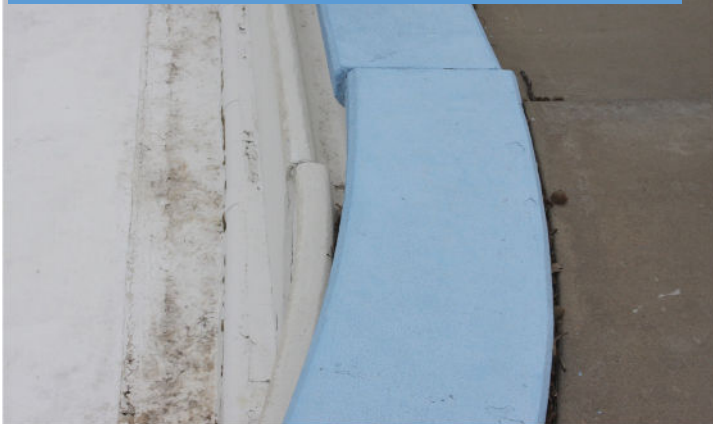
After years and years of use, structural movement and deterioration along with the effects of freeze / thaw cycling created large gaps between the sectionally poured concrete. Old steel piping used for the recirculation system rusted, cracked and did not function without leaking. The pool lost over 7,000 gallons a day.

Sectional Concrete Gutter & Coping Cap Movement

Before Stainless Steel gutter installation, adjustments had to be made to the walls at the sectional joints. While the walls were structurally intact, they experienced movement near the joints that caused them not to be 'plumb' with each other. Movement was generally restricted to the upper areas of the walls. Mechanical abrasion was used to rid the worse differences. Supporting stainless steel plates were added to the top (now cut portions) of the walls to restrict future movement. New decking included expansion joints that limited the concrete mass from pressuring onto the pool walls that would cause repeated irregularity.

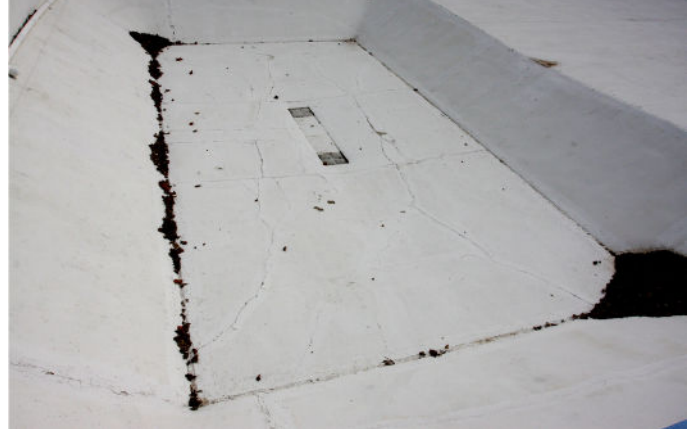
Turnover rates no longer met commercial standards. The existing diving well no longer met current diving and safety depth standards. Diving boards were roped off and not used. The concrete diving well suffered some of the worse freeze / thaw damage of the entire pool.

Freeze Damaged, Cracked & Outdated Diving Well

Because the diving well did not meet current depth standards for diving board use, plans were made to cut, remove and deepen the pool. That made poor Compressive Strength readings on the diving well floor irrelevant.

Following excavation, shotcrete was used to construct the new diving well and 0-Depth Entry.

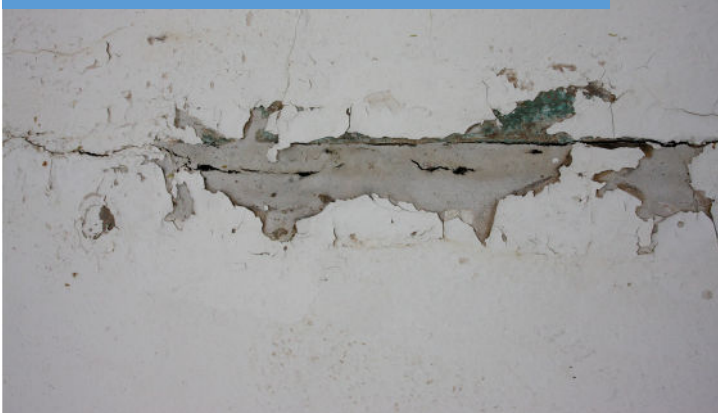
Peeling Paint off Expansion Joint Sealant

Abnormally wide (2" - 3") expansion joints were covered with layers of pool paint, however the joint edges were straight and sound. Finding suitable material for such wide joints proved to be challenging, but not impossible.

Environmentally friendly Hydro-blasting (UHP) removed layers of pool paint and remaining caulking and bitumen expansion sealants.

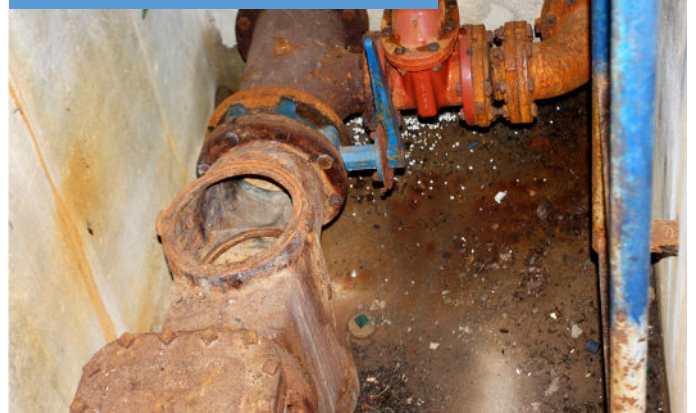
Corroded Cast Iron Plumbing

SCH-80 PVC plumbing was used throughout and a new 20-Hp pump updated the recirculation system to current 6-Hour Commercial Turnover Rates.

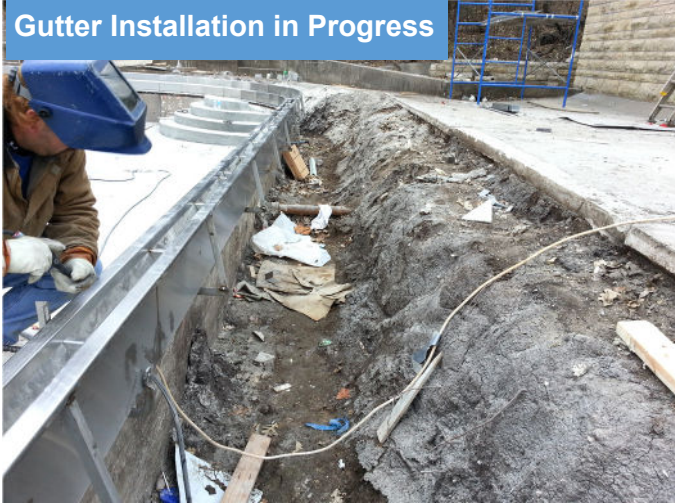
Gutter Installation in Progress

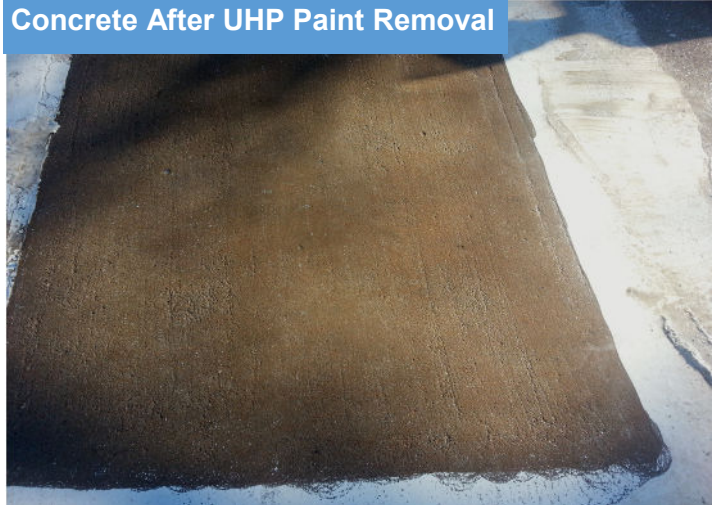
Concrete After UHP Paint Removal

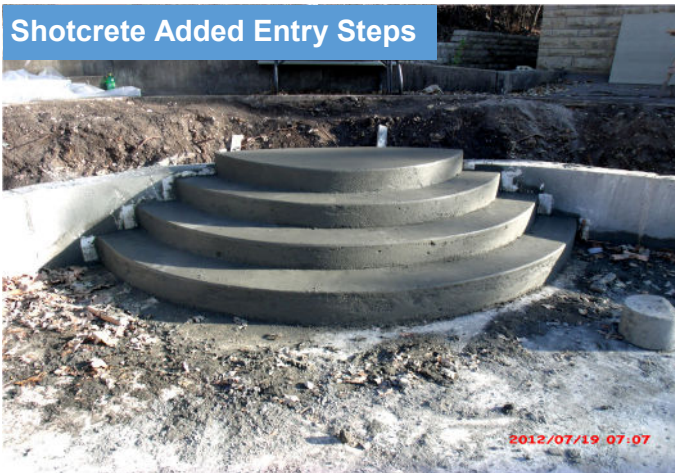
Shotcrete Added Entry Steps

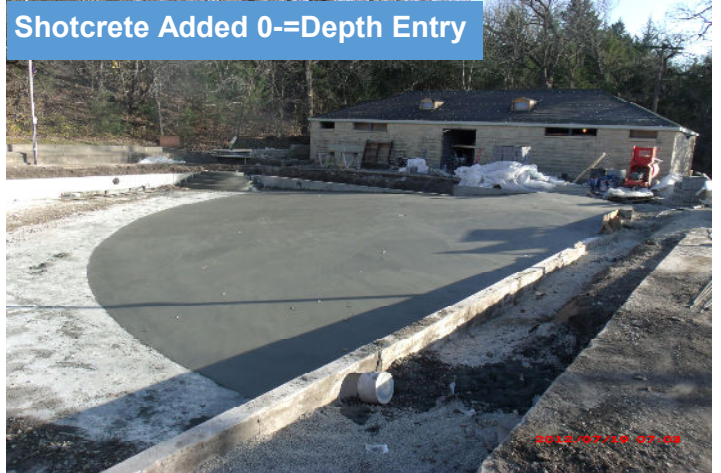
Shotcrete Added 0=Depth Entry

Lightweight fill was used below the reinforcing steel and shotcrete for the 0-Depth Entry.

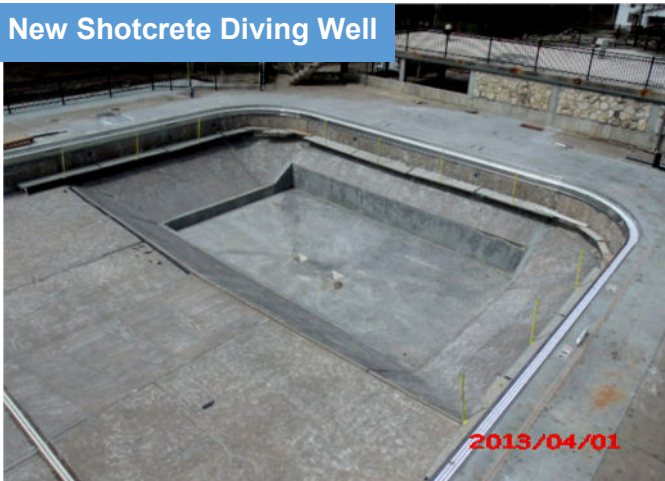
New Shotcrete Diving Well

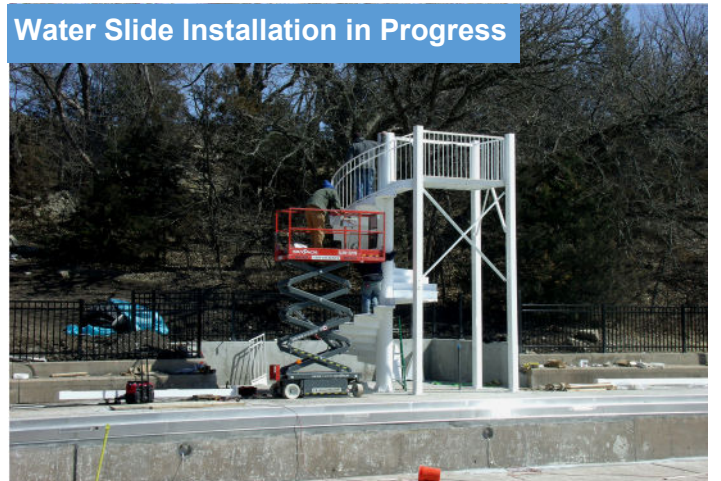
Water Slide Installation in Progress
