PROJECT HISTORY

SAVIOR PASTORAL CENTER – ROMAN CATHOLIC ARCHDIOCESE OF KANSAS CITY, KANSAS

COMPLETION: 2016

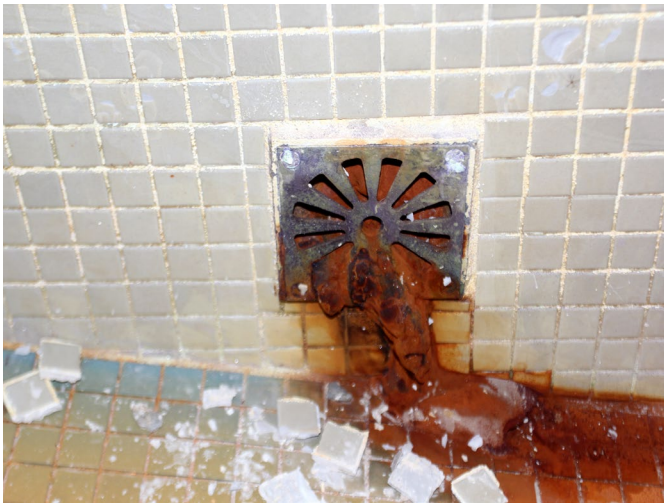
Return Line full of Rust

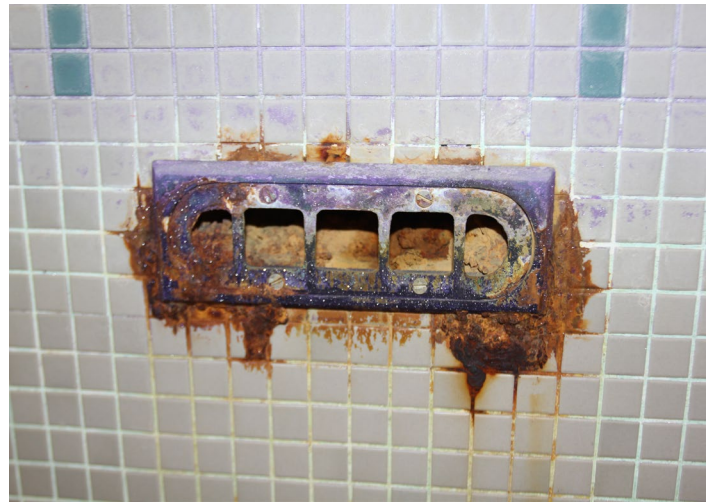
Recirculation lines constructed out of steel were so badly corroded that water could not flow through the lines. Both the deck drains and gutter suction lines had separated from piping allowing water to simply pour out of the pool onto the corridors and walkways below the pool. Water leaching through the concrete walls left unsightly calcium deposits and leakage on the exterior corridor walls, and a single main drain sump had to be updated to meet current VGB Code.

Corroded, Rust filled, Manganese covered return line

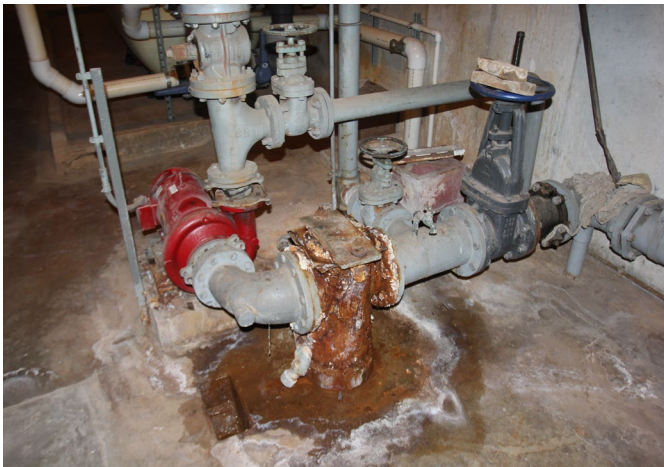
Condition of Strainer Before Renovation

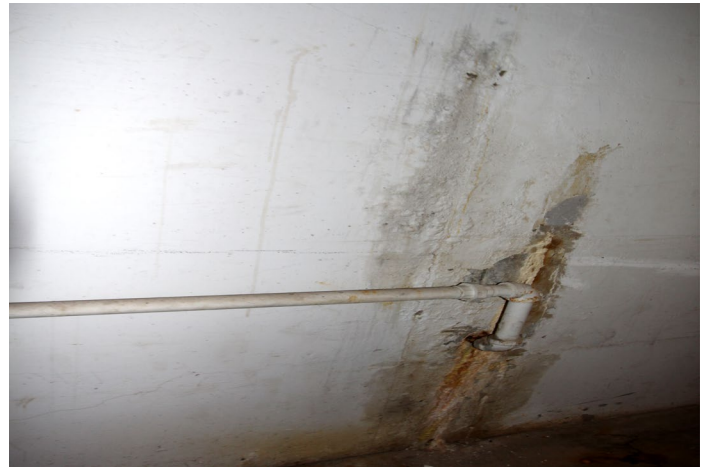
Calcium leaching from wall & around steel piping

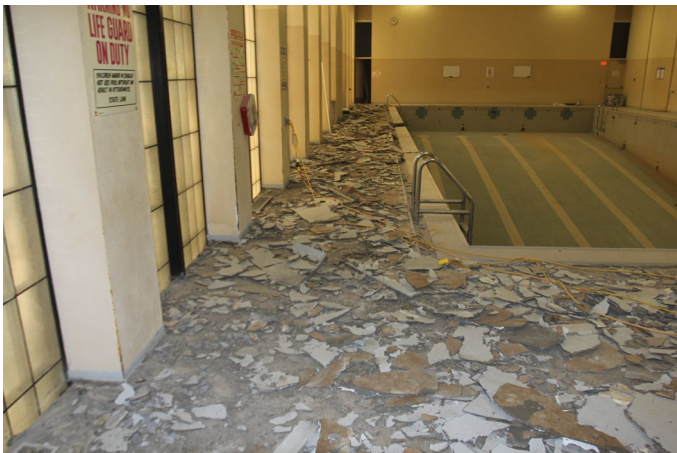
Thin Deck Membrane in process of Removal

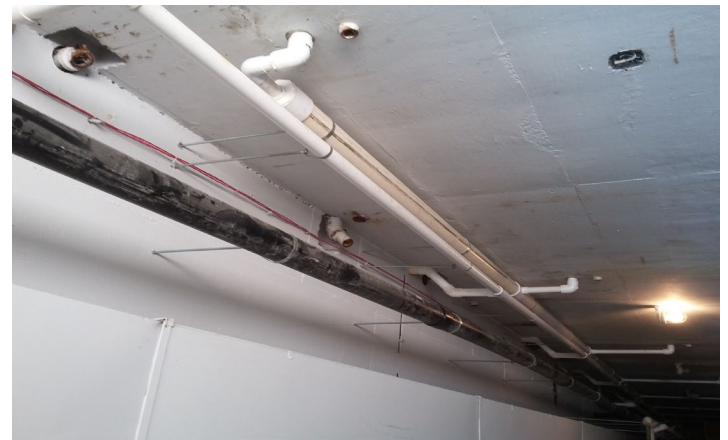
New PVC Recirculation Lines in Process of Installation

While most of the elevated existing steel plumbing lines seemed accessible, cutting and removal had to be done on scaffolding from the corridors surrounding the pool. New recirculation lines were cored through the concrete walls. Old steel lines were sealed and covered. After the existing tile was scarified, a Protective Barrier and multiaxial fabrics were installed, followed by new racing lanes and the INTER-GLASS® Reinforced Polymeric System. A new 15hp pool pump and automatic water leveler completed the pool part of the Project.
