PROJECT HISTORY

SAVIOR PASTORAL CENTER – ROMAN CATHOLIC ARCHDIOCESE OF KANSAS CITY, KANSAS

COMPLETION: 2016

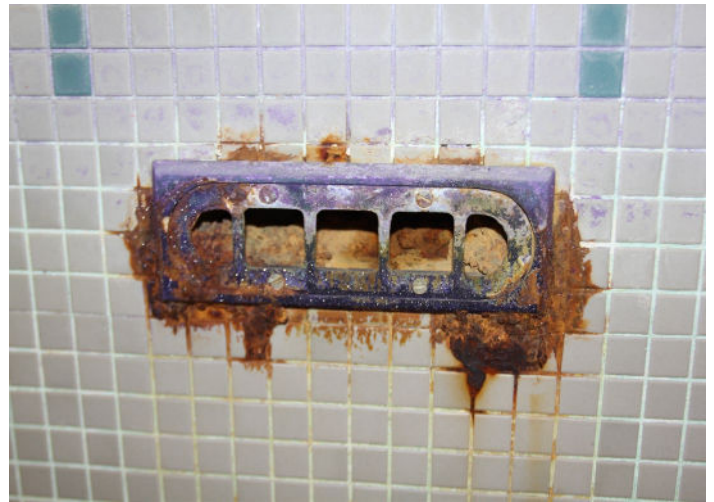
Recirculation lines constructed out of steel were so badly corroded that water could not flow through the lines. Both the deck drains and gutter suction lines had separated from piping allowing water to simply pour out of the pool onto the corridors and walkways below the pool. Water leaching through the concrete walls left unsightly calcium deposits and leakage on the exterior corridor walls, and a single main drain sump had to be updated to meet current VGB Code.

Corroded, Rust filled, Manganese covered return line

While most of the elevated existing steel plumbing lines seemed accessible, cutting and removal had to be done on scaffolding from the corridors surrounding the pool. New recirculation lines were cored through the concrete walls. Old steel lines were sealed and covered. After the existing tile was scarified, a Protective Barrier and multiaxial fabrics were installed, followed by new racing lanes and the INTER-GLASS® Reinforced Polymeric System. A new 15hp pool pump and automatic water leveler completed the pool part of the Project.

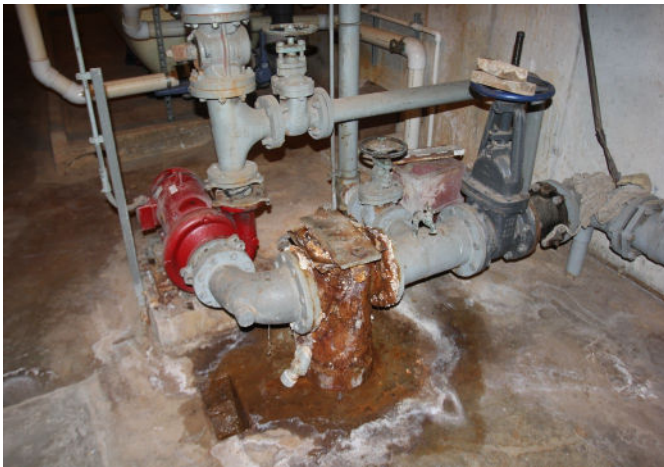
Condition of Strainer Before Renovation

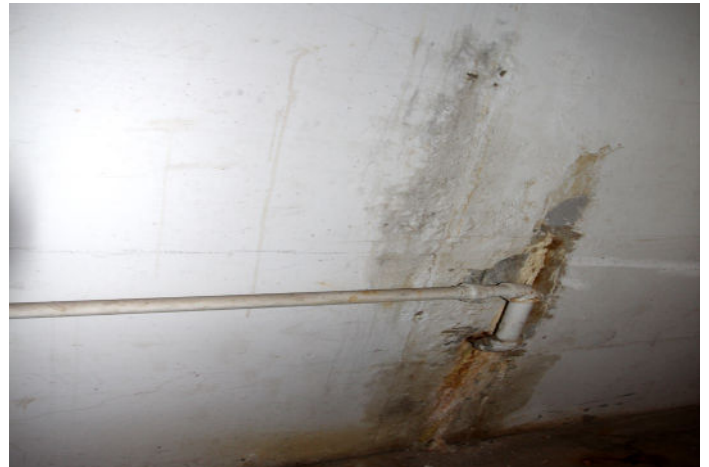
Calcium leaching from wall & around steel piping

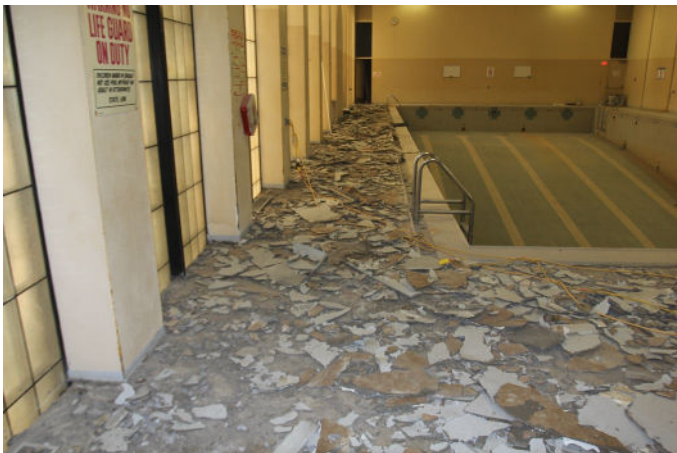
Thin Deck Membrane in process of Removal

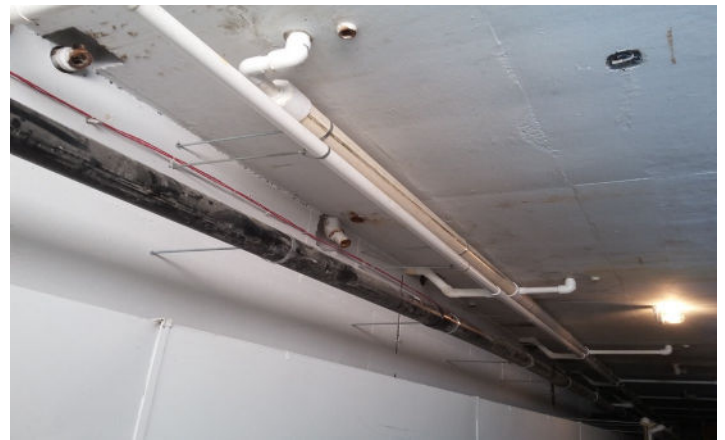
New PVC Recirculation Lines in Process of Installation
