### **PROJECT ASSESSMENT**

### **RE-SURFACING PLAN**

**CITY OF MISSION, KANSAS**  
**MISSION, KANSAS**

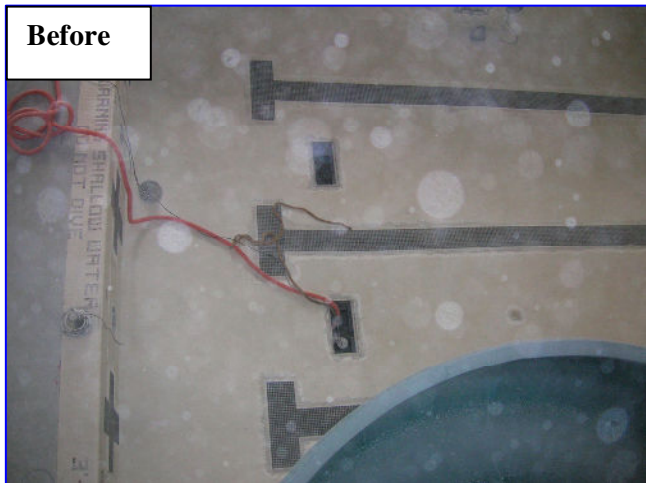
**Before**

Large indoor pool complex originally surfaced with white pool plaster. Heat in combination with chemically treated water yellowed the surface and deteriorated the smooth finish. The rough, spalling surface took its toll on swimmers, especially children’s feet. After years of draining, (repeated cycles of drying and wetting), cleaning and acid washing, the pool surface started to experience adhesion problems and a series of pop-offs developed.

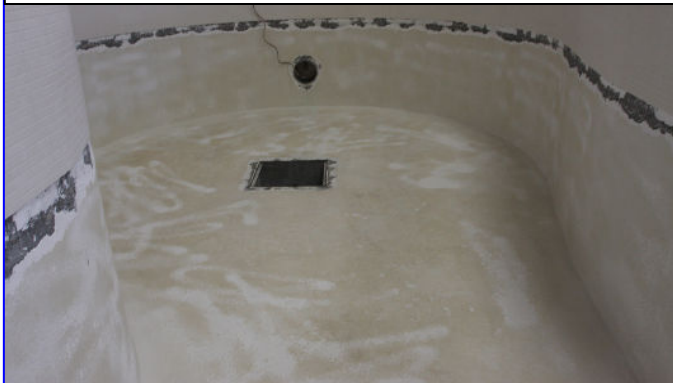
**Removal in Progress from the Yellowed Surface**

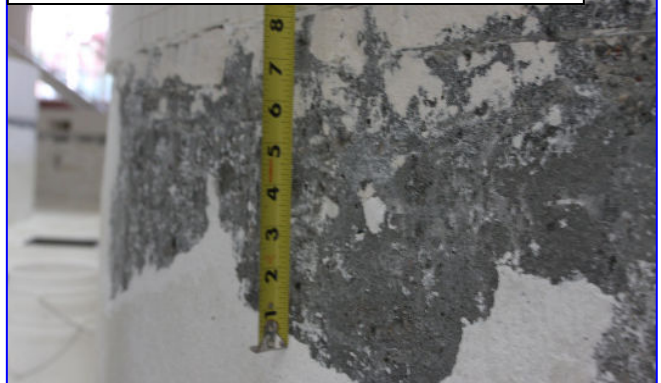
**Depth of Plaster Removal from Tile Line**

weakened top layer surface finish, followed by high-pressure water blasting (>5000 psi). Mechanical removal of the existing plaster from the tile line and other fixtures extended to a depth of 6–8”. Following cleaning and high-pressure water blasting, SGM bond coat was applied throughout the pool shell followed by a new, mist-cured Pebblecrete surface.

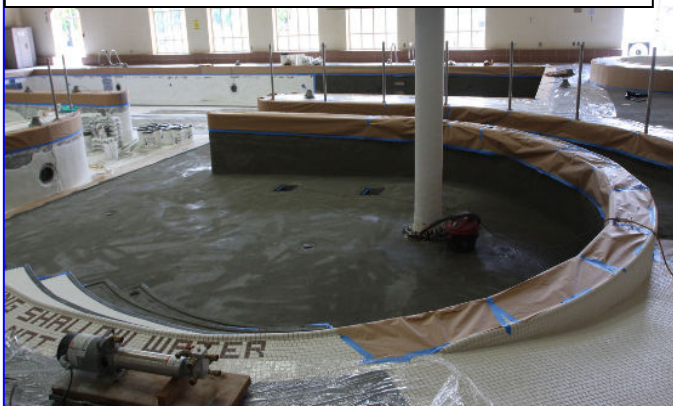
**Protective Paper During Bond Coat Installation**

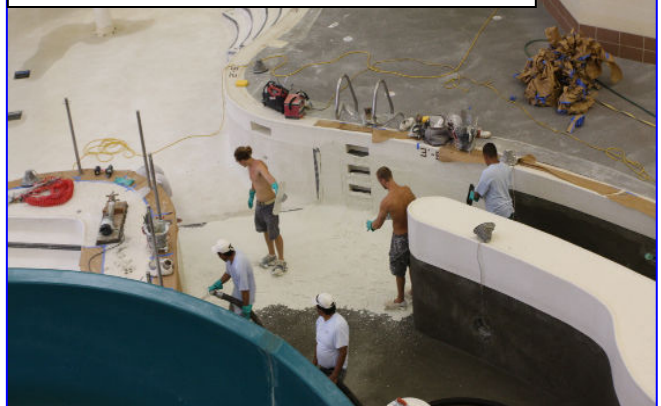
**Pebblecrete Installation in Progress**

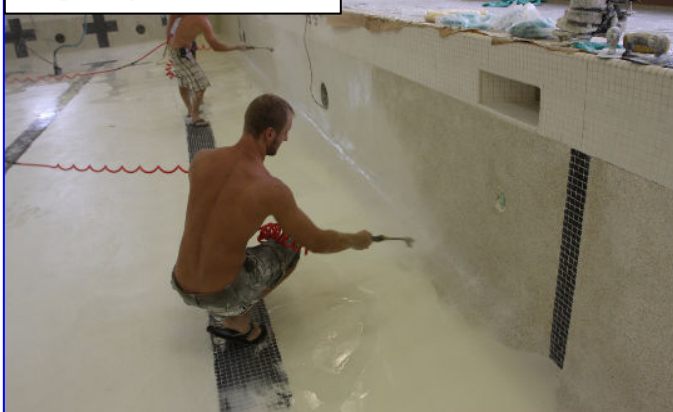
**Exposing the Pebbles**

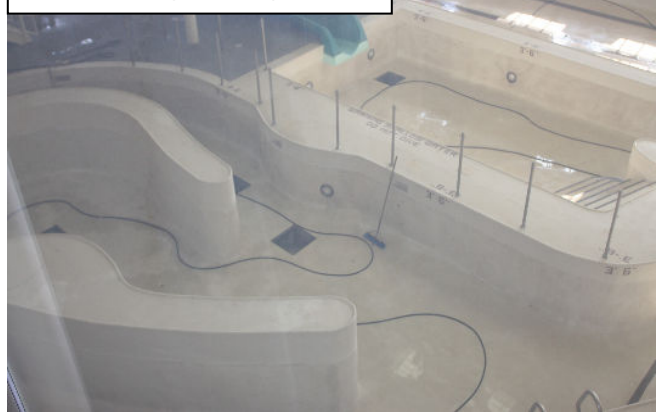
**Mist Curing in Progress**
