# PROJECT HISTORY

## SOUTHWESTERN OKLAHOMA STATE UNIVERSITY

WEATHERFORD, OKLAHOMA

COMPLETION: 2008

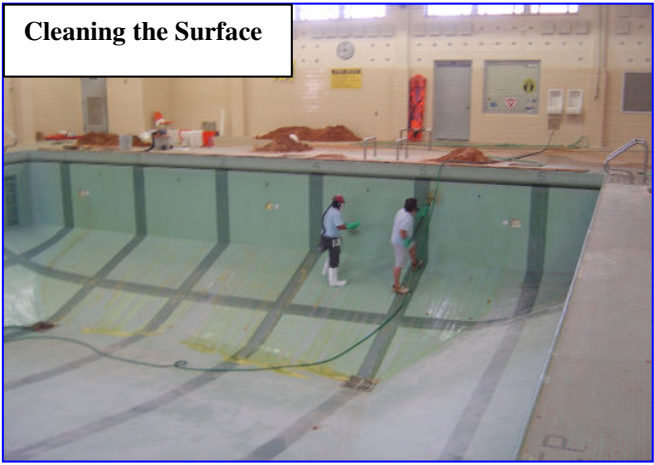
**Cleaning the Surface**

Pressure checks were placed repeatedly on the system to insure that no additional leakage through deterioration was found in the main return line, or through injury in the course of the piping transition. The surface of the main pool was thoroughly cleaned including high pressure water blasting. All necessary tile cutting, patching and replacement were done, including around the new PVC inlet fittings, followed by re-grouting of the entire tiled pool surface. Final cleaning of the pool surface restored a beautiful blue reflective look from the tile finish. Tile work was done to ANSI & TCA installation standards.

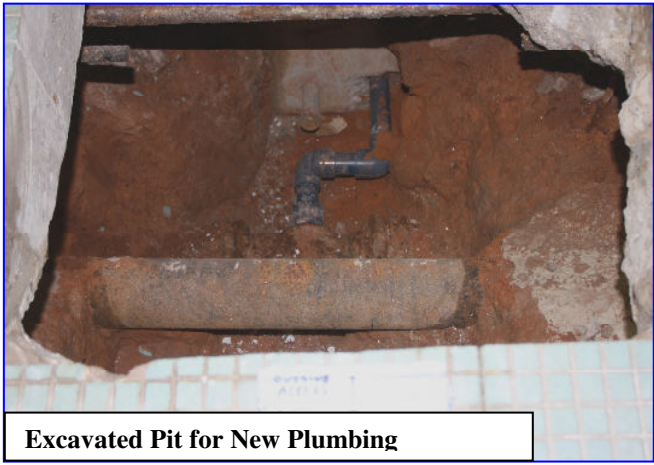
**Excavated Pit for New Plumbing**

Adjacent to each existing return line inlet fitting, a 4” square of the existing tiling was carefully removed. A new 2” hole was drilled into this 4” square area and through the pool wall. 16-pits corresponding directly to the locations of each return line inlet were first cut into the decking concrete, then excavated down equal to the depth of where the inlet line met the 6” main return line. Care was required so as not to injure this main return line, which was also cast-iron. Fortunately, threaded fittings were located below grade making the transition to new Schedule 80 PVC less complicated.

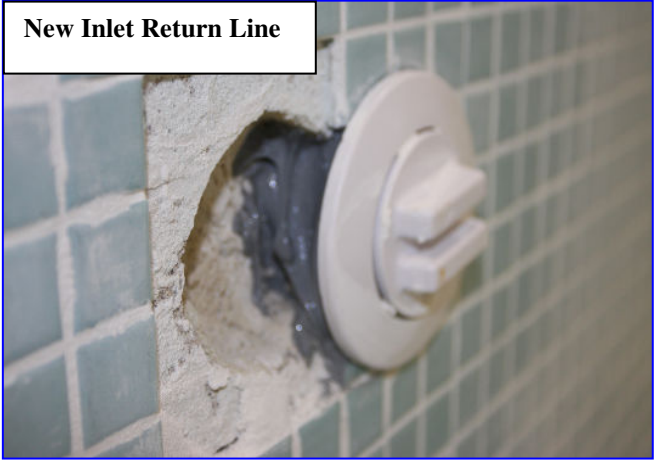
**New Inlet Return Line**

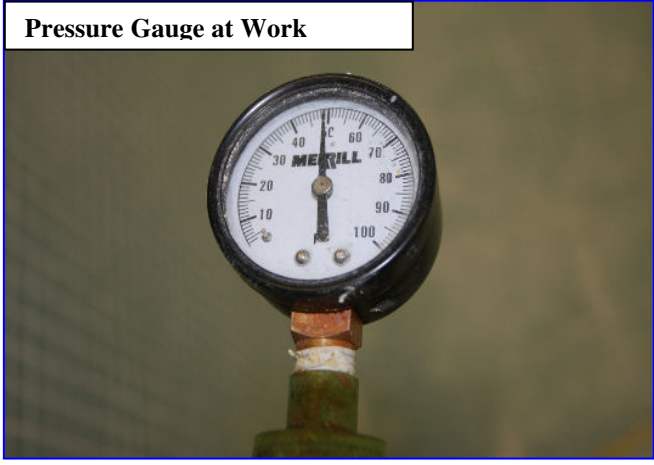
**Pressure Gauge at Work**

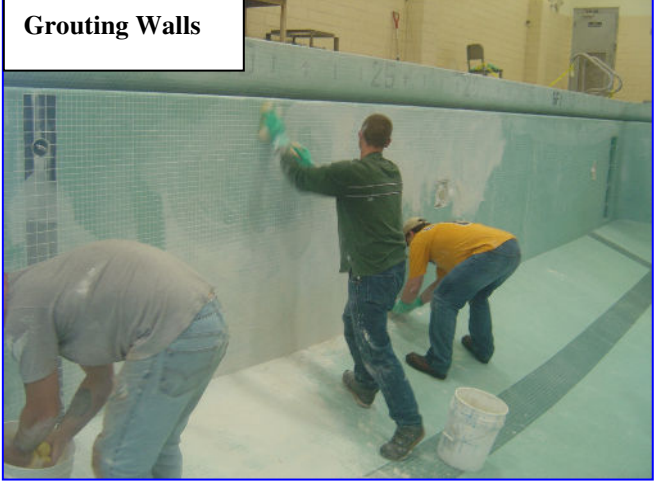
**Grouting Walls**

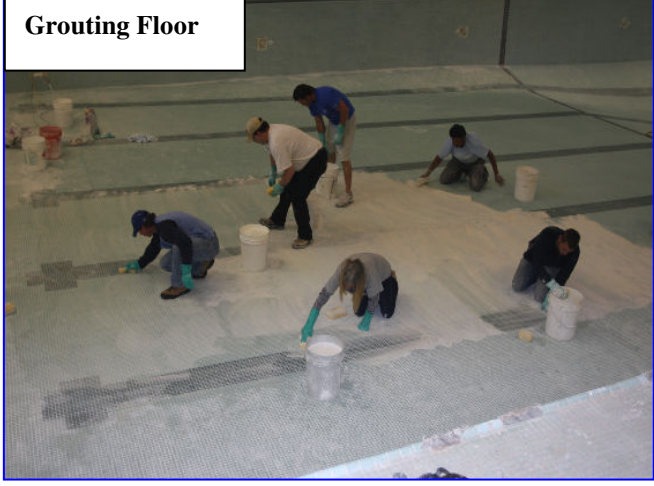
**Grouting Floor**
