PROJECT HISTORY OAKWOOD COUNTRY CLUB

COAL CITY, ILLINOIS

COMPLETION: 2008

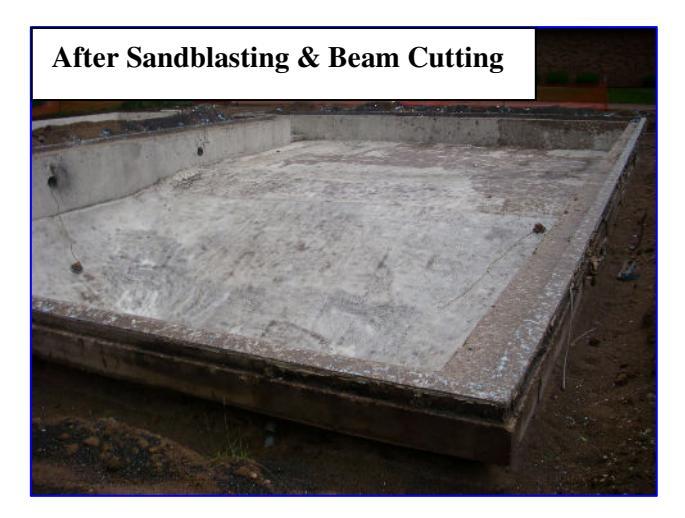
Condition of Pool Paint Before Sandblasting
