PROJECT HISTORY

METROPOLITAN CONDOMINIUMS

KANSAS CITY, MISSOURI

COMPLETION: 2007

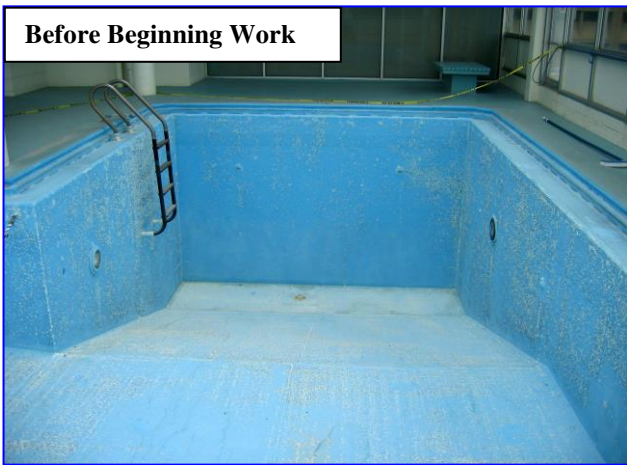
An indoor, sectionally fabricated aluminum pool that was plagued by unsightly deposits and surface discoloration throughout the pool surface. A by-product of aluminum corrosion, these white, crystalline, barnacle-type deposits were possibly an aluminum bromide chemical compound. Also evident on the surface was a large volume of ‘black pinholes’ that routinely appear when thick, high solids coatings are applied. With windows completely exposing the pool to UV rays from the sun, degradation and chalking of the existing pool coating left a film of residue rubbing off of the pool surface. No provisions were in place to protect dissimilar metals (S/S, aluminum, & galvanized steel) coming into contact with each other in this very active, electronic environment. Surface and fixture corrosion was extensive.

Before Beginning Work

Being an indoor pool on the 14th floor made abrasive blasting somewhat impractical. Eventually, mechanical grinding was chosen to remove all the deposits and degraded coating from the pool surface and gutter channels. In an effort to rid the contact of dissimilar metals touching each other, corroded stainless steel

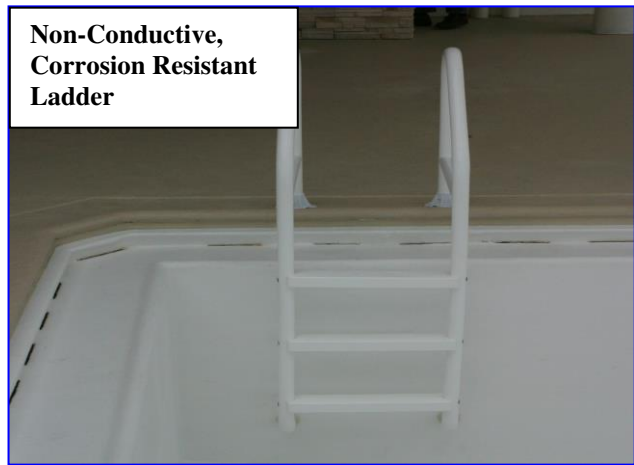
Non-Conductive,
Corrosion Resistant
Ladder

ladders were replaced by non-conductive, reinforced vinyl ladders, the existing metal lights were replaced by low voltage, plastic bodied lights, and the entire pool surface was sealed with the non-conducting INTER-GLASS® Reinforced Composite System.

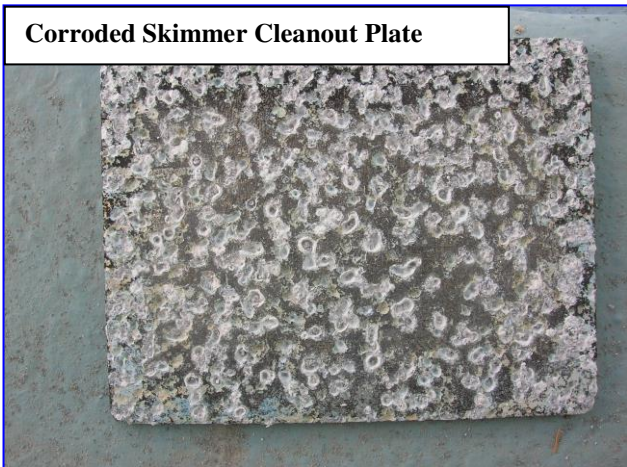
Corroded Skimmer Cleanout Plate

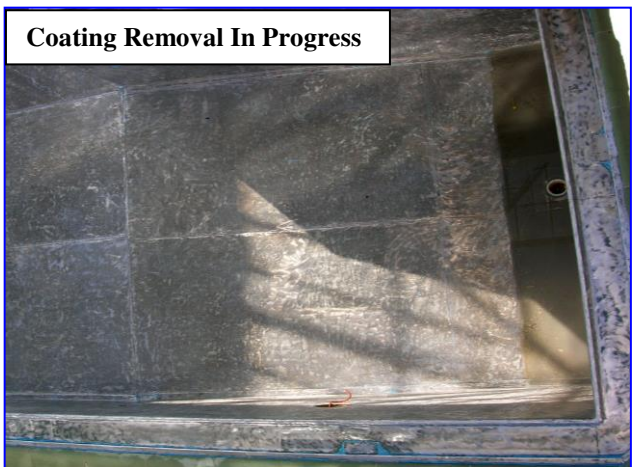
Coating Removal In Progress

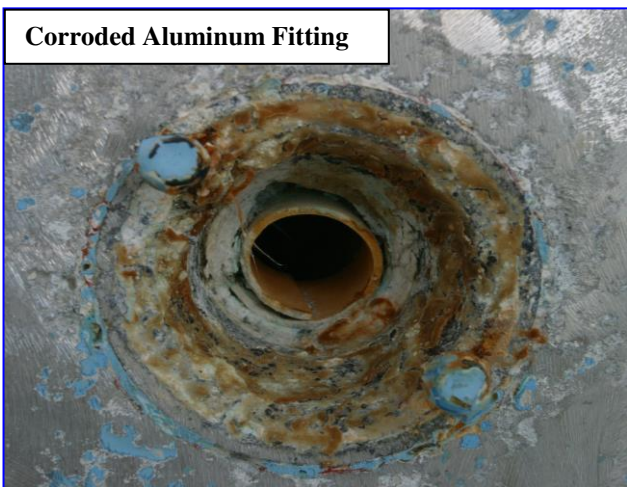
Corroded Aluminum Fitting
