PROJECT ASSESSMENT

RE-SURFACING PLAN

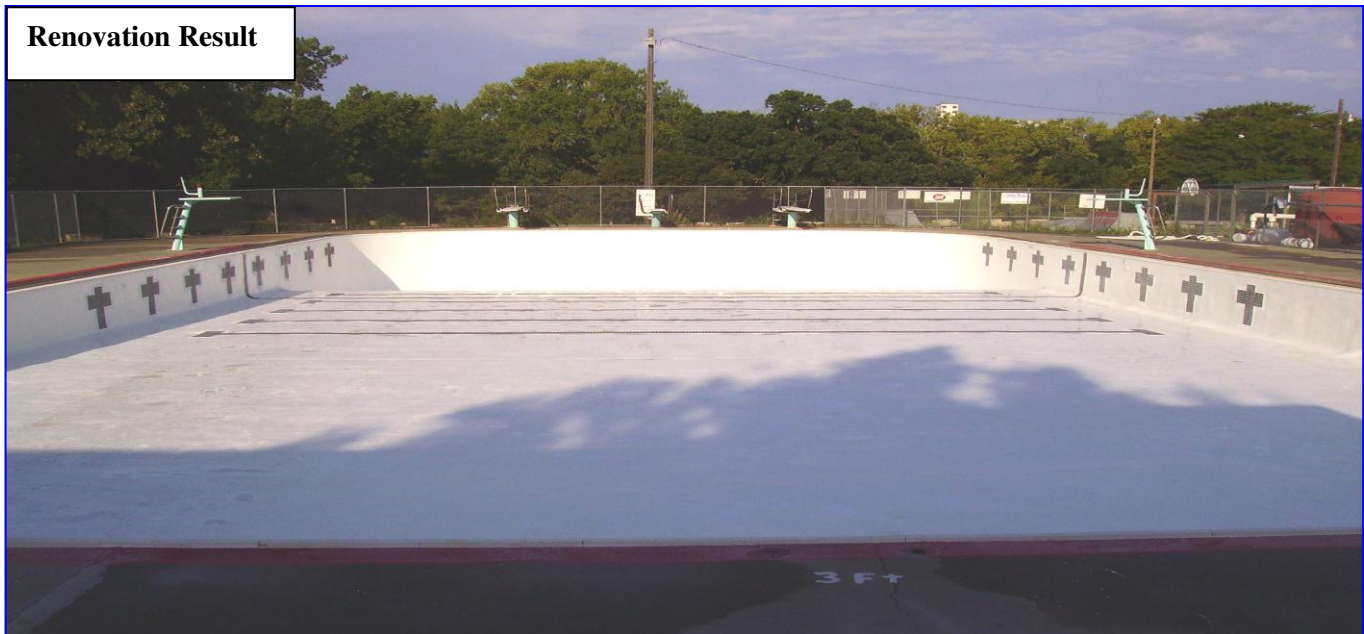
A pool that had originally been built in the 1940’s and had undergone several re-plastering jobs now opted for the more permanent, climate durable INTER-GLASS® System. Staining and algae plagued the pool and porous pool plaster surface. Painted racing lanes and targets that continued to fade and chalk and needed repainting from year to year were now scheduled to be changed to frost-proof tiling.

Following preparation and high pressure water-blasting (>5000 psi), a Protective Barrier System was installed over the entire surface of the main and kiddy pools. Frost-proof, non-glazed racing lane tiling were installed

over 8-lanes and the depth transition line. The INTER-GLASS® Reinforced Composite System surface was then installed over both pools.
