**PROJECT ASSESSMENT**

A pool that had originally been built in the 1940’s and had undergone several re-plastering jobs now opted for the more permanent, climate durable INTER-GLASS® System. Staining and algae plagued the pool and porous pool plaster surface. Painted racing lanes and targets that continued to fade and chalk and needed repainting from year to year were now scheduled to be changed to frost-proof tiling.

**RE-SURFACING PLAN**

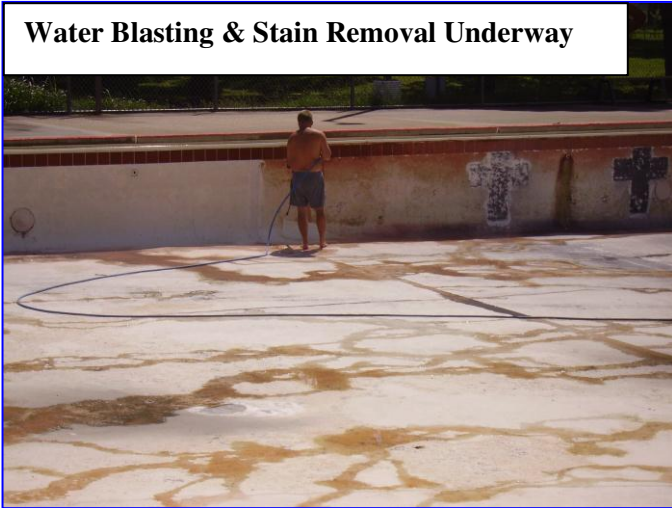
**Water Blasting & Stain Removal Underway**

Following preparation and high pressure water-blasting (>5000 psi), a Protective Barrier System was installed over the entire surface of the main and kiddy pools. Frost-proof, non-glazed racing lane tiling were installed

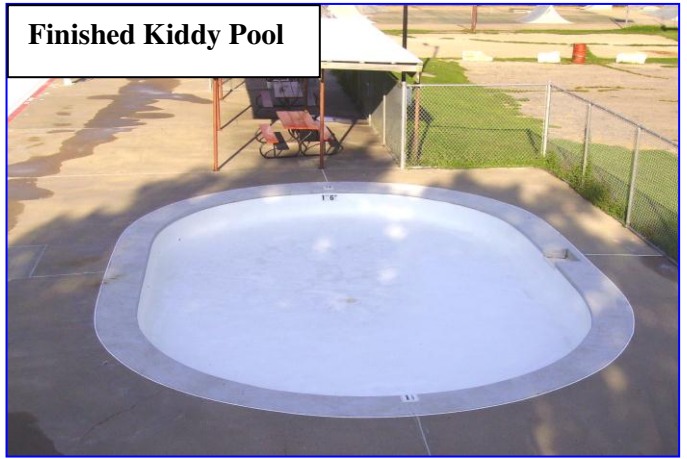
**Finished Kiddy Pool**
