**PROJECT HISTORY – ADDITION OF 0-DEPTH ENTRY & REMODEL – BUILT 1967**  
**CITY OF STANBERRY** **COMPLETION: 2012**  
**STANBERRY, MISSOURI**

**PROJECT ASSESSMENT**

**RENOVATION PLAN**

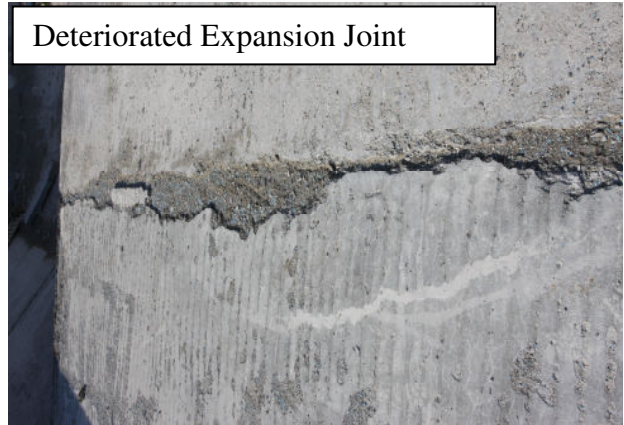
Deteriorated Expansion Joint

Before the Project began, a non-intrusive Schmidt Hammer test was done on the entire pool shell to test the concrete’s Compressive Strength. Additional follow-up testing was done by taking core samples. Expansion joint areas posed a major re-building challenge. The existing gutter system was wrought with concrete degradation, leakage and freeze / thaw damage. Cutting off the gutter exposed the use of shrinkage aggregates in the original concrete mix and cracking it creates. The entire 80’ shallow end wall was removed as was the entire pool decking area.

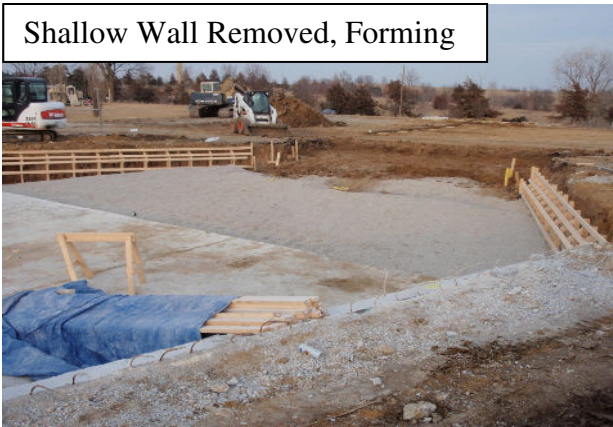
Shallow Wall Removed, Forming

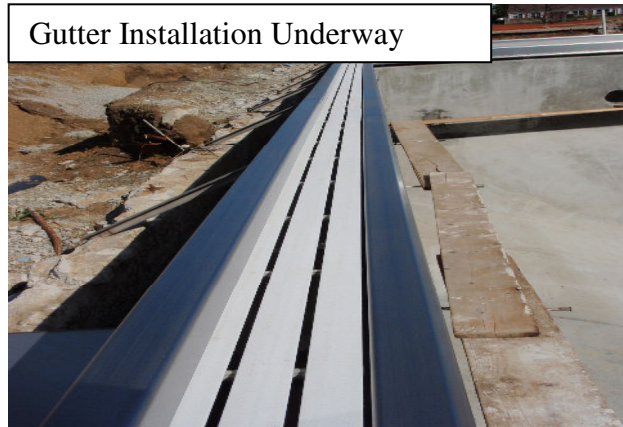
Gutter Installation Underway

Engineers specified jointing requirements for adding the new 45’ long Zero-Depth Entry area. Both sub-surface and deck drains were planned and subsequently added with the new deck. Concrete densifiers were added to the concrete walls. A new perimeter Stainless Steel Gutter System was installed. New dual fiberglass filters and recirculation pumps were added along with a new pool slide. Finally, the entire pool’s interior surface was finished with the INTER-GLASS® Reinforced Polymeric System.
