PROJECT ASSESSMENT

RENOVATION PLAN

HOLIDAY INN - MIDTOWN

GRAND ISLAND, NEBRASKA

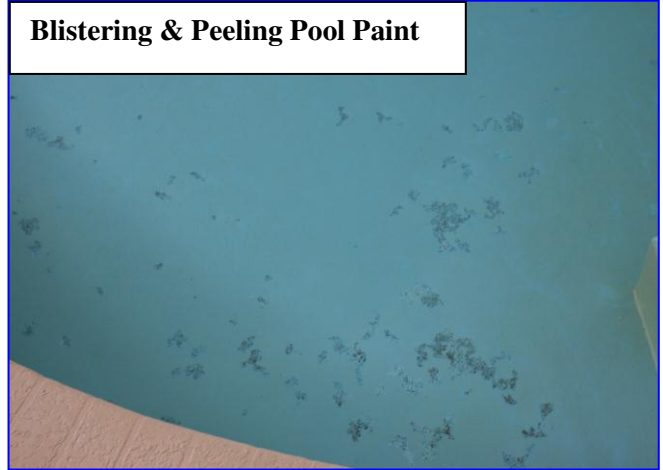
Remodeling and renovating this large, holodomed pool set in the middle of an operating hotel required specialized attention. Past, repeated pool paintings did not solve the pool’s yellowing stained appearance. Each new layer of pool paint continued to blister and chalk. The existing waterline tiling was old and out of date, and safety markings such as depth and step demarcation were lacking.

Blistering & Peeling Pool Paint

Abrasive blasting was required to remove layers of blistering and peeling pool paint. Set just yards away from an operating restaurant, the entire pool setting required tarping before any work began. Ventilation units and tubing were set up for air circulation and to remove any residual fumes and dust out from the hotel.

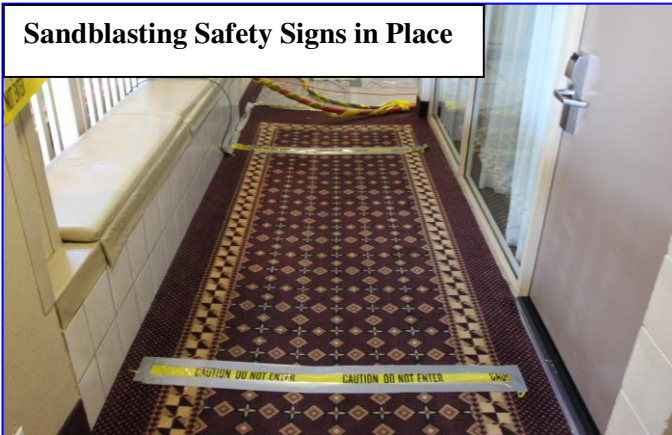
Sandblasting Safety Signs in Place

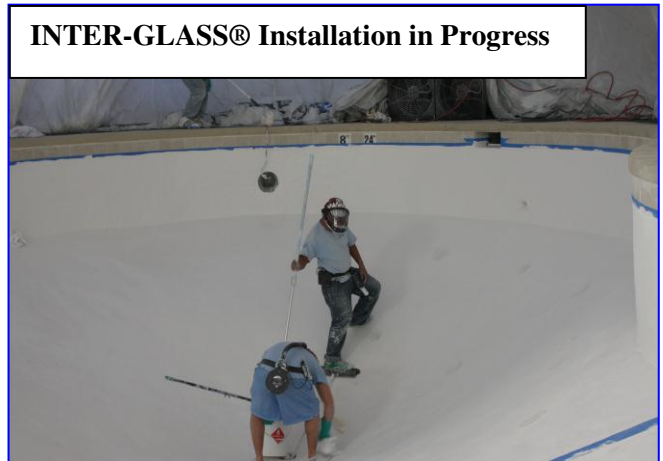
INTER-GLASS® Installation in Progress

The existing tiling was mechanically removed. Following abrasive blasting, high pressure water blasting (>5000 psi), and new tile installation, the INTER-GLASS® Reinforced Composite System was installed over the entire remaining pool interior surface.
