PROJECT ASSESSMENT

HOLIDAY INN - MIDTOWN

GRAND ISLAND, NEBRASKA

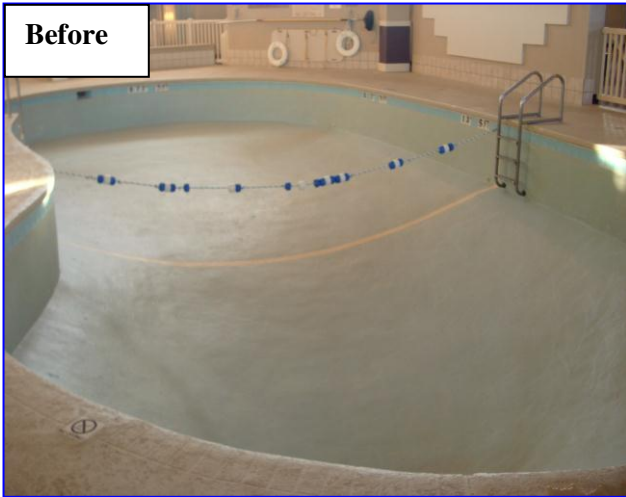
Before

Remodeling and renovating this large, holodomed pool set in the middle of an operating hotel required specialized attention. Past, repeated pool paintings did not solve the pool’s yellowing stained appearance. Each new layer of pool paint continued to blister and chalk. The existing waterline tiling was old and out of date, and safety markings such as depth and step demarcation were lacking.

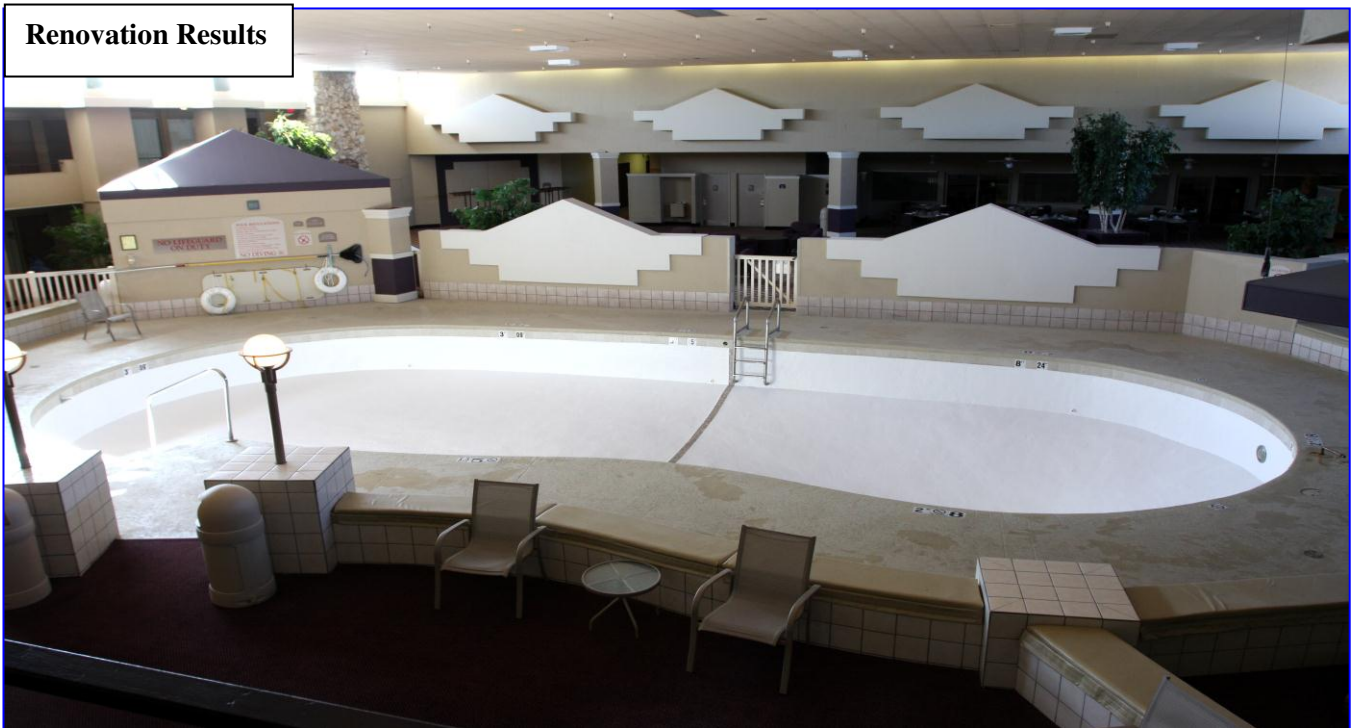
Renovation Results

The existing tiling was mechanically removed. Following abrasive blasting, high pressure water blasting (>5000 psi), and new tile installation, the INTER-GLASS® Reinforced Composite System was installed over the entire remaining pool interior surface.

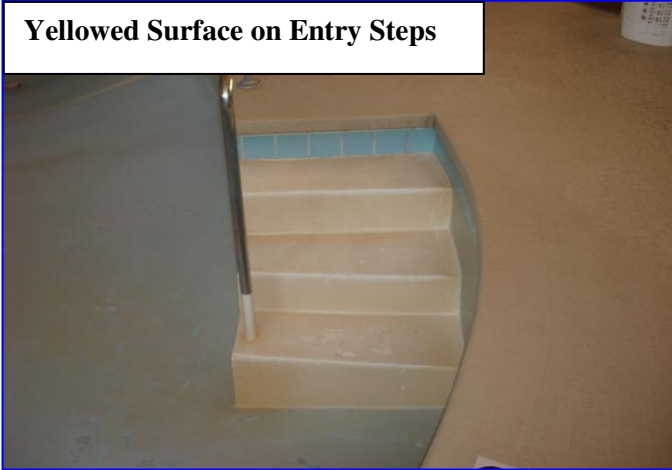
Yellowed Surface on Entry Steps

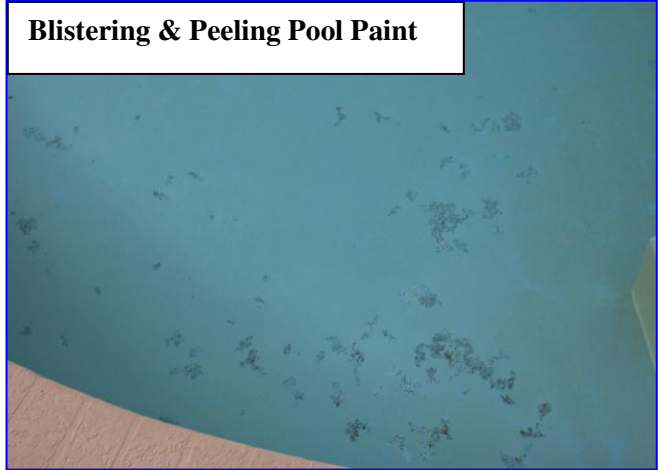
Blistering & Peeling Pool Paint

Abrasive blasting was required to remove layers of blistering and peeling pool paint. Set just yards away from an operating restaurant, the entire pool setting required tarping before any work began. Ventilation units and tubing were set up for air circulation and to remove any residual fumes and dust out from the hotel.

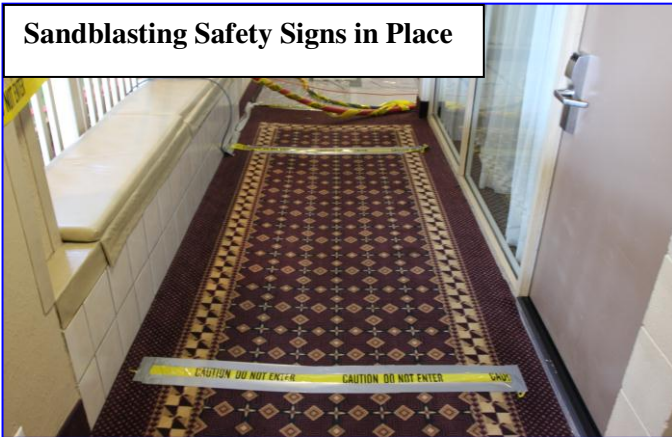
Sandblasting Safety Signs in Place

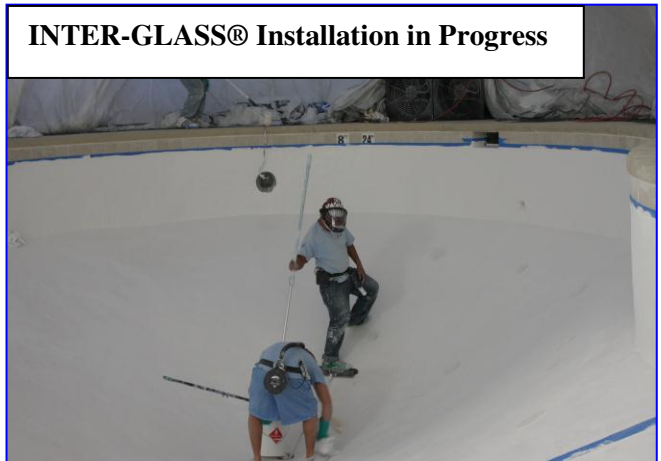
INTER-GLASS® Installation in Progress
