## PROJECT HISTORY

### LINDEN WOODS HOMEOWNERS ASSOCIATION

KANSAS CITY, MISSOURI

COMPLETION: 2006

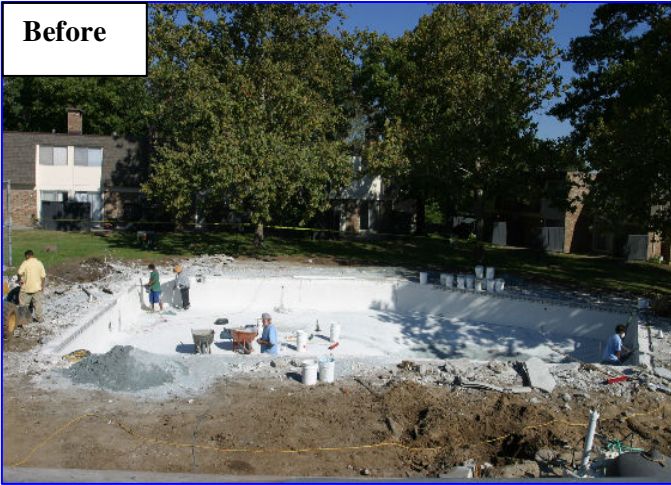
Before

The reconstruction of this commercial pool was part of a complete renovation on an aged and neglected rental facility. Virtually everything needed to be replaced on this pool project including the decking, circulation plumbing, equipment, and pool interior. As the property was turning into residential condominiums, besides the basic needs to have the pool function again, the owners opted to add aesthetic enhancements such as a waterfall, colorful decking and a reflective Diamond Brite pool interior.

For the first couple of weeks of this project, demolition ruled the day as the deck was removed, the painted surface was abrasive blasted. The failing pool tile was removed and trenches were dug for new circulation plumbing. Aesthetics in the choice of finish elements were very important on the job as the pool was blueprinted to be the prime, highlight attraction

fixture of this property. New circulation lines including an additional suction line were added to increase flow to the added waterfall. Light weight synthetic boulders were brought in to build the waterfall. New frost-proof tiling was added, a new deck poured and Tahoe Blue was chosen as the pool interior surface.

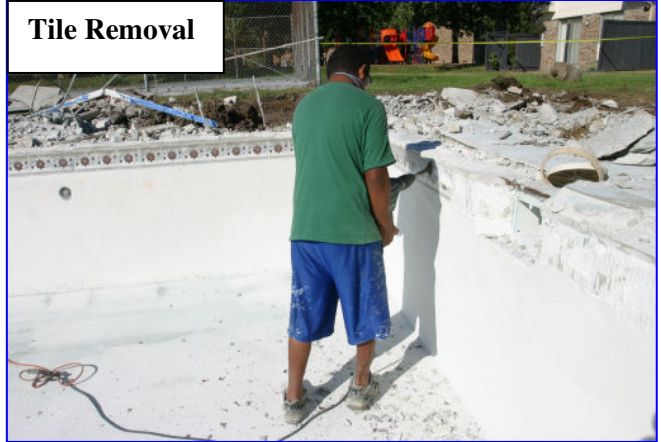
**Tile Removal**

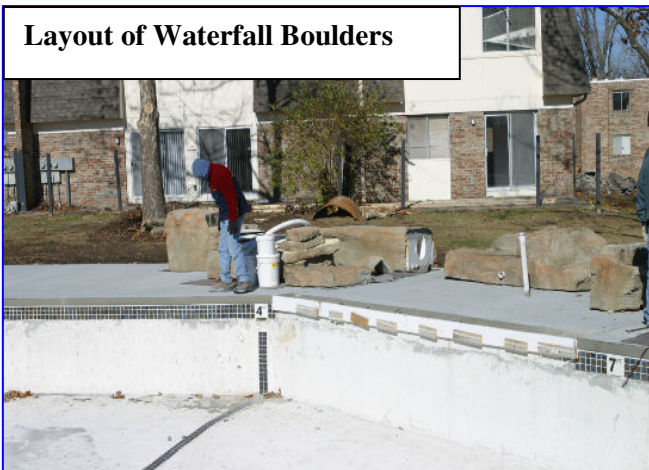
**Layout of Waterfall Boulders**

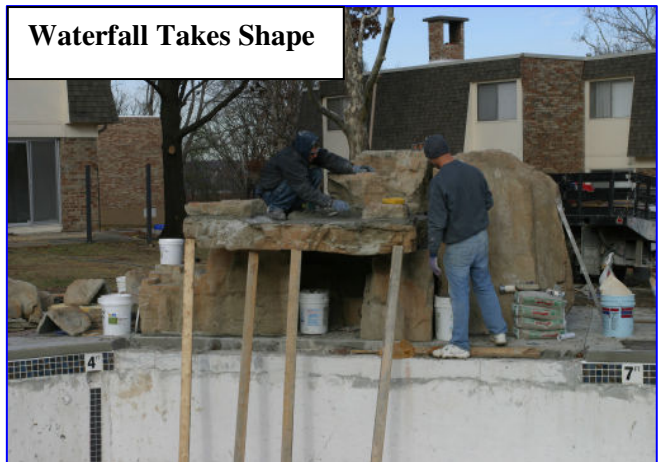
**Waterfall Takes Shape**

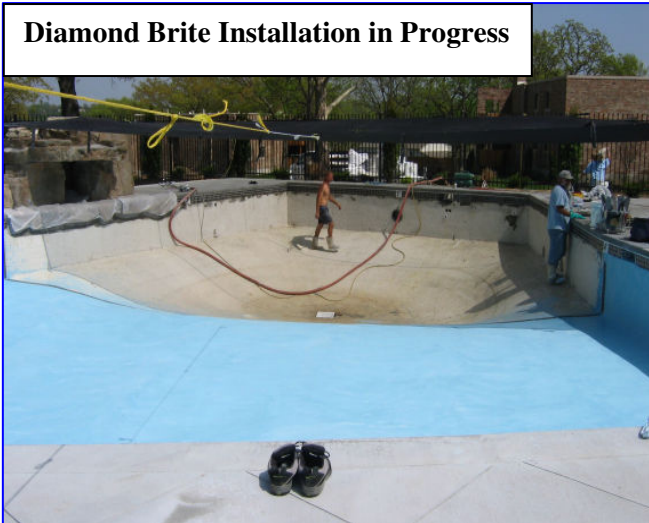
**Diamond Brite Installation in Progress**

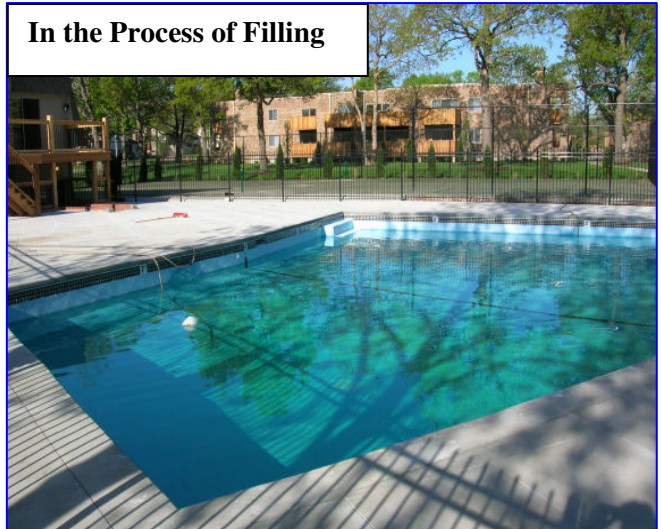
**In the Process of Filling**
