PROJECT HISTORY

McKEE FOODS COMMUNITY POOL (LITTLE DEBBIE CAKES)

CHATTANOOGA, TENNESSEE

COMPLETION: 2008

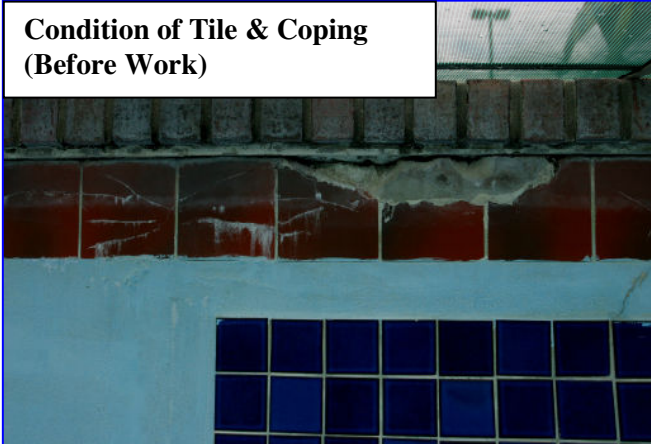
Condition of Tile & Coping
(Before Work)

Core drill and Schmidt Hammer testing determined that the pool was structurally sound for renovation. The deteriorating brick coping and unglazed tiling were mechanically removed. Abrasive blasting (coal slag) was used to remove the remaining pool paint and the various deposits from the pool surface. Several hydrostatic relief ports were drilled through the pool shell to offer relief to subsurface water while the pool was drained. These same ports would serve to offer relief in the future when the pool is

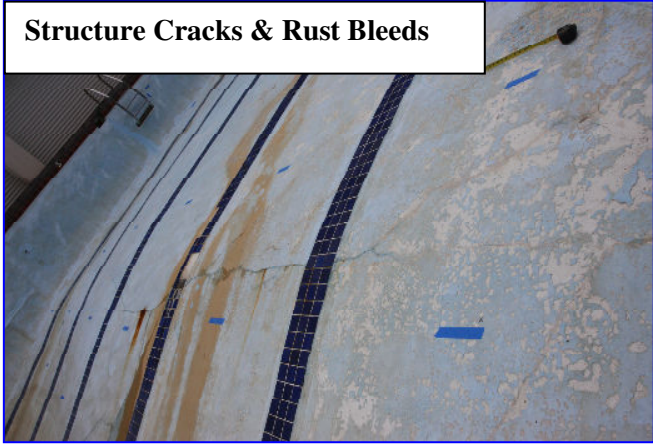
This large shot-creted pool was affected by numerous structure cracks created largely by the effects of hydrostatic pressure and poor construction practices. Built on a clay base with no gravel bedding and a lack of hydrostatic relief ports, subsurface water had no routes of escape. Numerous cracks and voids were created from this pressure in various areas of the pool. While the pool was drained, water bled through the cracks from underground, and while full, pool water leaked out through those same cracks in the pool shell. Rust bleeds from chemically treated water touching the reinforcement steel, as well as calcium and ettringite deposits were evident throughout the pool surface. The brick coping, un-glazed waterline tiling and ‘paint over plaster’ pool surface were all in a state of degradation.

Structure Cracks & Rust Bleeds

drained periodically for cleaning. Up to 4-diaphragm pumps were used at one time to control and remove subsurface water and relieve pressure on the pool shell during renovation. Structure cracks were sealed with a high-grade epoxy and permanently sealed with the **InterSteel Crack Repair** method. Following placement of new frost-proof waterline tiling and a pour *in situ* coping, the entire pool received the INTER-GLASS® Reinforced Composite System.

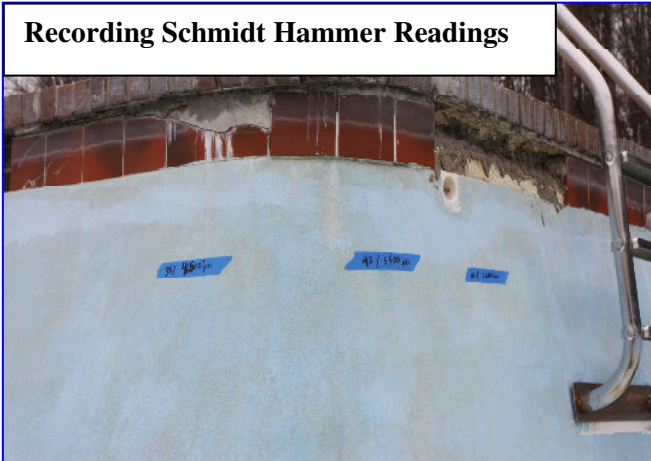
Recording Schmidt Hammer Readings

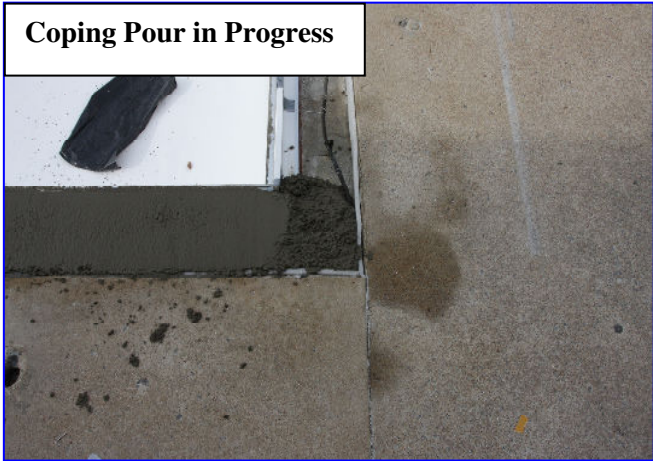
Coping Pour in Progress

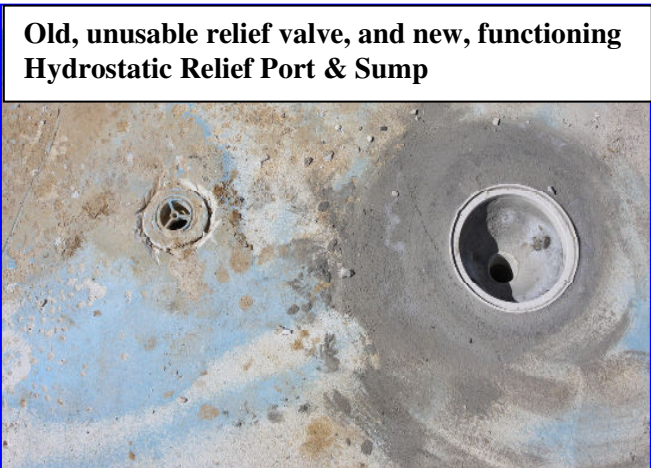
Old, unusable relief valve, and new, functioning
Hydrostatic Relief Port & Sump

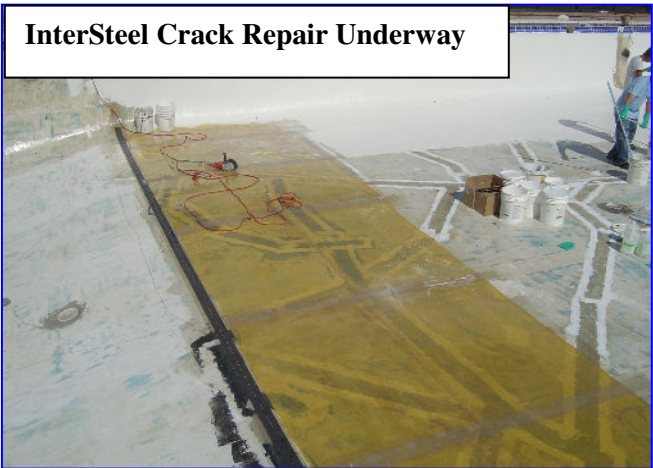
InterSteel Crack Repair Underway
