PROJECT HISTORY

RIVER OAKS TOWNHOMES ASSOCIATION

CALUMET CITY (CHICAGO) ILLINOIS

COMPLETION: 2003

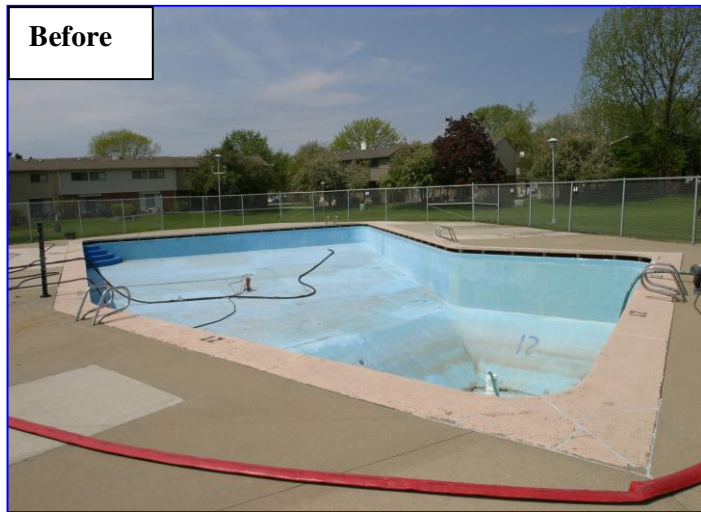
Before

There were two parts involved in this renovation, the pool itself, and a concealed, weir-type channel gutter system. The painted pool surface was peeling and flaking, along with the discoloration and chalkiness generally inherent with most painted surfaces. The pool shell was also beset by severe water leakage through numerous structure cracks. The greater challenge however rested in accessing and repairing the original concrete gutter channel. This original weir-type system rested underneath a two-foot wide section of concrete decking, making it inaccessible to inspection, maintenance and repair. Like the pool shell, this concrete covered gutter system also had structure cracks and experienced water leakage.

Hit by a budget crisis, the owners could not spend in excess of \$400,000 to construct a new pool. There were several goals in this renovation: Sealing the structure cracks in the pool and gutter, keeping the gutter system in working condition, while making it accessible for future inspection and maintenance, and resurfacing both vessels. The two-foot wide concrete walkway was removed, exposing the concrete channel gutter. Both the pool and gutter channel were abrasive blasted to remove the failing pool paint. In lieu of replacing the concrete walkway over the gutter channel, a specially built sectional

gutter grating, handhold and support system was designed and installed over the gutter channel. Such a system would now allow periodic inspections of the gutter, plus safety and comfort for the swimmers. Frost-proof waterline and depth transition tiling was added onto the pool. Structure cracks were filled with a high-grade epoxy and permanently sealed with the **InterSteel Crack Repair** method, and the entire pool and gutter received the INTER-GLASS® Reinforced Composite System.

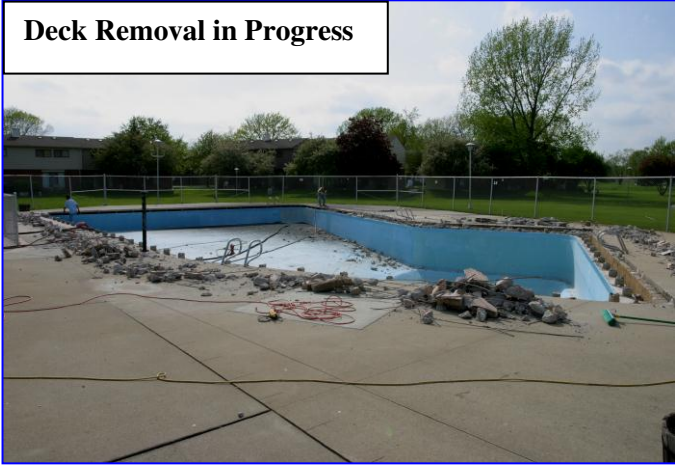
Deck Removal in Progress

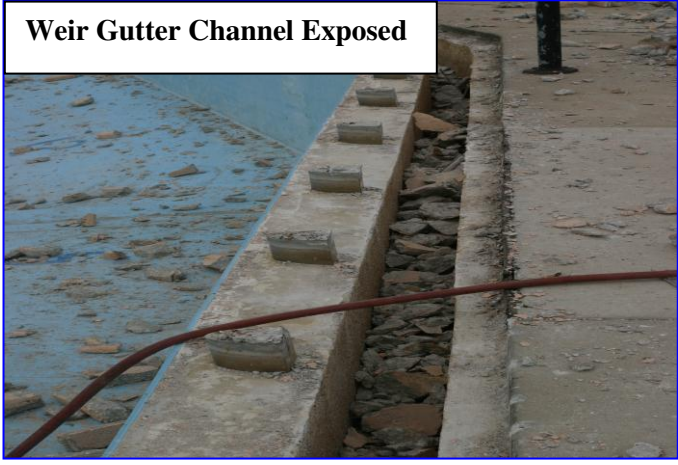
Weir Gutter Channel Exposed

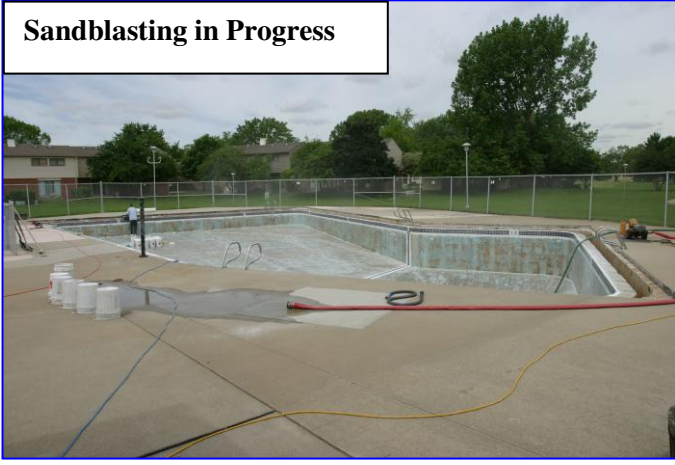
Sandblasting in Progress

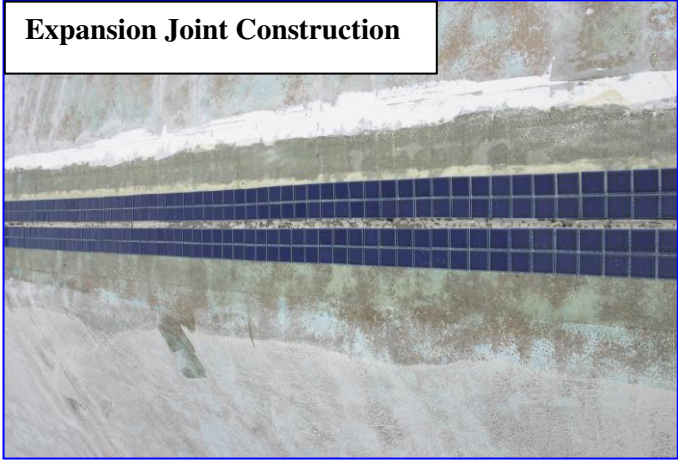
Expansion Joint Construction

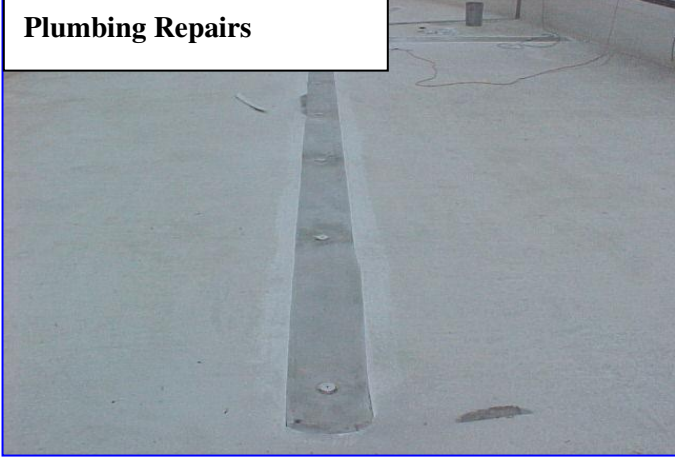
Plumbing Repairs

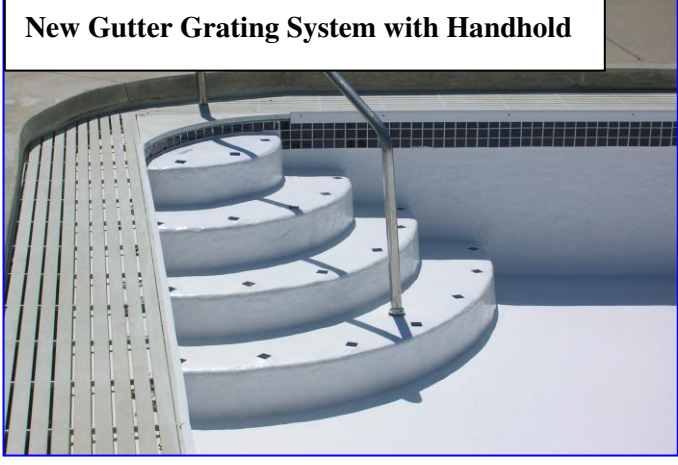
New Gutter Grating System with Handhold
