PROJECT HISTORY – **OUTDOOR WORK IN EXTREMELY COLD TEMPERATURES**

SHERATON HOTEL – CROWN CENTER

KANSAS CITY, MISSOURI

COMPLETION: 2013

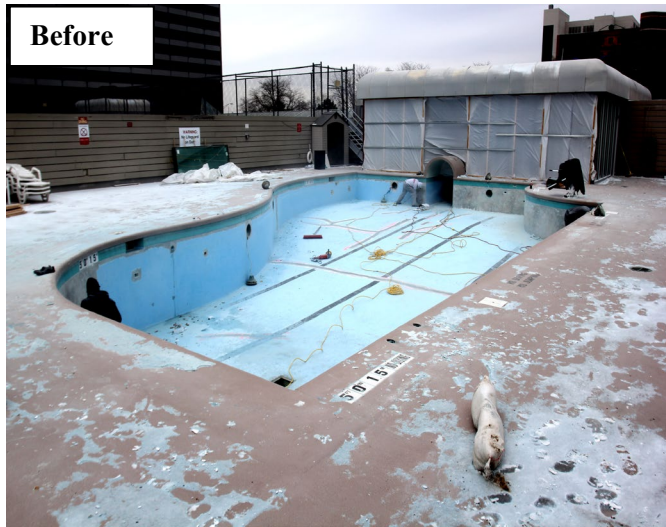
Before

The Sheraton Hotel – Crown Center swimming pool is located five (5) stories above ground level, and directly above the hotel’s main kitchen. Drained in early November 2013 for some minor remedial work, a surprise cold snap with frigid temperatures stopped the work in its tracks. Within a day of experiencing extremely cold temperatures on the outdoor portion of this concrete pool, and heated kitchen temperatures underneath, the concrete shell developed a number of cracks from ‘thermal shock’. Subsequently, melting water from snow showers seeped through the cracks into the kitchen below, causing it to have to close.

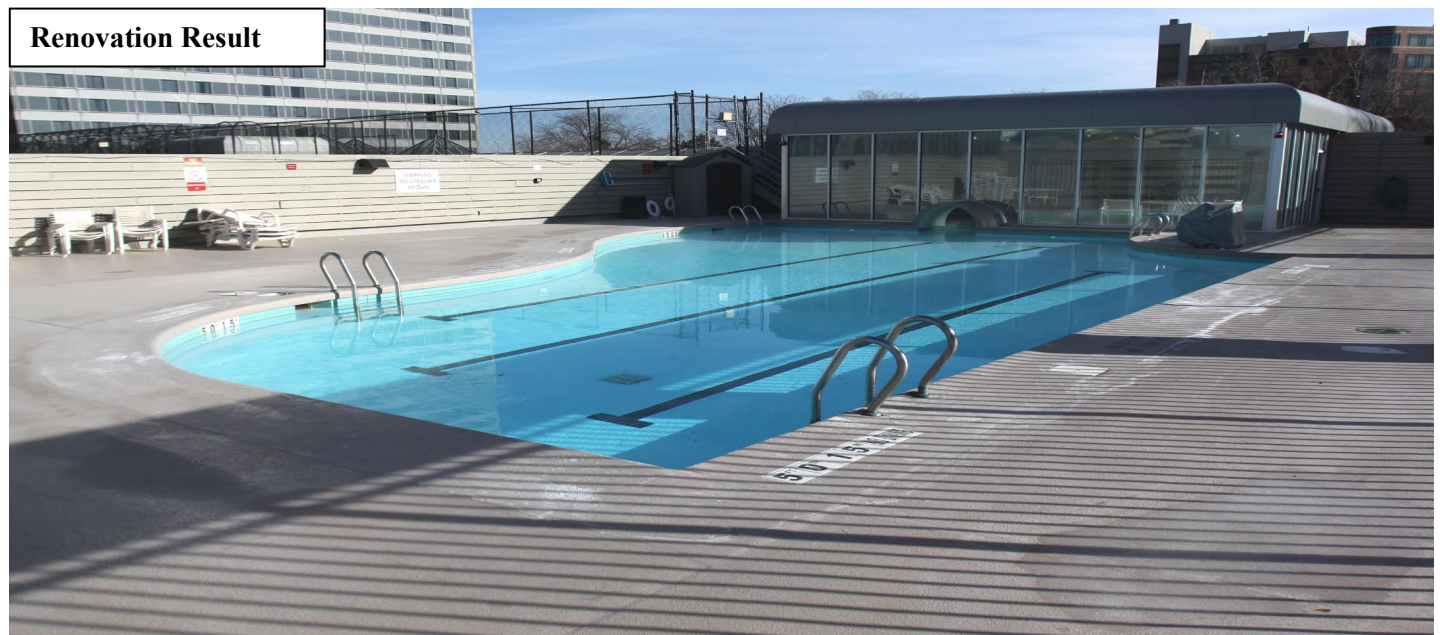
Renovation Result

conditions without the use of any water. Pool paint was removed manually with every square inch of debris and residue hand vacuumed. The entire pool was tarped and heated with materials-friendly radiant heat. Cracks were routed, cleaned, injected with epoxy and permanently sealed with Aramid fabrics. Ceramic racing lane tiling was set. Finally, the entire pool was re-surfaced with INTER-GLASS®. The Project was successfully completed, pool filled with water and in operation a week before Christmas.

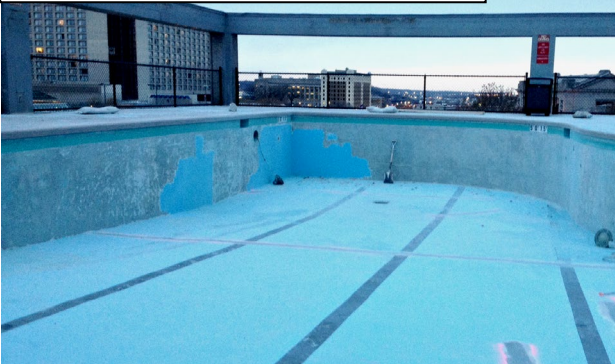
Paint Removal Underway

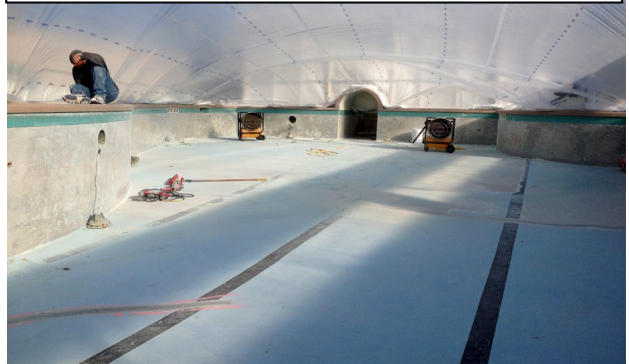
Structure Tarped, Radiant Heating Begins.

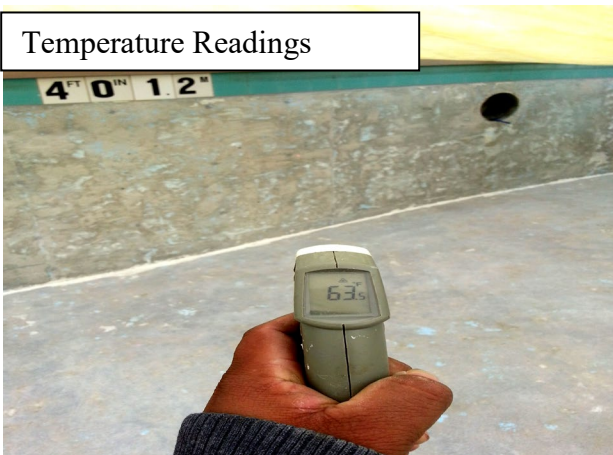
Temperature Readings

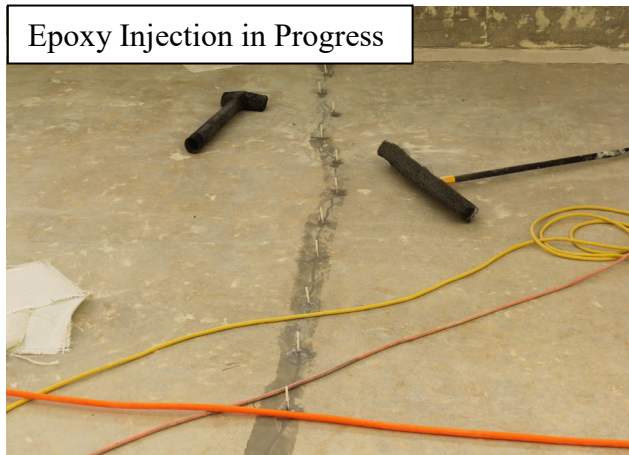
Epoxy Injection in Progress

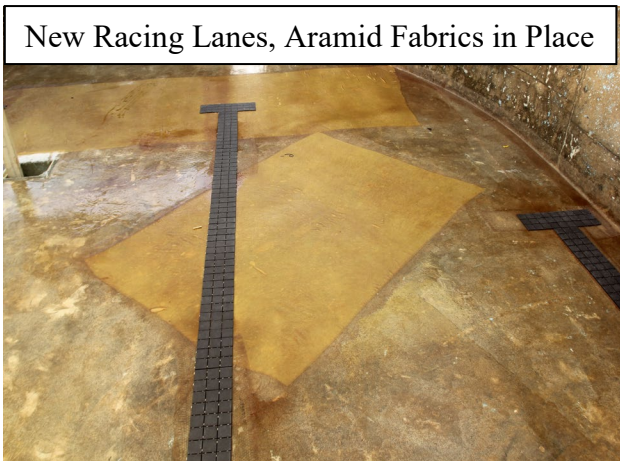
New Racing Lanes, Aramid Fabrics in Place

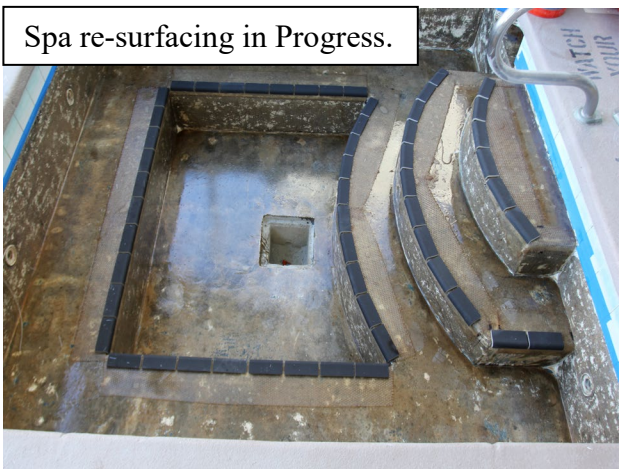
Spa re-surfacing in Progress.
