2012 Preservation Award Winner

# BEFORE HISTORIC RESTORATION PROJECT

# THE ELMS HOTEL & SPA – HISTORIC RESTORATION PROJECT

## EXCELSIOR SPRINGS, MISSOURI

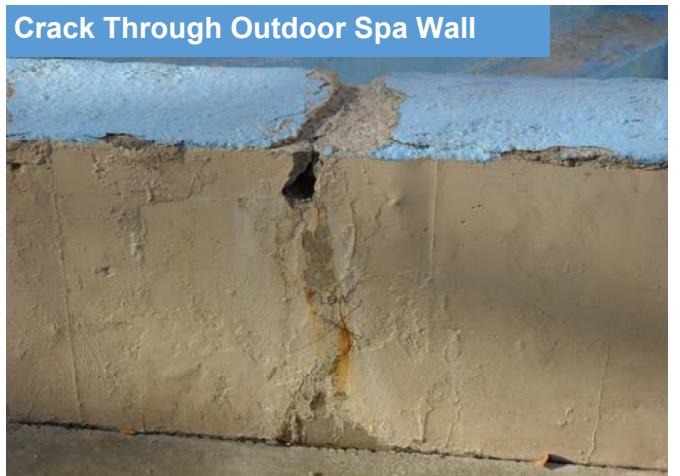
shown through the peeling surface material making the vessel appear as though it was constantly dirty. A structure crack developed through one wall of the spa allowing spa water to freely drain on to the sidewalk.

Crack Through Outdoor Spa Wall

Paint and other failing surfacing materials on the outdoor spa were completely removed down to a sound concrete base. In addition to repairing a structure crack in the spa wall, several broken and compromised recirculation and air lines had to be removed and replaced.

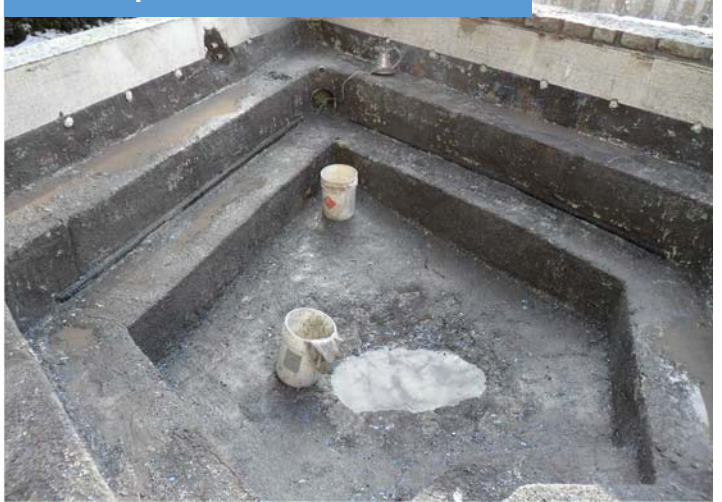
**Gutted Spa to Sound Concrete Base**
