PROJECT ASSESSMENT

“Shot-crete Job Gone Wrong”

RENOVATION PLAN

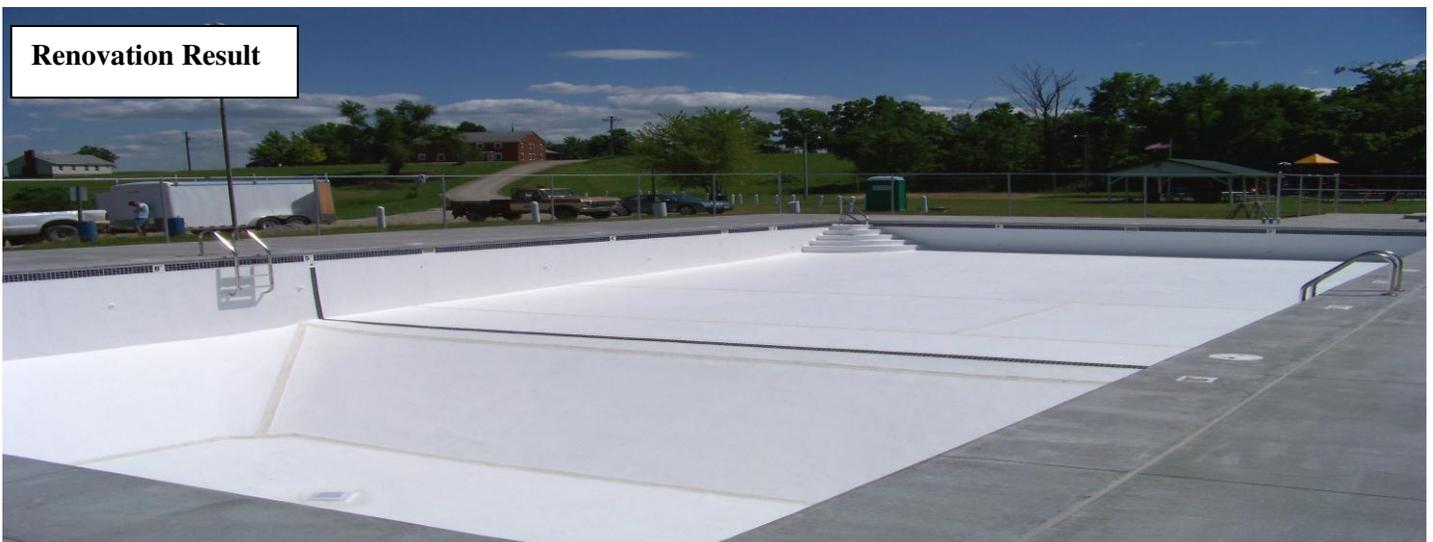
that was placed was of such a wet mix that settlement cracks were rampant throughout the pool floor. Conversely, the pool walls and entry steps once finished were so rough that a complete cement-render job was necessary to ready the pool for a reasonably smooth surface. To combat these irregularities and problems with the pool surface, and several sectional pours, the **InterSteel Crack Repair Method** and INTER-GLASS® Reinforced Composite System were installed over the entire pool interior.
