**PROJECT ASSESSMENT**  
*“What needed to be done”*

# CITY OF BURLINGAME, KANSAS

## BURLINGAME, KANSAS

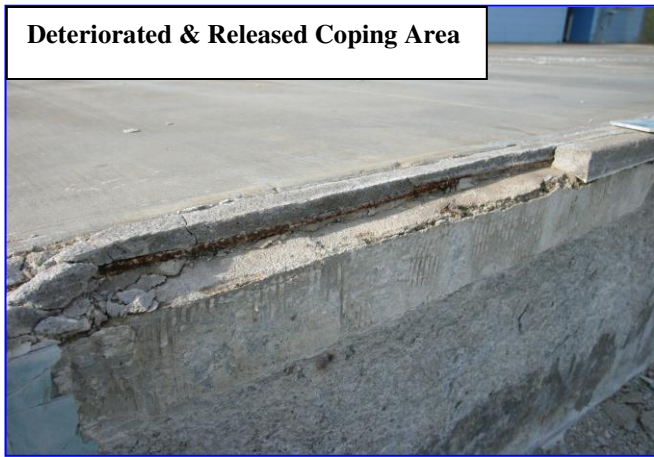
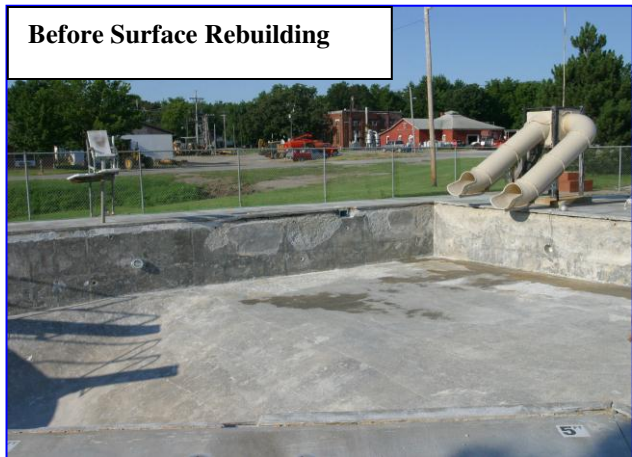
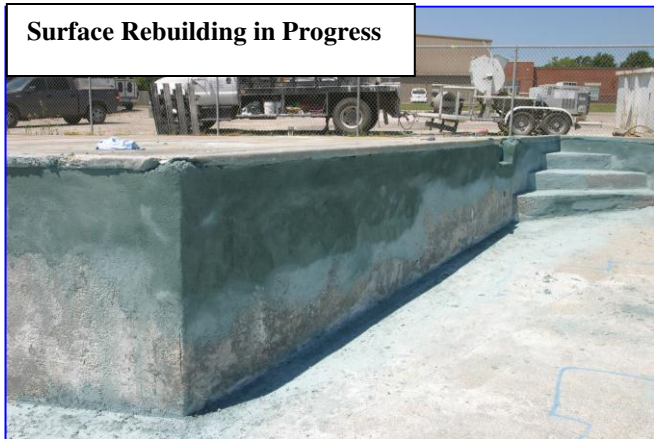
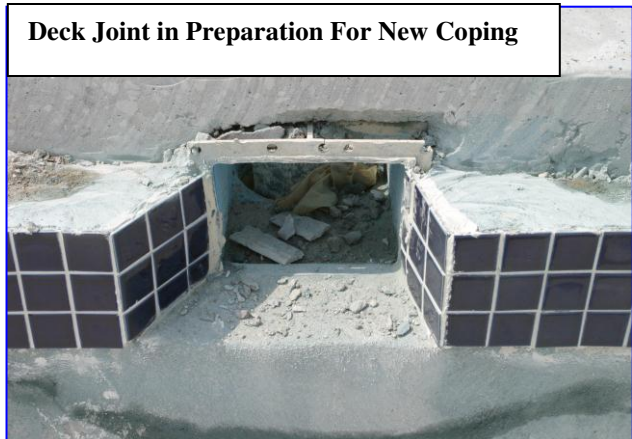
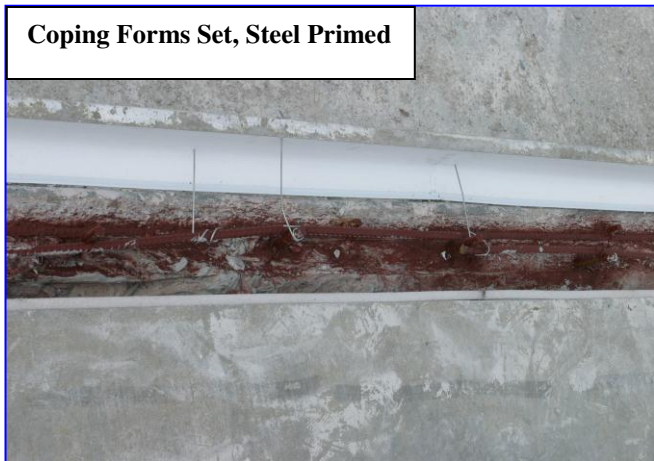
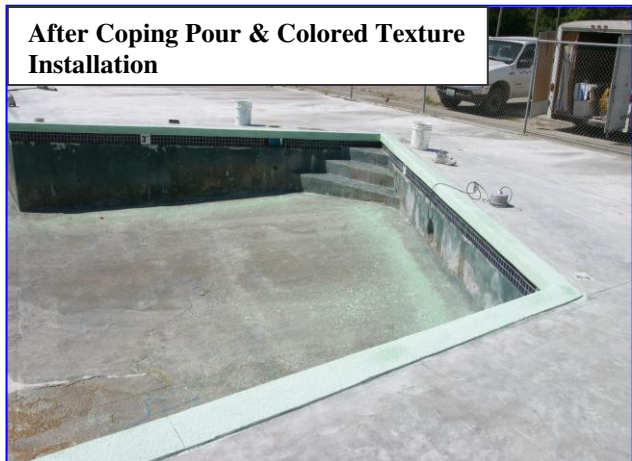
SAMPLE PICTORIAL SEQUENCE ON BACK OF THIS PAGE

This large, formed and poured commercial pool was in need of complete re-construction. The entire pool interior including the expansion joints and waterline tiling was covered with a spray applied fiberglass liner only a couple of seasons before our work began. With no room for expansion or contraction, and a poorly prepared substrate, the liner began to release pulling off chunks of freeze damaged sub-surface concrete along with it. The pool coping was badly deteriorated and releasing from the bond beam at numerous locations around the perimeter of the pool.

Following removal of the liner, waterline tiling and all loose and deteriorated concrete, the surface received high-pressure abrasive water blasting. High-grade epoxy sealants filled structure cracks in the pool shell. The complete existing concrete surface including the tile bed area was reinforced with a pneumatically applied, course, quartz aggregate cementitious render coat utilizing fibers, bonding and water reducing agents

in the mix. New frost-proof waterline tiling was installed. Particular care was taken to cut and rebuild a previously filled expansion joint between the existing pool shell and pool decking before forming and pouring an *in situ* cantilever coping, topped with colored kool-deck. The INTER-GLASS® Reinforced Composite System was installed over the entire remaining pool interior surface.
