## PROJECT ASSESSMENT

"PVC Problems."

## **RENOVATION PLAN**

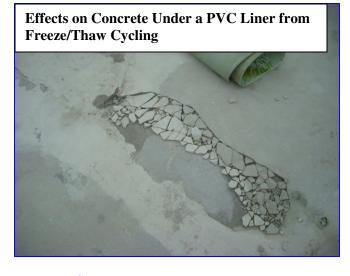
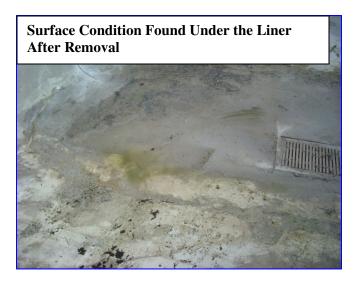
Several years ago, the camp owners of this large outdoor, shot-creted and plastered pool opted to install a PVC Liner. After some years of use, the liner began exhibiting unappealing traits such as folds, discoloration, and pinholes resulting in tears and water loss. Moisture and condensation that transport through the liner and seep up through the pool shell by hydro static pressure became trapped. Yearly cycles of trapped freeze / thawed water damaged the plaster and concrete surface under the liner, resulting in tearing apart layers of the subsurface and demonstrating how damage and corrosion beneath an unbonded sheet lining can proceed unnoticed for several years. Structure cracks also affected the pool shell.

The deteriorated liner and disintegrating, contaminated felt material under the liner were cut apart and removed. Chunks of plaster and concrete damaged by being trapped under the liner through several years of freeze/thaw cycling were removed. Following high water pressure blasting (>5000 psi), and setting up

hydrostatic water pressure relief by diaphragm pumping, all the structure cracks were permanently sealed with a high-grade epoxy sealant and InterSteel. Finally, the entire pool received the INTER-GLASS® Reinforced Composite System that included a frost-proof tiled depth transition line.
