PROJECT ASSESSMENT

RENOVATION PLAN

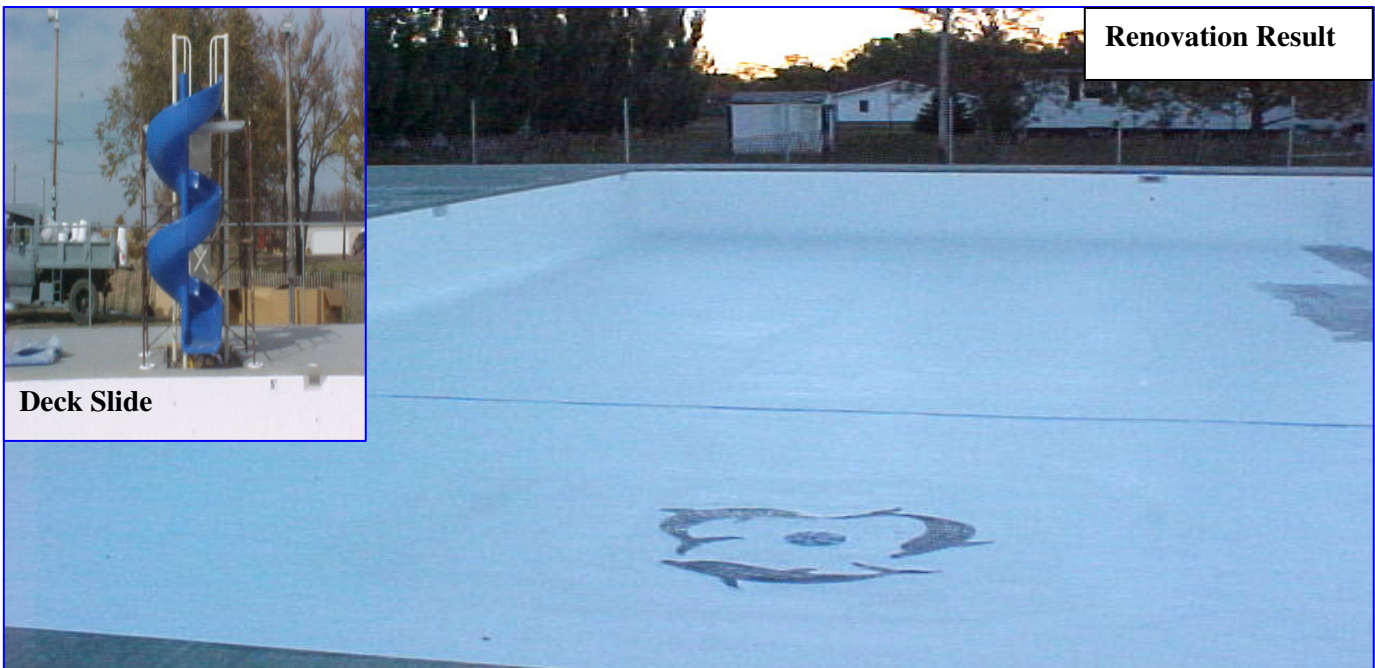
The 12 FT deep end of this large, shot-creted city pool had raised (floated) out of the ground. The plumbing had cracked and the pool leaked water at an alarming and costly rate. All of the concrete decking was in a cracked and deteriorated state. The “inside” corner of the L-shaped pool had cracked severely and appeared to be falling away from the pool. Blistering and peeling pool paint and freeze damage plagued the pool surface.

Work began, as a 14” track saw was set onto the pool walls to begin cutting off the raised pool shell. Demolition continued as the pool decking was broken up and removed from site. Deep trenching was required for this cold climate, Frost Depth Chart Zone. Abrasive blasting was used to remove the existing layers of pool paint, and to clean the numerous structure cracks throughout the pool shell – some sustained as a result of the pool floating. The area around the structurally affected inside corner of the

pool was reinforced with steel and concrete shoring. New concrete decking around the main and kiddie pools was constructed with the strictest of commercial standards including ½” steel on 14” centers. Structure cracks were permanently sealed with the **InterSteel Crack Repair Method**, and the entire pool received the INTER-GLASS® Reinforced Composite System. Finally, a circular, deck mounted slide was plumbed into the system to accentuate the pool and entice community participation at the City pool.
