### PROJECT ASSESSMENT

### RENOVATION PLAN

# LAKE PARK PLAZA CONDOMINIUMS

## CHICAGO, ILLINOIS

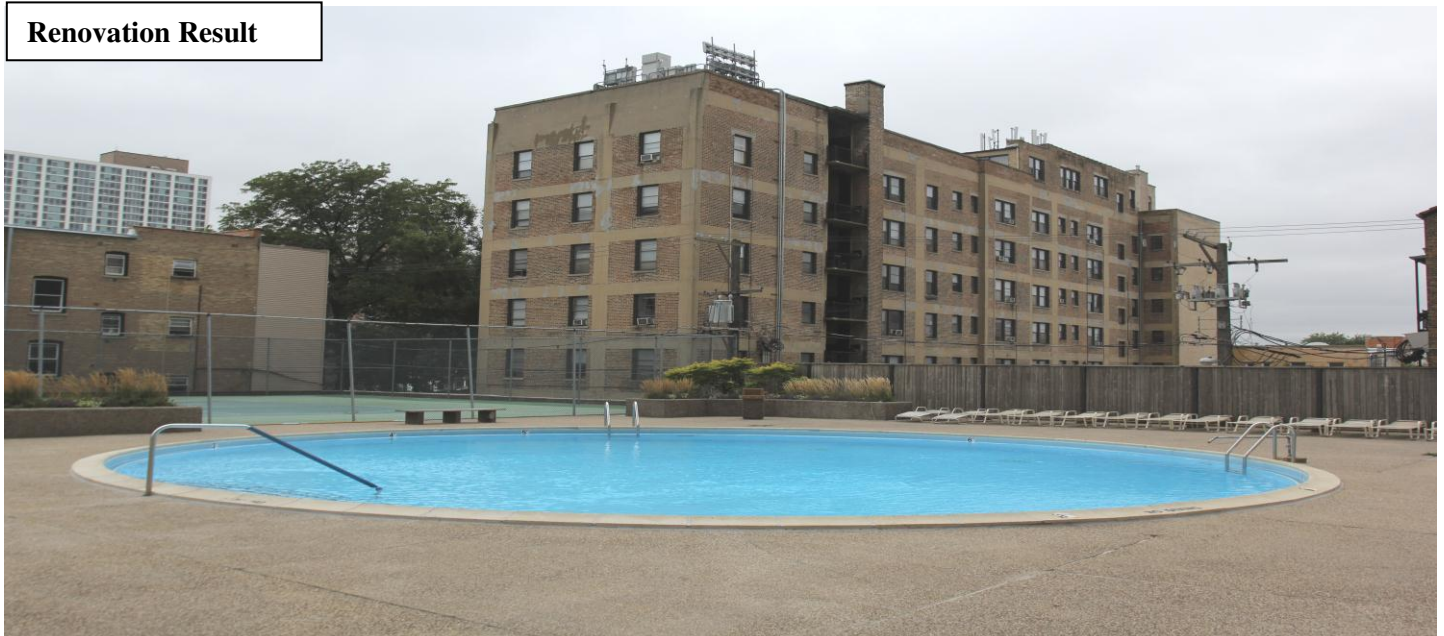
### Renovation Result

The Lake Park Plaza galvanized metal pool not only had a degraded and mottled painted surface, it had a delaminating fiberglass liner installed over pool paint. Composite materials do not adhere to paint so the existing liner released cleanly. Under the paint, we found the protective zinc & iron coating generally applied to prolong the time before corrosion activates. Most of this protective coating was still intact, however some degradation and residue were evident where the coating had worn through to the metal. Following ISO 8501 – :

2007 (Swedish Standards), all foreign matter was removed by Water Jetting. The surface received a heavy Zinc enriched coating followed by an installation of the **INTER-GLASS® Reinfo Polymeric System**. *Metal pool surfaces require monitoring & periodic inspections. A PVC membrane or liner should never be used. Completely hiding the surface, periodic inspections cannot take place while corrosion may continue under the membrane from entrapped water.* **INTER-GLASS®** which is fully adhered to the metal surface permits required surface monitoring.
