PROJECT HISTORY
REGATTA CONDOMINIUMS
CHICAGO, ILLINOIS

COMPLETION: 2016

PROJECT ASSESSMENT

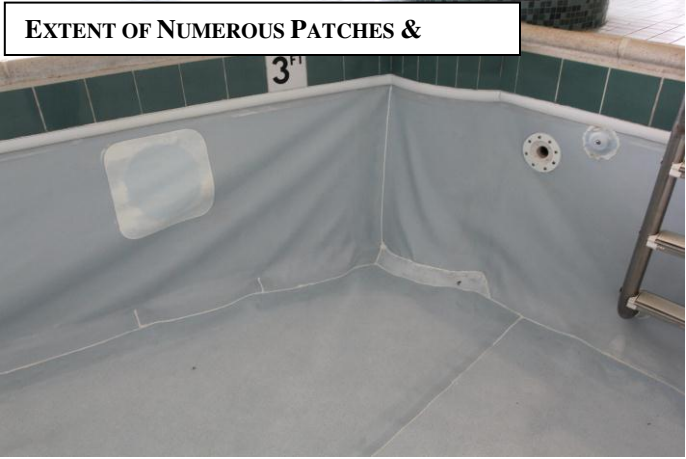
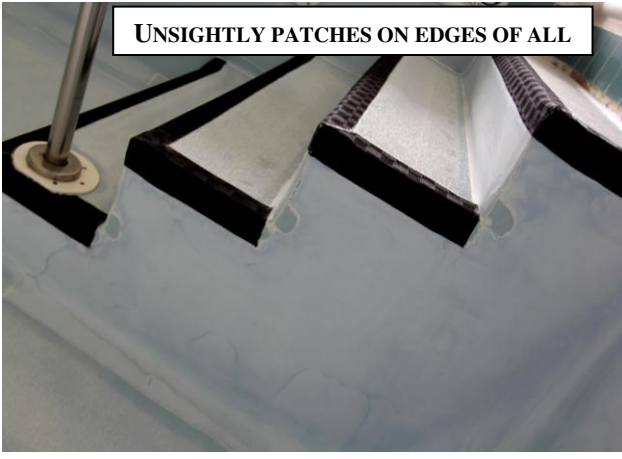
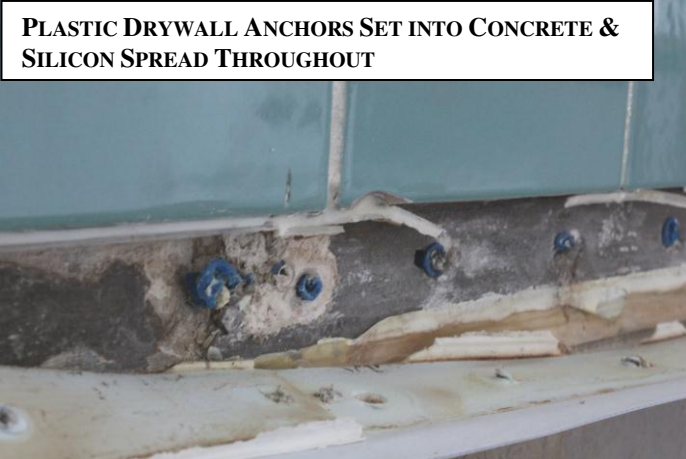
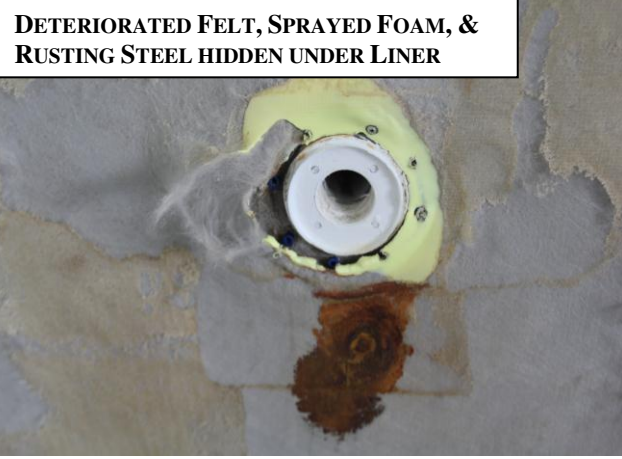
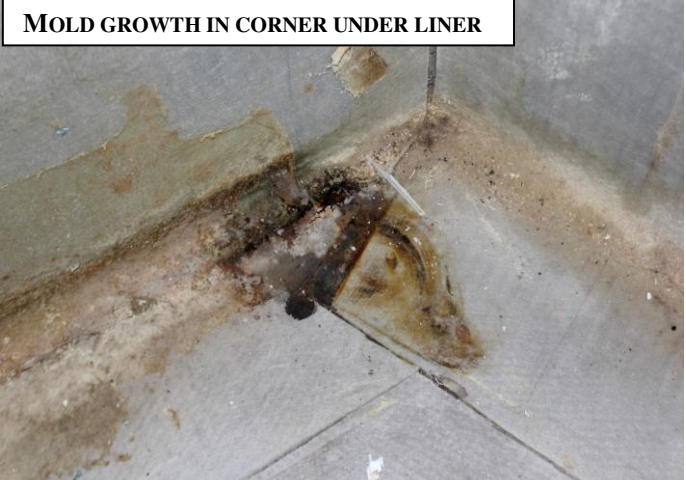
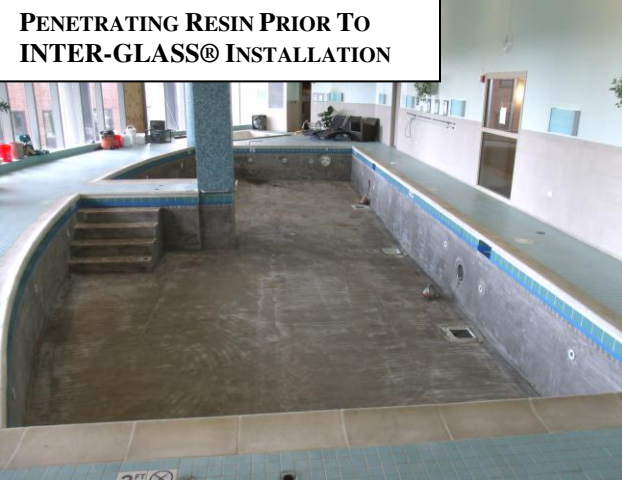
A wrinkled, discolored and patched PVC liner is not very appealing to look at, especially at a prestigious condominium association overlooking Lake Michigan. However, there was another problem that overshadowed the liner’s appearance, and that was water leakage through the liner to the condominium unit directly below the pool. Notwithstanding numerous patches in the liner, water continued leaking to the floor below resulting in the pool being closed for several years. It was time for a re-surfacing change.

Generally, removal of the actual PVC liner is fairly easy. Once it is cut into sections, it can be pulled away, rolled up and discarded. The difficulty in the removal process comes in removing the glued, degraded felt backer material placed onto the concrete under the vinyl.

A plastic ‘ending point’ to the liner was added directly under water line tiling. This holding track was held in place by plastic drywall anchors drilled into the concrete and Tap-con® screws on approximately 3” centers. Each screw was then covered with ‘globbs’ of silicon.
