PROJECT HISTORY

SAVIOR PASTORAL CENTER – ROMAN CATHOLIC ARCHDIOCESE OF KANSAS CITY, KANSAS

COMPLETION: 2016

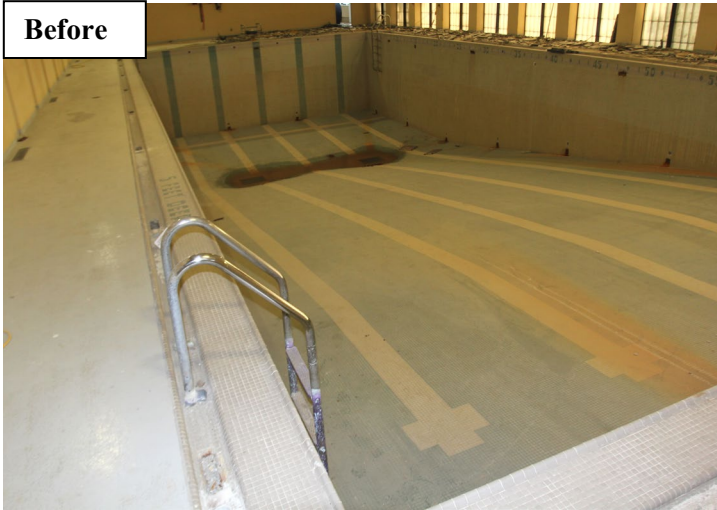
Before

Originally constructed in the late 1950's, the Savior Pastoral swimming pool had a fully (very dull) green tiled pool interior and brown colored slurred decking that gave the entire setting a dark, dank, unappealing look.

Recirculation lines constructed out of steel were so badly corroded that water could not flow through the lines. Both the deck drains and gutter suction lines had separated from piping allowing water to simply pour out of the pool onto the corridors and walkways below the pool. Water leaching through the concrete walls left unsightly calcium deposits and leakage on the exterior corridor walls, and a single main drain sump had to be updated to meet current VGB Code.

The costs of completely removing the existing tiling and re-surfacing with new, brighter tile was cost prohibitive. And given the condition of the cracked concrete walls, re-surfacing with a Cement-based material was not practical. A white INTER-GLASS® interior, accented with black racing lanes and targets and light beige decking served to seal surfaces from water loss and brighten the room. Old steel plumbing lines were manually removed from the structure and replaced with SCH 40 PVC. The concrete basin was cut and excavated for a new unblockable VGB Compliant main drain system.

While most of the elevated existing steel plumbing lines seemed accessible, cutting and removal had to be done on scaffolding from the corridors surrounding the pool. New recirculation lines were cored through the concrete walls. Old steel lines were sealed and covered. After the existing tile was scarified, a Protective Barrier and multiaxial fabrics were installed, followed by new racing lanes and the INTER-GLASS® Reinforced Polymeric System. A new 15hp pool pump and automatic water leveler completed the pool part of the Project.
