PROJECT ASSESSMENT

RENOVATION PLAN "How it was done"

DAVENPORT COUNTRY CLUB

DAVENPORT, IOWA

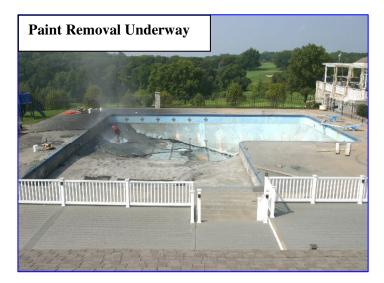
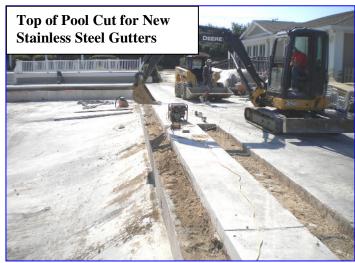
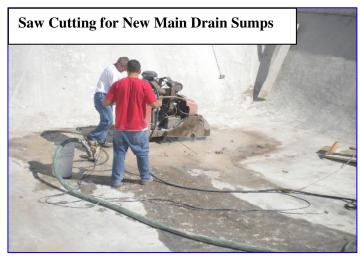
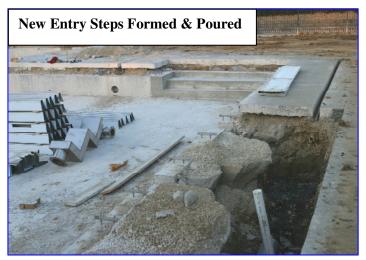
Pictorial Sequence on Back Page

The first course of work in this project was to remove numerous layers of pool paint from the surface. This was followed by cutting off the top of the pool walls to accommodate new stainless steel gutters, and excavation for new main drain sumps and circulation lines. Part of the shallow end wall was cut out for off-set entry steps so as not to interfere with the pool's racing lanes during competitions. Due to the pool's unusual depth, two sets of scaffolding had to be used during sandblasting and re-surfacing. A sectioned

gutter grating and support system was designed for installation over the gutter channel. Such a system would now allow periodic inspections of the gutter, plus safety and comfort to the swimmers. Frost-proof racing lane, target and depth transition tiling was added onto the pool. Structure cracks were filled with a highgrade epoxy and permanently sealed with the InterSteel Crack Repair method using Kevlar® (by Dupont), and the entire pool received the INTER-GLASS® Reinforced Composite System.
