PROJECT ASSESSMENT
“What needed to be done”

RENOVATION PLAN
“How it was done”

CITY OF BURLINGAME, KANSAS

BURLINGAME, KANSAS

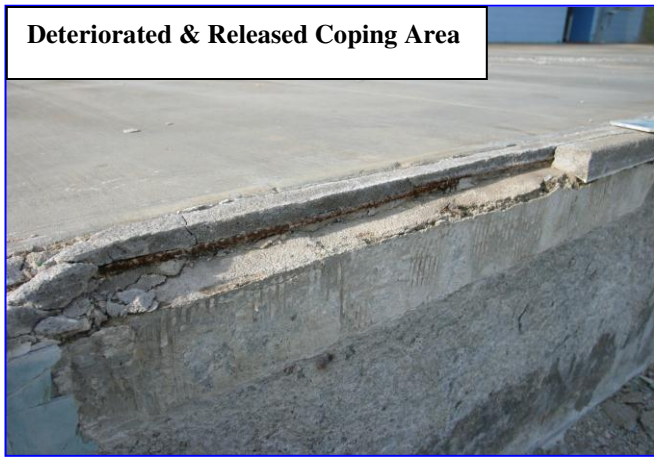
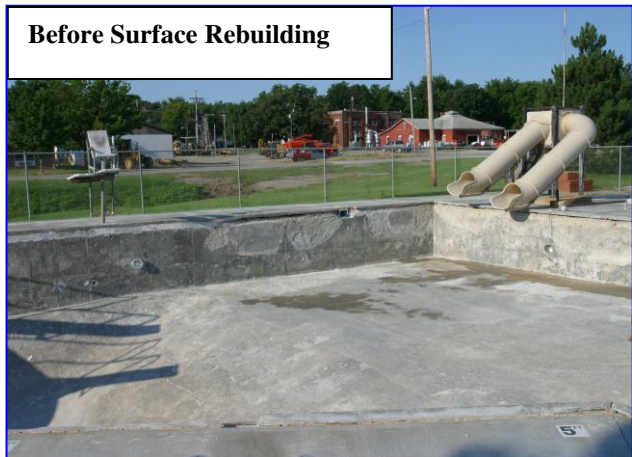
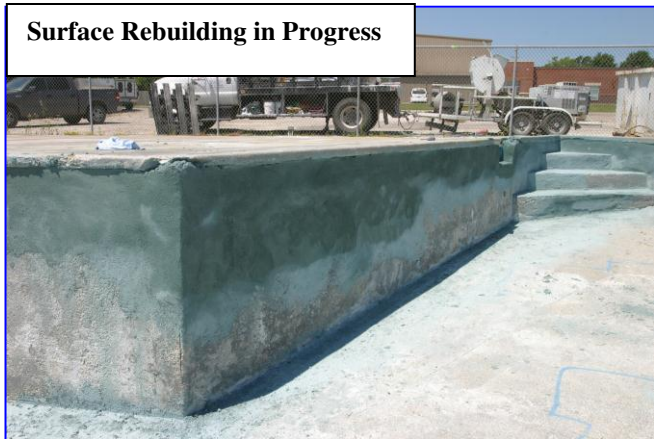
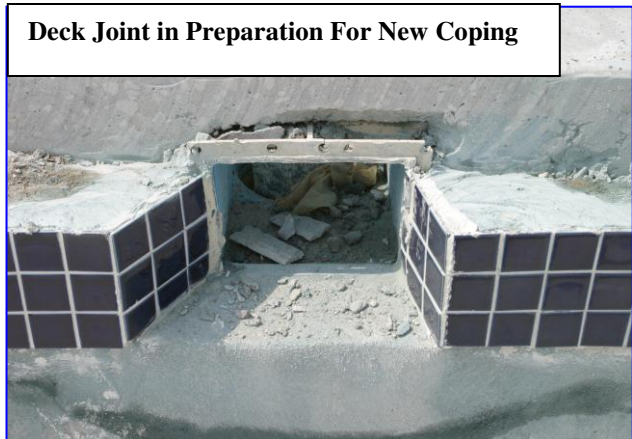
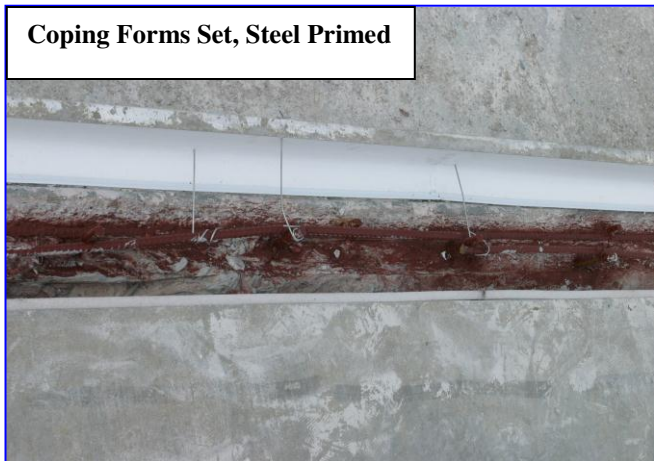
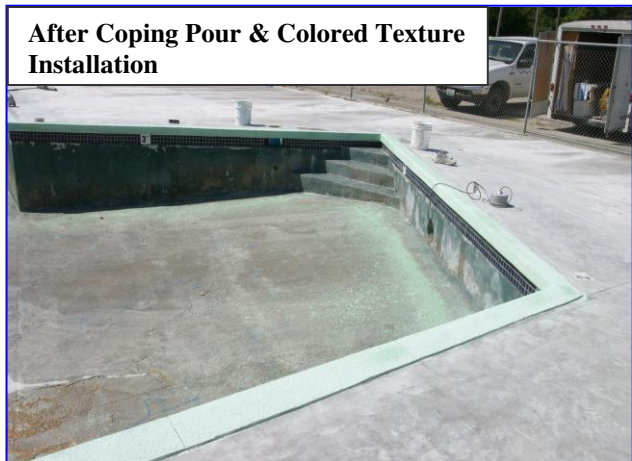
SAMPLE PICTORIAL SEQUENCE ON BACK OF THIS PAGE

Following removal of the liner, waterline tiling and all loose and deteriorated concrete, the surface received high-pressure abrasive water blasting. High-grade epoxy sealants filled structure cracks in the pool shell. The complete existing concrete surface including the tile bed area was reinforced with a pneumatically applied, course, quartz aggregate cementitious render coat utilizing fibers, bonding and water reducing agents

in the mix. New frost-proof waterline tiling was installed. Particular care was taken to cut and rebuild a previously filled expansion joint between the existing pool shell and pool decking before forming and pouring an *in situ* cantilever coping, topped with colored kool-deck. The INTER-GLASS® Reinforced Composite System was installed over the entire remaining pool interior surface.
