RENOVATION PLAN "How it was done"

STONEGATE MEADOWS

KANSAS CITY, MISSOURI

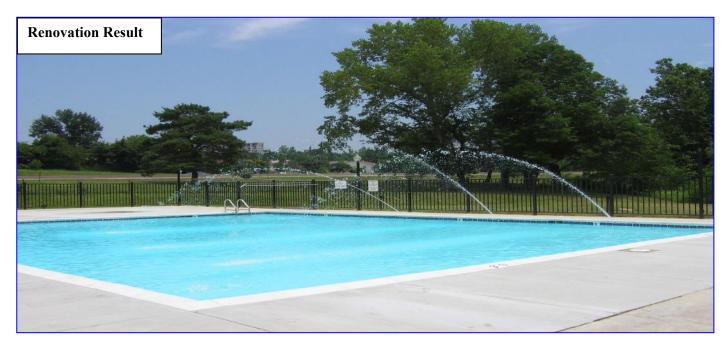
deteriorated pool paint. A new concrete wall was added across the pool and the deep end was filled in. Coping stones were added to the top perimeter of the pool along with new frost-proof waterline tiling. Four feet of concrete decking around the pool perimeter received a gray kool-deck surface and INTER-GLASS® was installed on the pool surface. Finally, deck surface sprayers were installed as an added aesthetic feature to the pool setting.
