THE WILSON PARK POOL – HISTORIC RESTORATION

FAYETTEVILLE, ARKANSAS

COMPLETION: 2012

PROJECT ASSESSMENT "What needed to be done"

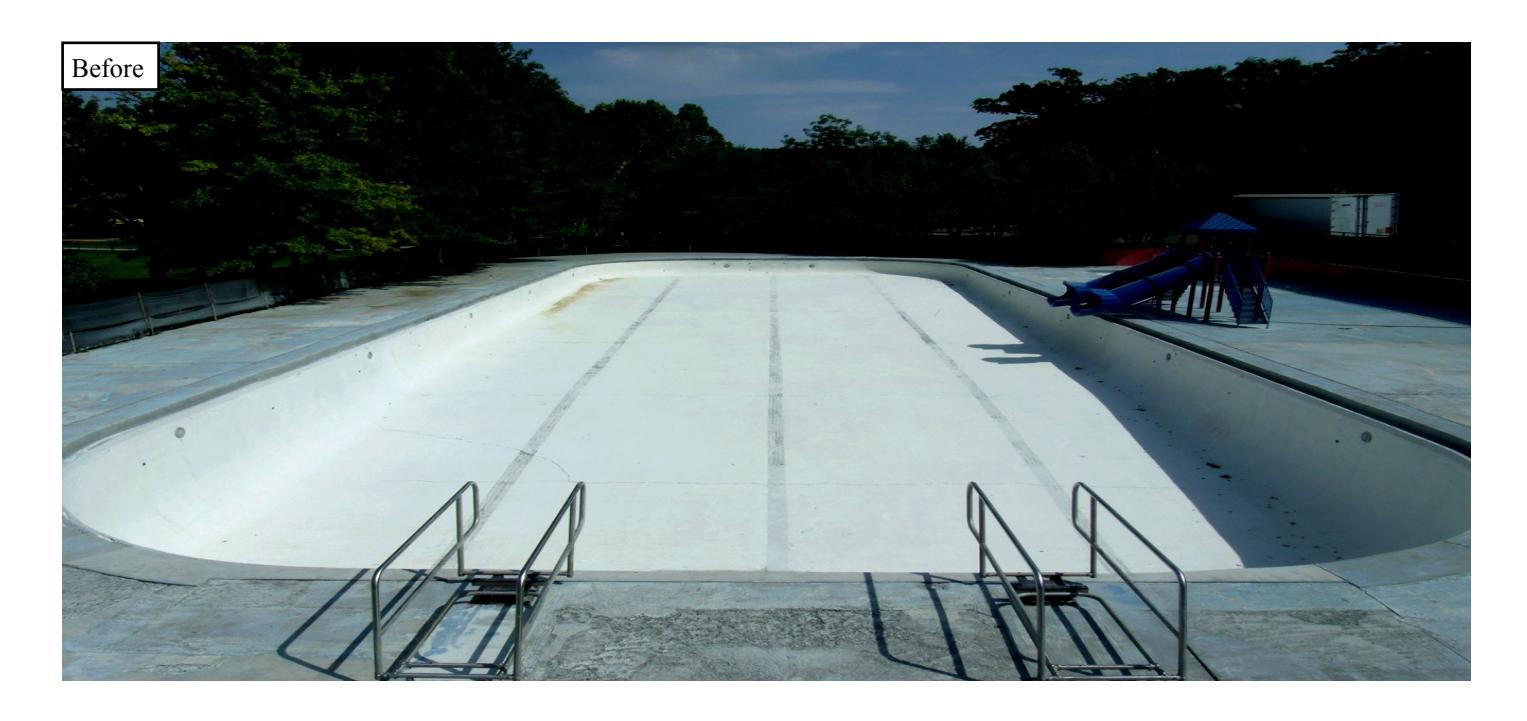
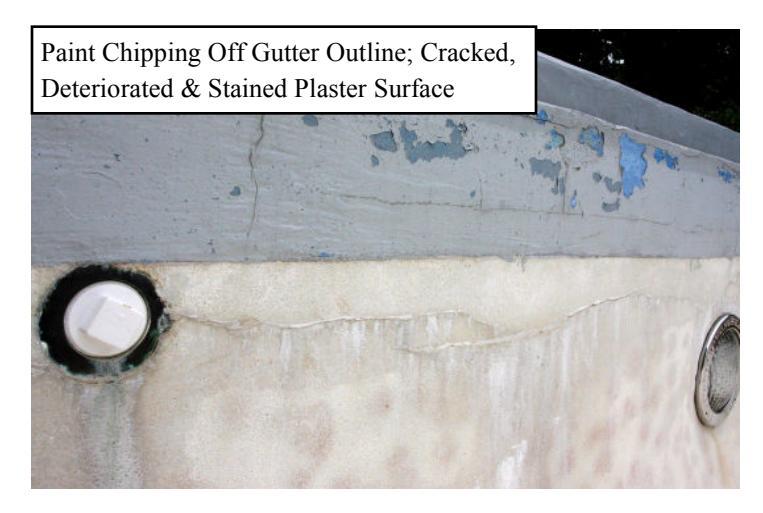
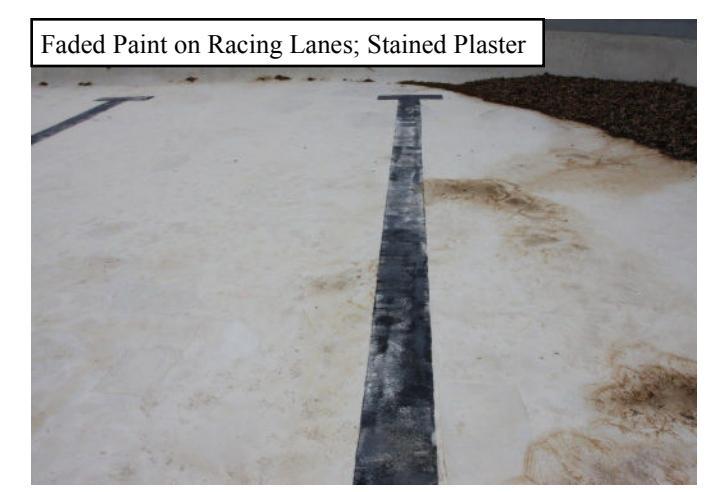
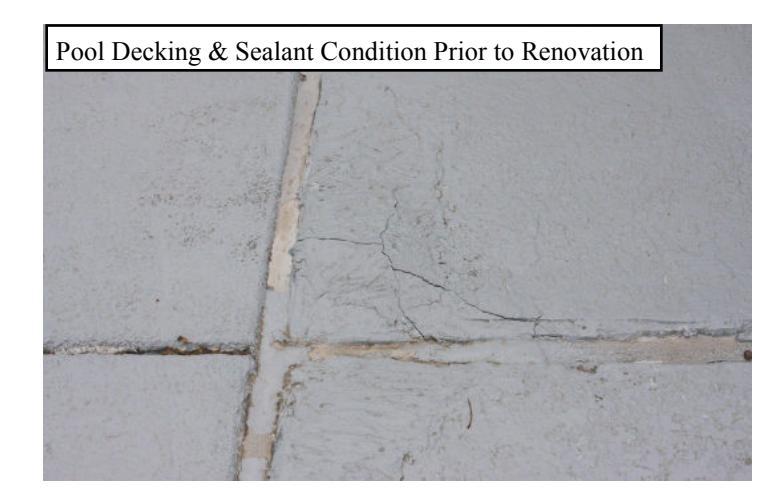
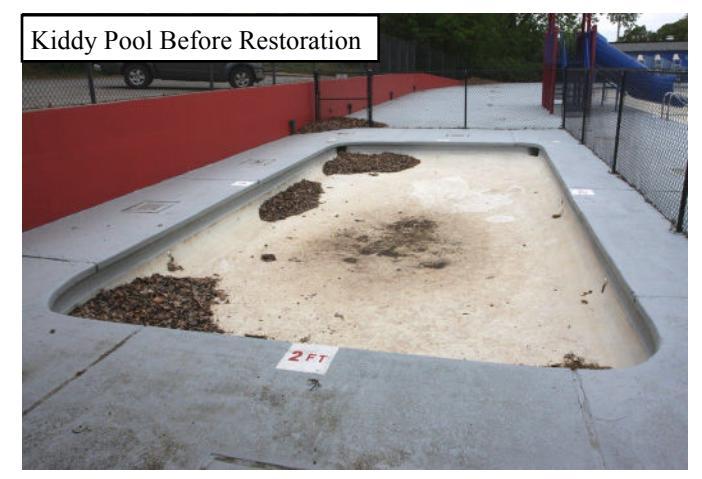
ON-SITE INSPECTION

The Wilson Park Pool was originally constructed in the mid-20's, and is located in the Rock House Historical District of Fayetteville. With very few exceptions, the pool is structurally sound and near perfectly water level. After years of use and enjoyment, but in some disrepair and in need of beautification, in 2012 a major Restoration Project was undertaken on the pool. Work was required to repair and seal a number of transverse structure cracks in the pool floor, the plaster finish on both the main and kiddy pools was very worn, stained and rough and needed resurfacing, and the pool decking texture was in a very degraded state.

A unique feature of the Wilson Park pool is that Scull Creek runs from east to west under the entire 160' length of the pool. Built at a site that was known as Trent's Pond, the original bathhouse and changing rooms were underneath the west side of the pool. And while in disrepair, closed, and full of stalactites, these rooms can still be visited and viewed for a real perspective of the original construction. The pool remains empty during the off-season, the plaster surface had numerous shrinkage cracks throughout. The concrete gutter had been painted several times. Parts of the gutter overflow cap had cracked and released creating a safety issue for pool users.

- First, layers of decking paint and deteriorated texture had to be removed from the pool decking,
- Second, the pool interior had to be thoroughly cleaned and scarified, but with care not to exceed a surface preparation roughness of CSP 3. With the pool remaining empty during the off-season, a Cement-based surface prone to shrinkage would not be placed. INTER-GLASS® was chosen for resurfacing as it presented the best solution and warranty choice for the pool interior. If the pool had a very rough surface, further preparation would have been required putting the Restoration budget in jeopardy,
- Third, the transverse structure cracks in the pool had to be permanently sealed and covered, and
- Fourth, Scull Creek had to be environmentally protected from Restoration debris entering the water.

Clean, environmentally recognized Hydro-blasting (40K Water Jetting) was chosen as the best preparation method on both the deck and pool surfaces. Fabric guards were installed on the fencing surrounding the pool to prevent pieces of deteriorated texture and paint from entering landscape and planted areas around the pool. Debris was confined to the decking and to inside the pool shell. Blasting water and debris were filtered through large containment units. Debris was captured within the containment units and cleaned filtered water was released onto the surrounding grounds. After the blasting and removal process was over, structure cracks in the pool were cleaned, prepared, epoxy injected and covered with InterSteel. Old sealant material in the decking area was removed. Each joint was cleaned and prepared for new sealants. Toe-stubbers were mechanically removed. New grounded and bonded brass anchors for pool ladders and rails were installed. A significant area encompassing both 1-meter dive stands was removed and replaced with new concrete. A thin, fully adhered, high Bonding Strength Slurry Coat was installed throughout the entire decking for leveling and filling purposes.
